On-Site Septic System Property Transfer Report

20832 SE 263rd PL
Covington, WA

PROJECT: ON SITE SEWAGE SYSTEM RECORD DRAWING

OPERATION / PERFORMANCE MONITORING REPORT

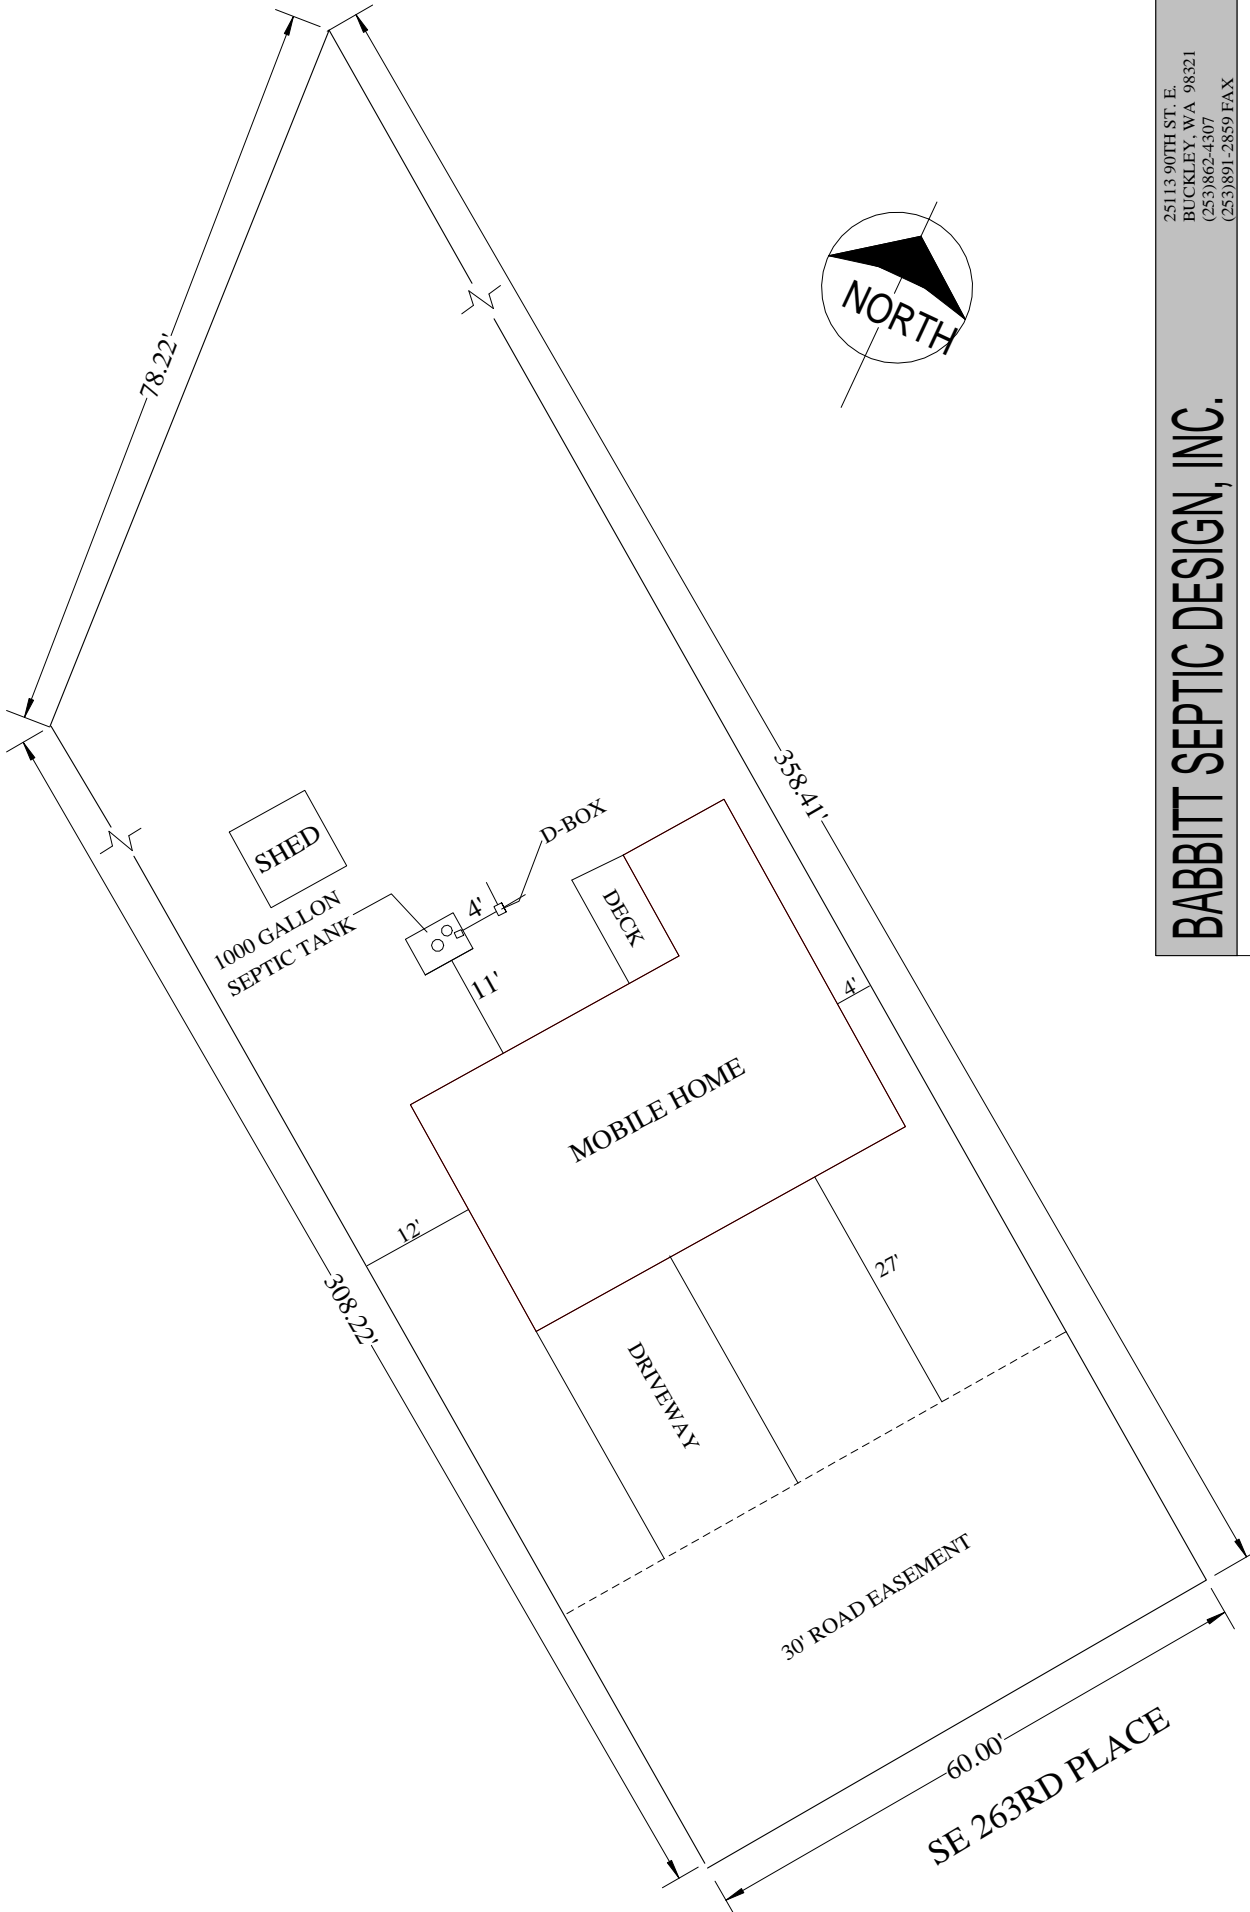
DRAWING # 1 OF 1
 DRAWN BY/DATE A140708

System in good working order. Drainfield passed stress test; accepted ~ 450 gallons of water over 90 min.
