Revised Report Geotechnical Engineering Services Ravensdale Reclamation Trench Filling and Restoration Project Ravensdale LLC Property Section 1, T21N, R6E and Section 36, T22N, R6E Ravensdale Area, King County, Washington

> June 29, 2020 ICE File No. 1352-001

Kurt Erickson and Fred Wagner Ravensdale LLC P.O. Box 365 Gig Harbor, Washington 98335

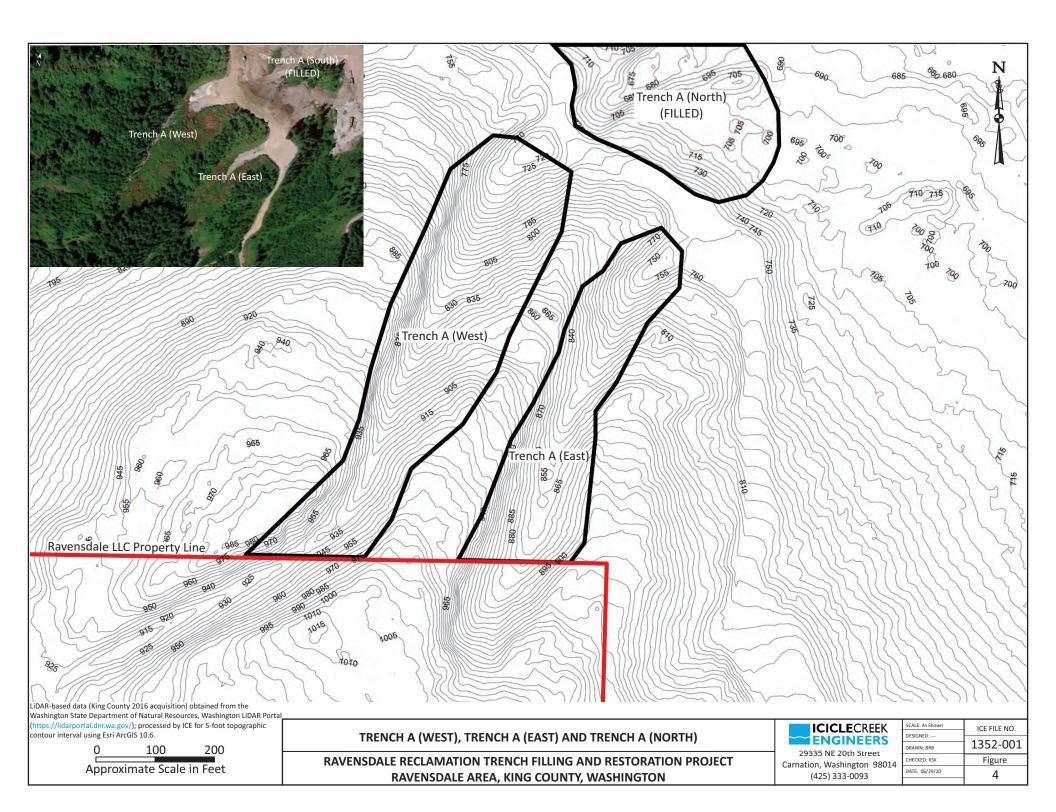
Trench A (West) – Trench A (West) as shown on Figure 4 is an open-ended, relatively steep/deep slot in the hillside that extends to the south property line. The sidewalls are near vertical on the west side, and near 100 percent grade on the east side. The base of the slot has scattered blackberry and other invasive plants and bare bedrock; no surface water was observed.

Trench A (East) – Trench A (East) as shown on Figure 4 is similar to Trench A (West) as an open-ended, relatively steep/deep slot in the hillside that extends to the south property line. The sidewalls are near vertical on the west side, and near 100 percent grade on the east side. The base of the slot has scattered blackberry and other invasive plants and bare bedrock; no surface water was observed.

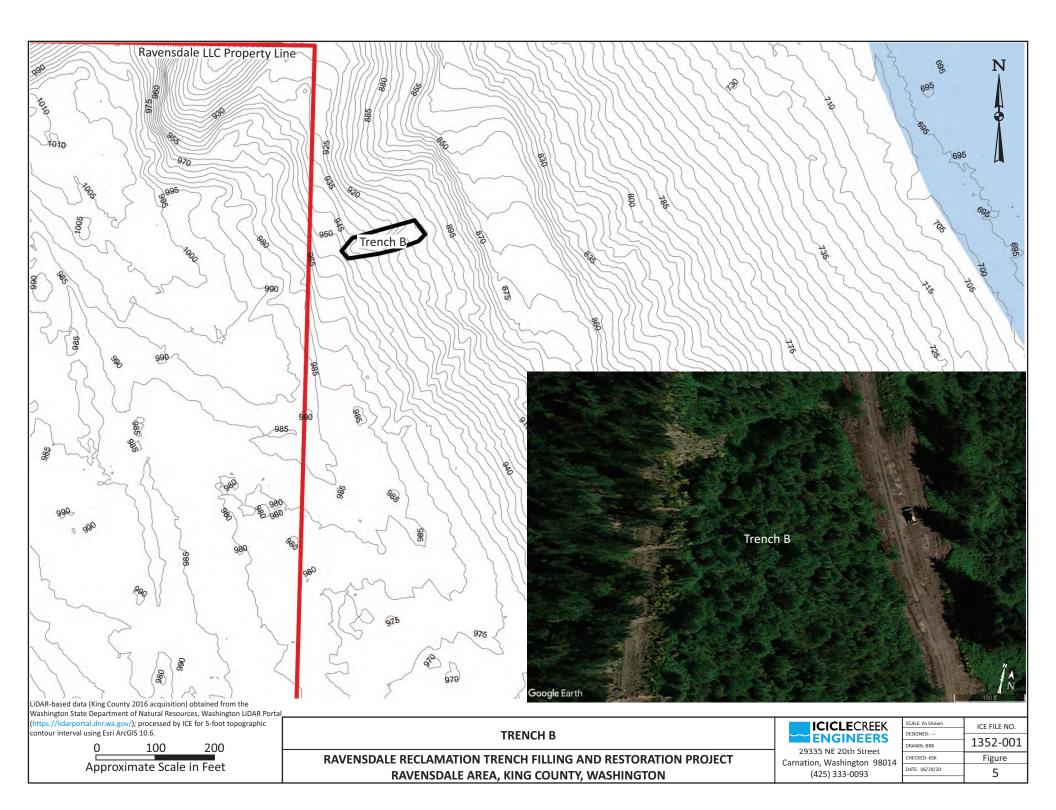
Trench B – Trench B (formerly referred to as Trench K) as shown on Figure 5 is very shallow (less than 5-feet deep) and occurs on a very steep hillside covered with dense brush. We expect that because of the very steep site conditions and small area that Trench B will be filled.

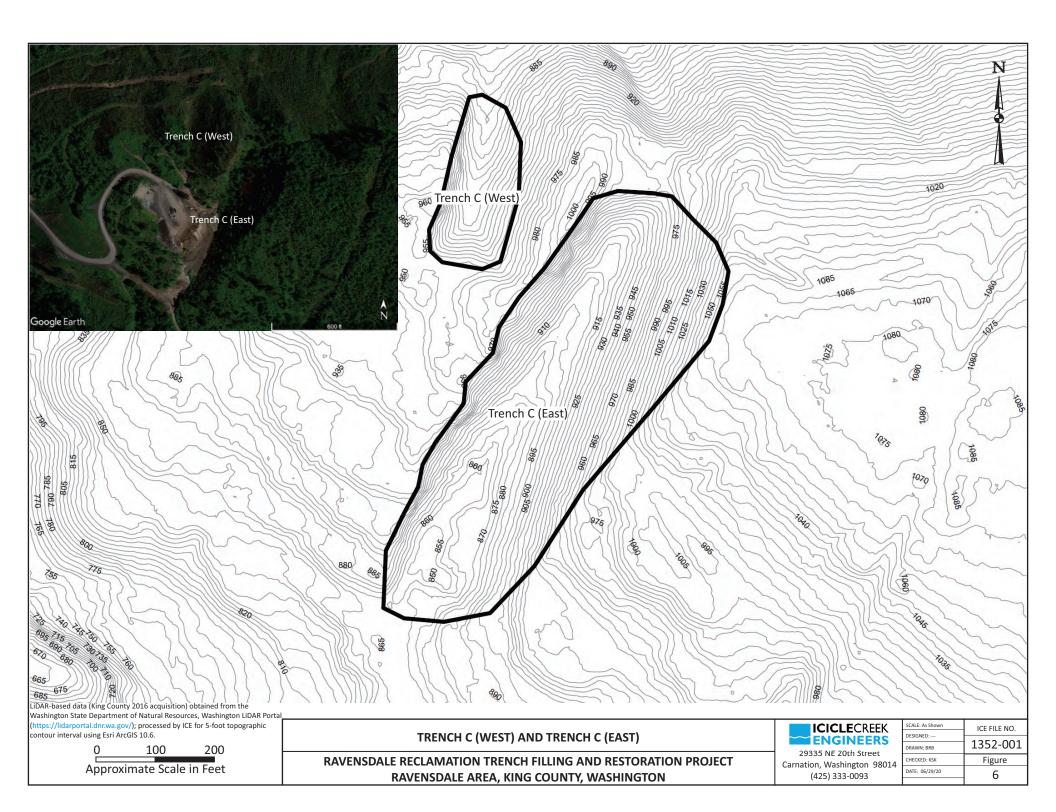
Trench C (West) – Trench C (West) as shown on Figure 6 "daylights" to a steep, recently clear-cut slope (more than 40 percent grade) overlooking the Ravensdale valley. It appears that this hillside has been partially graded in the past (bench topography).

Trench C (East) – Trench C (East) as shown on Figure 6 has been substantially filled. During our October 2, 2019 site visit, we observed wet soil conditions at the toe of the new fill that has caused localized slumps and failures extending out from the toe of the new fill. It appeared that a crude fill embankment had been constructed at the distal toe area (yet to be filled) to contain turbid water and shallow landslides. The crude fill embankment appeared to be effective in containing the turbid water runoff and shallow landslides. No further filling should occur at Trench C (East) until a plan is developed to stabilize the area of wet, soft soil accumulation.

Based our limited site observations during fill placement at Trench C (East) in October 2019, it appears that some of the imported fill is either end dumped or pushed out onto an open slope creating a "sidecast fill" condition. This method of fill placement is not favorable for achieving compaction and establishes downsloping planes of weakness where slope failure may occur. However, sidecast fill may be completed in closed Trenches such as Trench E or at least 300 feet from the toe (berm/buttress) area of the other downslope open-ended Trenches.

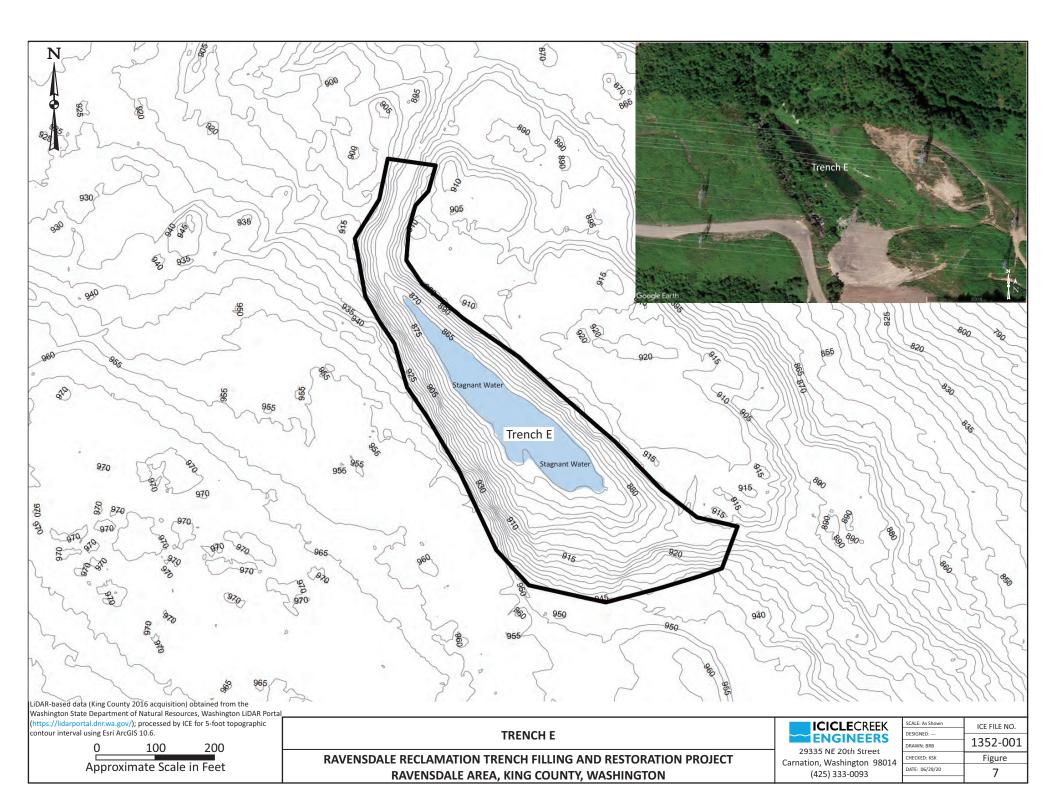
Trench E – Based on our field observations and topographic mapping (Washington LiDAR Portal, Esri ArcGIS) using 2-foot topographic contour interval, Trench E exists in a closed depression (watershed) with no stream inflow or outflow as shown on Figure 7. The underlying bedrock is generally considered to be impermeable.

Based on our site observations on October 2, 2019, the water surface appears to fluctuate by at least 4 feet. Any inflow or outflow of water from the wet area is by direct precipitation or evaporation.

As a performance example, the current end-slope at the Trench E site that was previously partially filled is sloped at about a 33-percent grade (3H:1V slope). We observed local gullying and slumping of the surface of this fill which suggests that a maximum slope of 33-percent grade (3H:1V) is appropriate with emphasis on erosion control and surface water drainage improvements to improve outcomes for the permanent condition.

Trenches E and F are likely the easiest to fill. The stagnant water in Trench E should be pumped out before filling. Trenches E and F are basically closed depressions, therefore filling the excavation with loose, poor quality fill has little or no adverse impacts. Trenches E and F should be designated the sites where the most unsuitable fill (very wet soil, clays and silts) should be placed. Trench E has been partially filled. Trenches E and F should be filled to restore groundwater and surface water flow conditions in addition to eliminating the high-risk safety hazard for Trench E of the near vertical hanging wall that is adjacent to the access road.
