**SE 416TH STREET OVERLAY:
SHINGLES IN PAVING DEMONSTRATION**

**Post-Construction Pavement Condition
SEPTEMBER 2010**

RSD-TR-0100

SE 416th Street Overlay: Shingles in Paving Demonstration Post-Construction Pavement Condition - September 2010

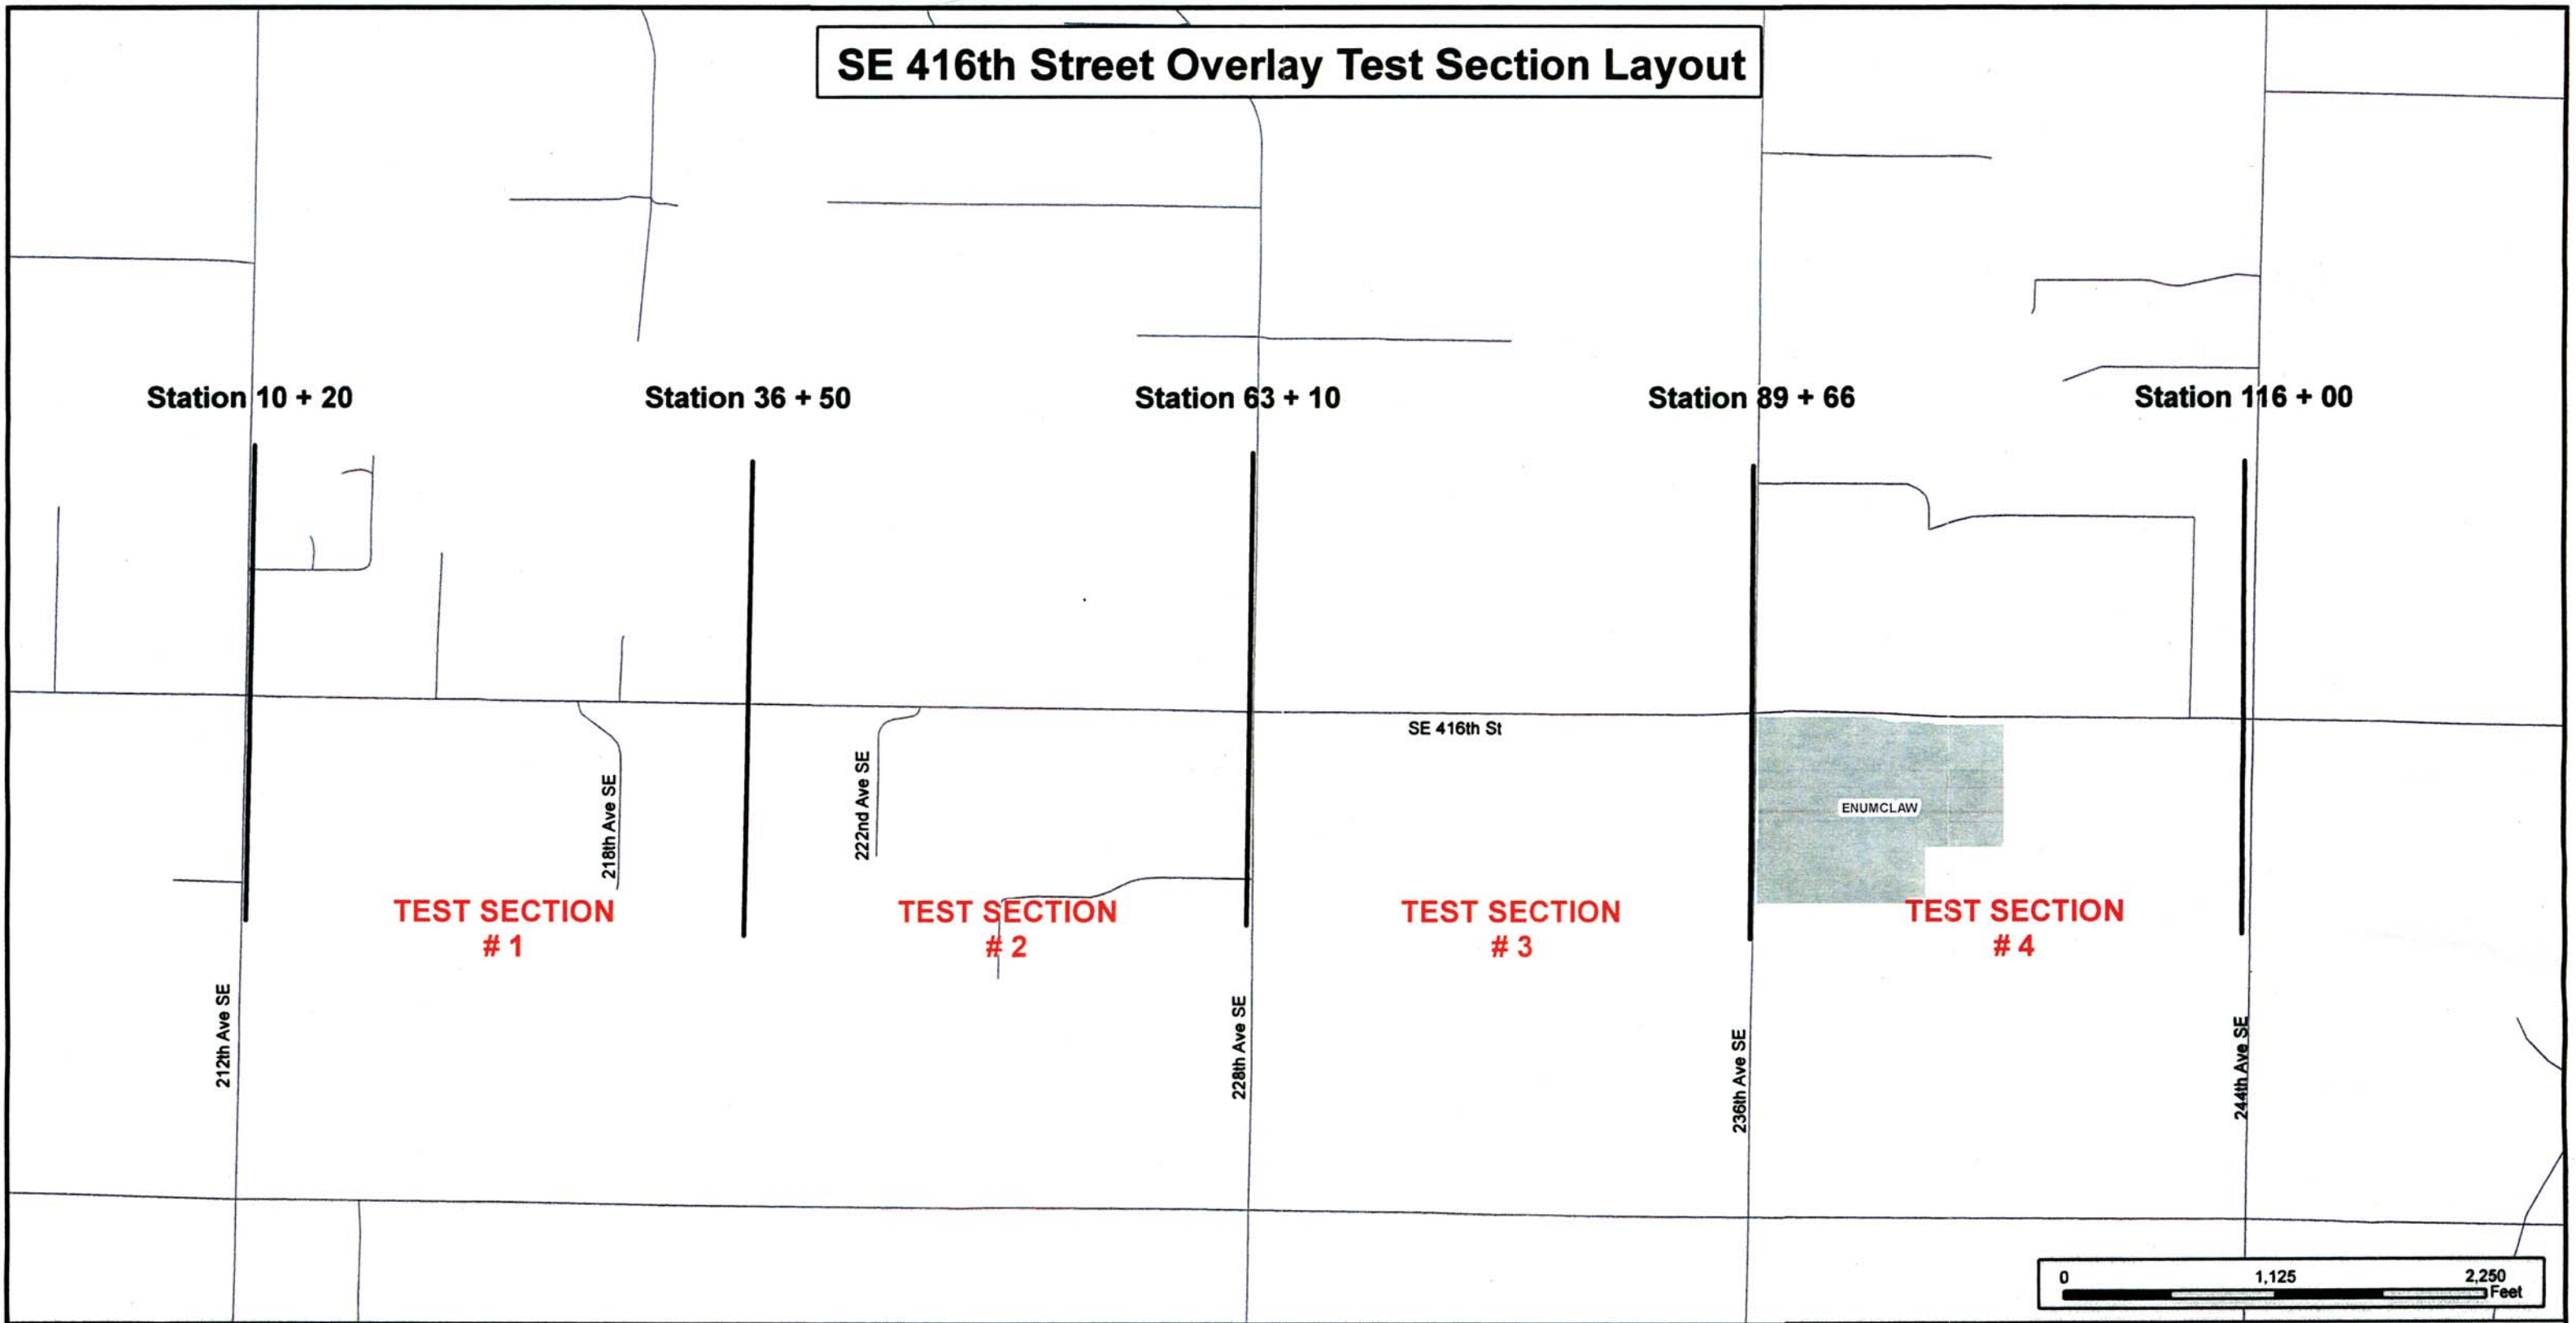
Figure 2

The roadway was divided into four separate test sections, each approximately 1/2 mile in length. The division allowed for one test section each of RAP with HMA and RAP/RAS with HMA to be sited on both the western and eastern portion of the roadway. Each test section required about 1000 tons of HMA to provide for a 2-inch thick overlay. The test section layout for this project is shown in Table 1.

TABLE 1				
Se 416TH Street Overlay				
Test Section Layout				
Lane Description	Test Section #1	Test Section #2	Test Section #3	Test Section #4
Stationing	10+20 to 36+50	36+50 to 63+10	63+10 to 89+66	89+66 to 116+00
Lane 1 (eastbound)	HMA Mix with 15% RAP	HMA Mix with 3% RAS and 15% RAP	HMA Mix with 3% RAS and 15% RAP	HMA Mix with 15% RAP
Lane 2 (westbound)	HMA Mix with 15% RAP	HMA Mix with 3% RAS and 15% RAP	HMA Mix with 3% RAS and 15% RAP	HMA Mix with 15% RAP
