Damaged Pipe Investigation

Discovery Park Environmental Learning Center February 16, 2017 6:30-8:30 p.m.

Pipe Background

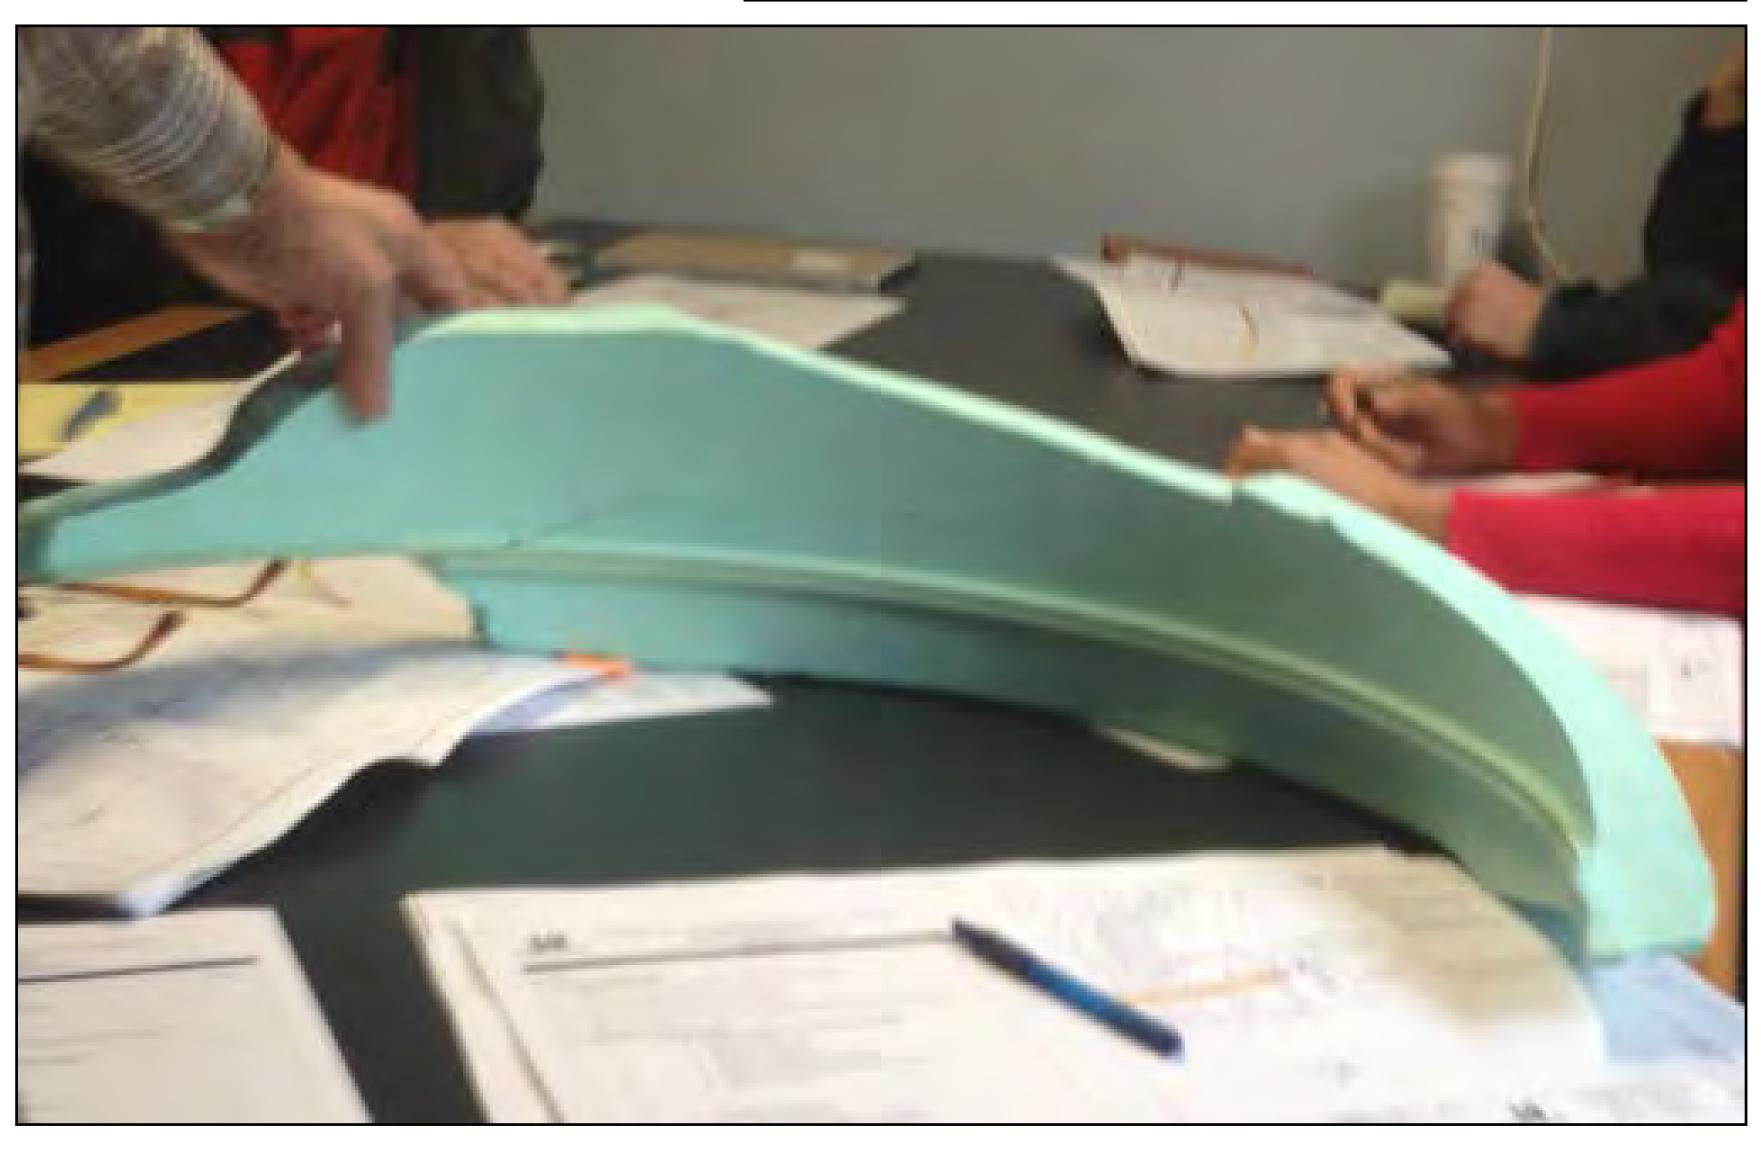
Investigation starts September 2016 Tank did not fill during storm

- Inspections eliminate
 City sewers as source
- No indications of a problem from surface
- Pipe debris found in November

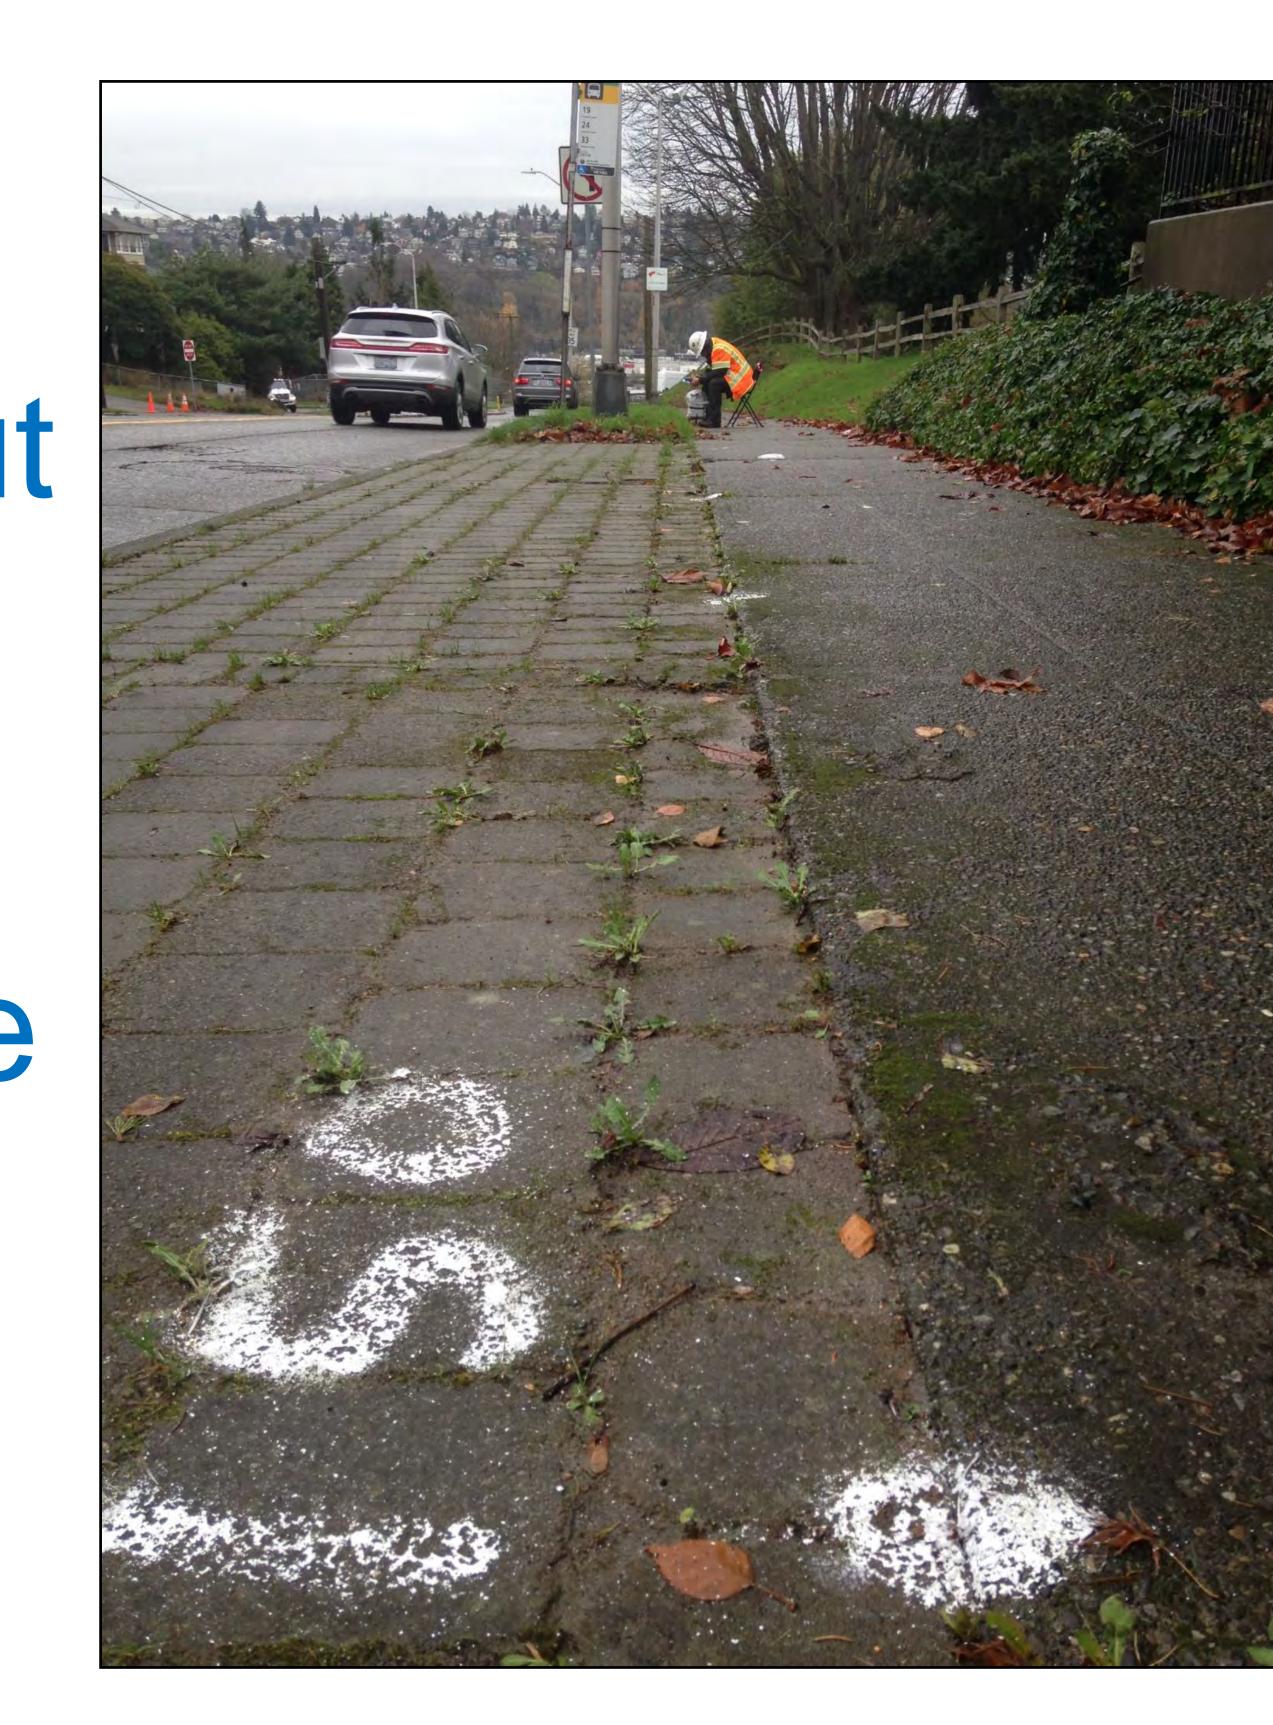
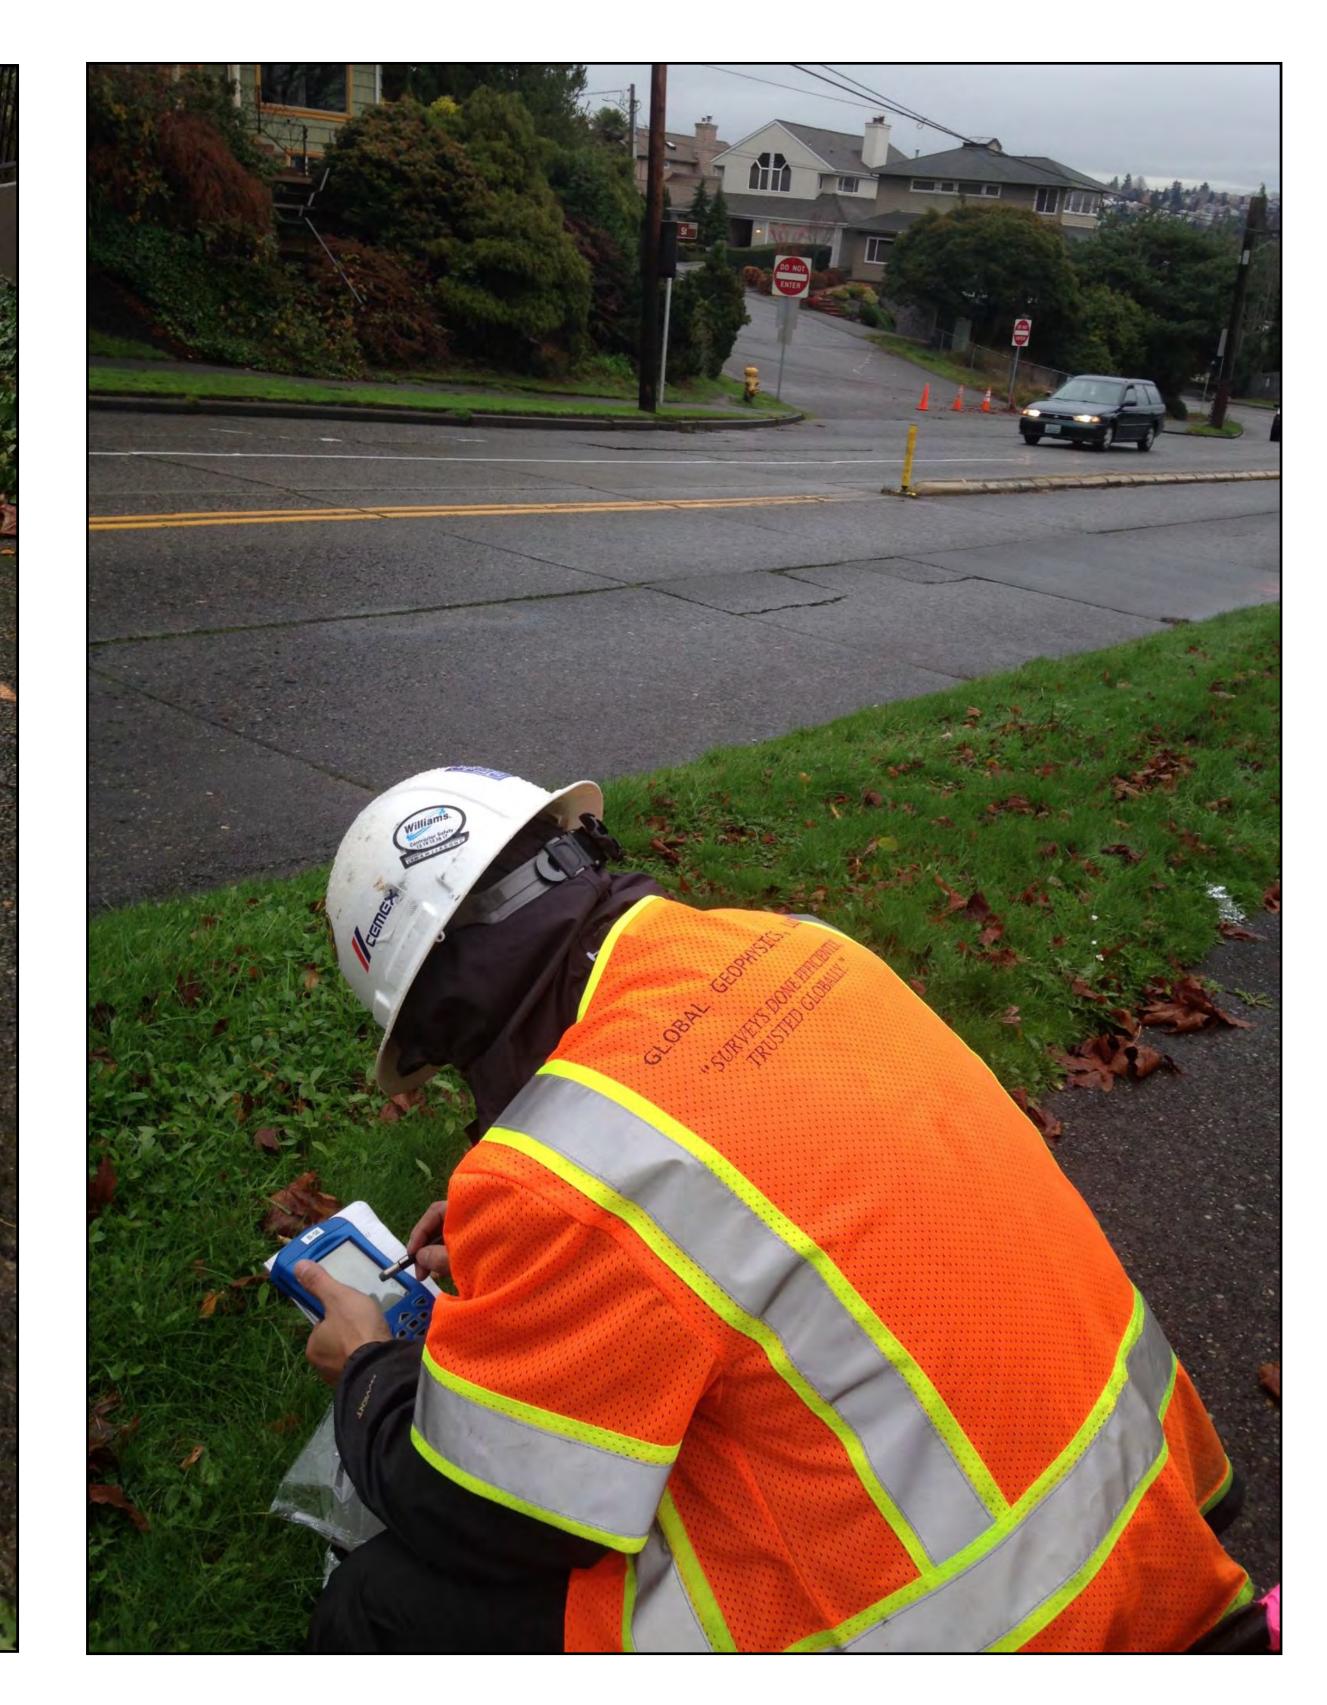
Geophysical Surveys – December 2016 Two types: microgravity & electrical resistivity

Each gathers different information about soils along pipe No areas of soil loss near surface 2 locations of interest located deeper down

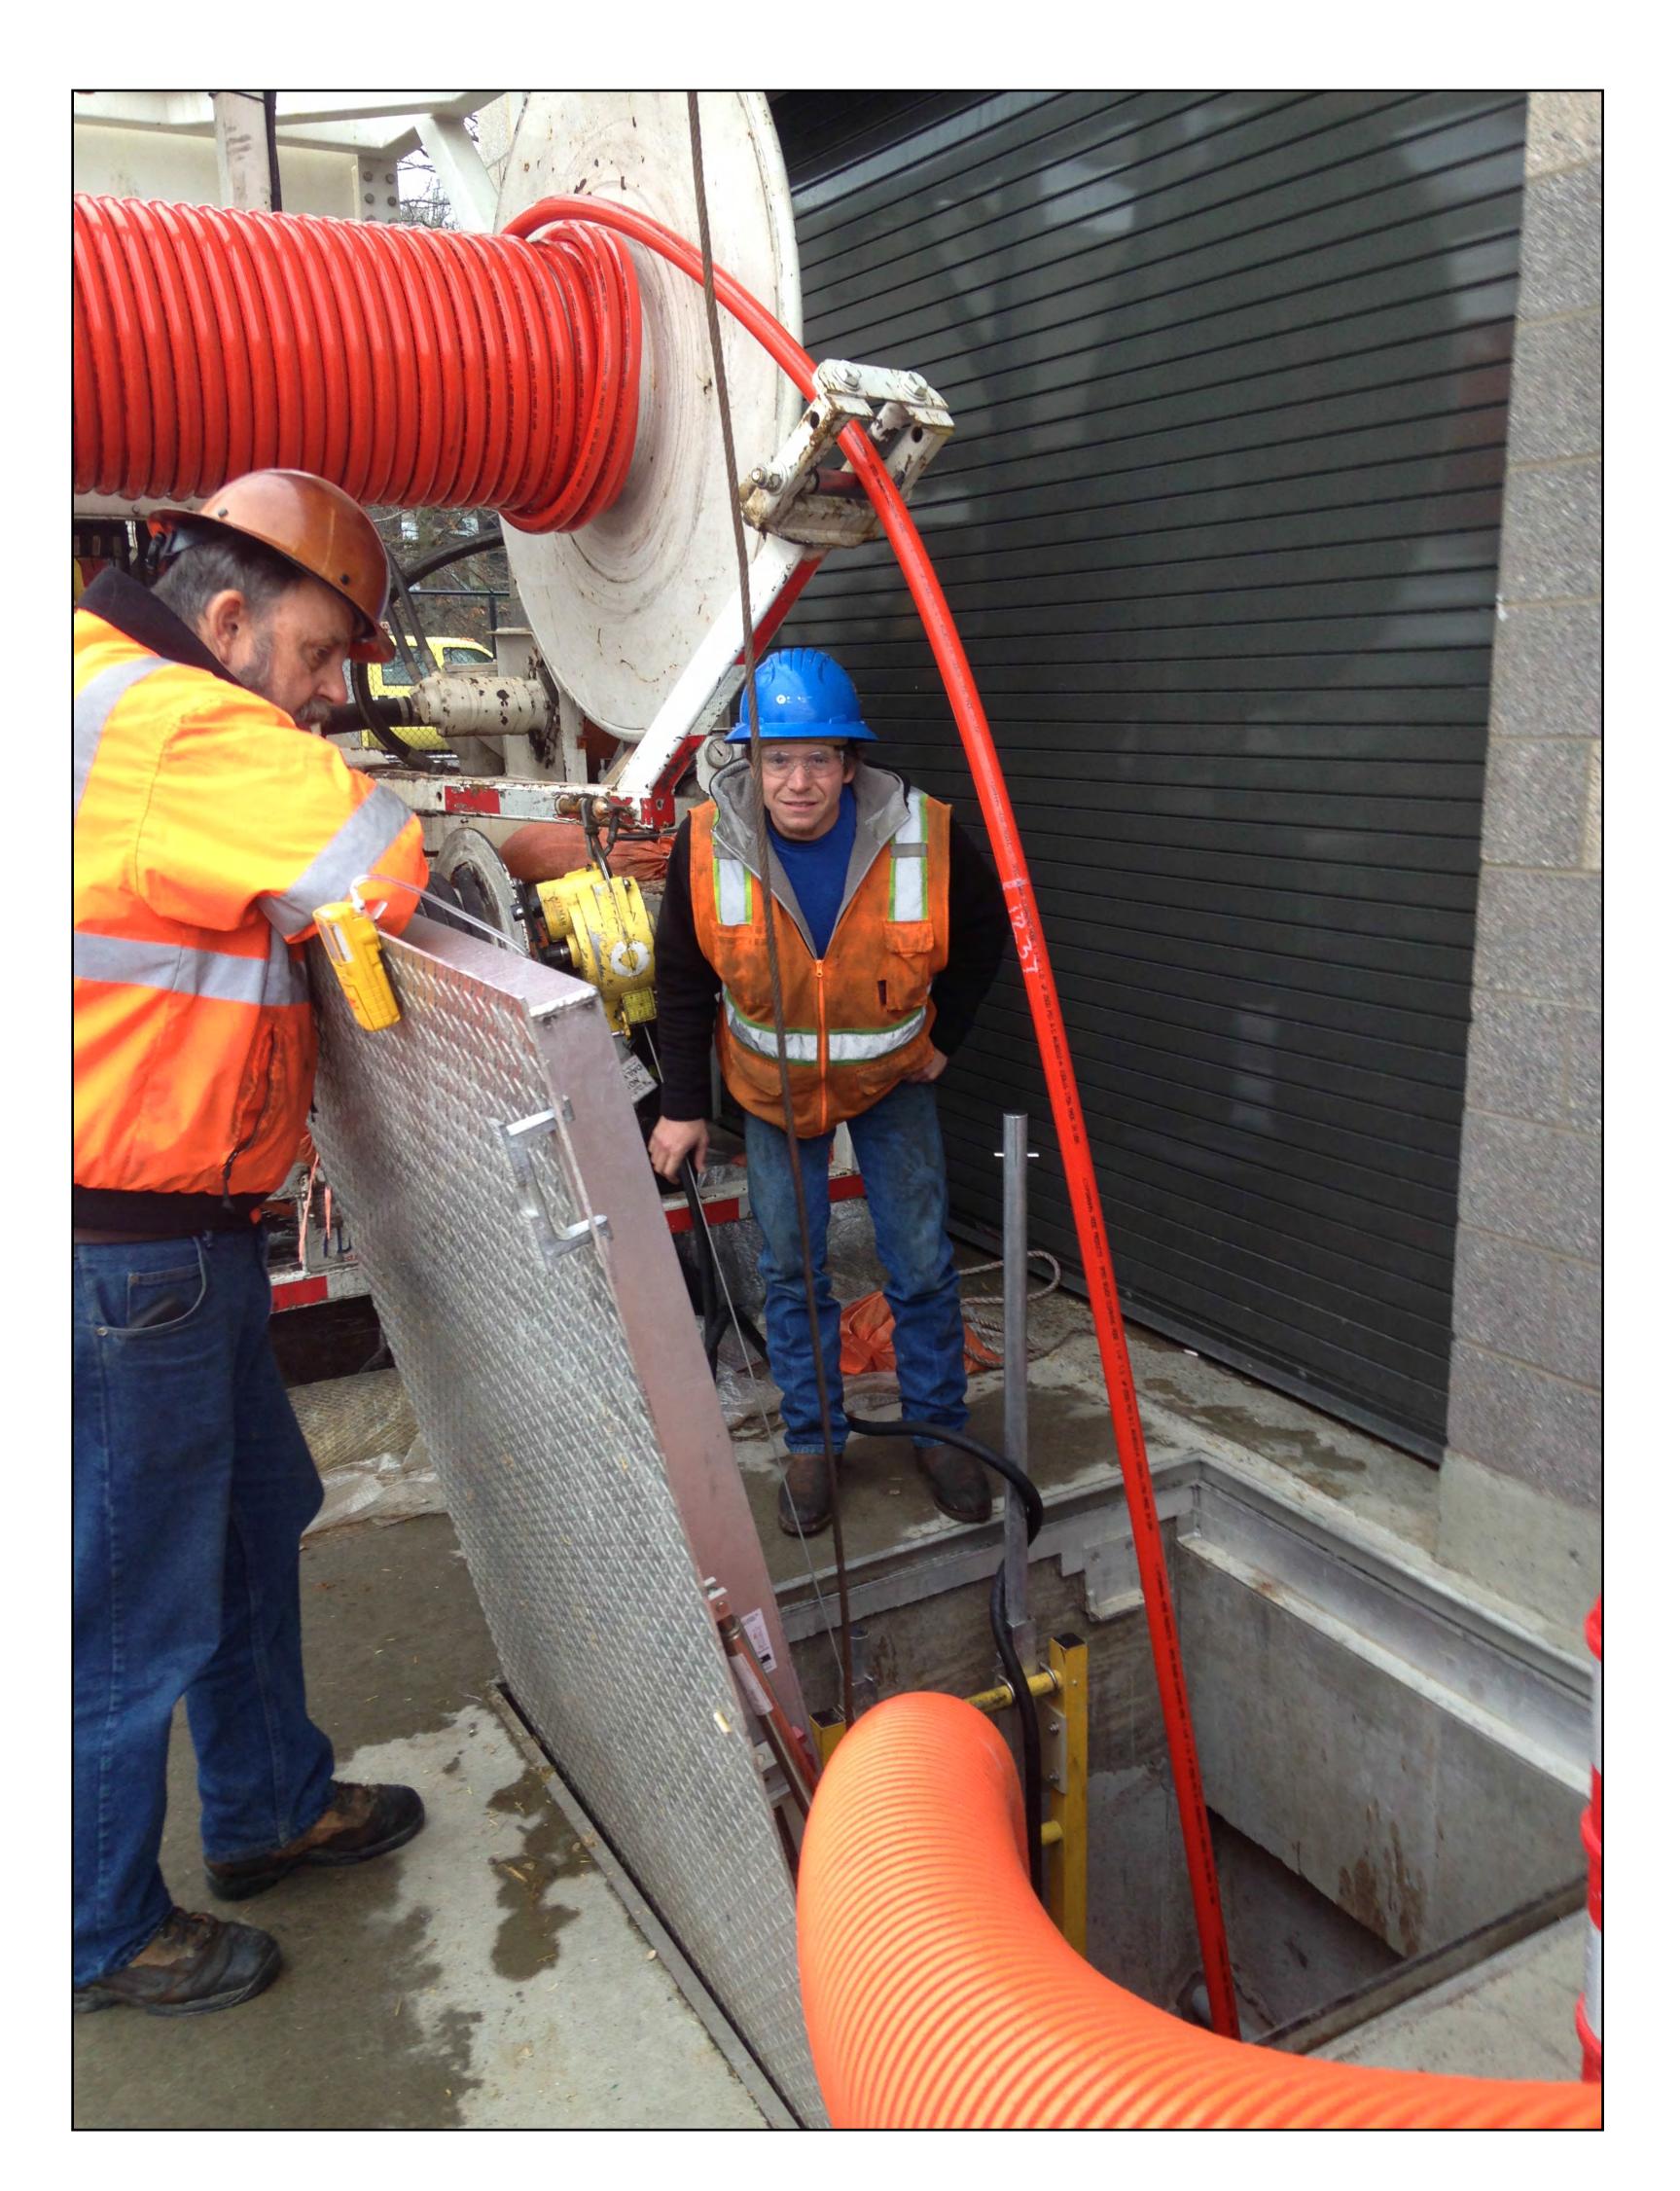
Pipe Cleanout – January 2017

- California-based pipe cleanout specialty company hired
- Water rose on upstream (western) side of pipe during clean out
- Prevented camera inspection
- Pipe remains blocked
