WARRANTY INSPECTION

SUPPLEMENT TO THE PILOT PROJECT REPORT

Regional Infiltration and Inflow Control Program
King County, Washington

August 2006

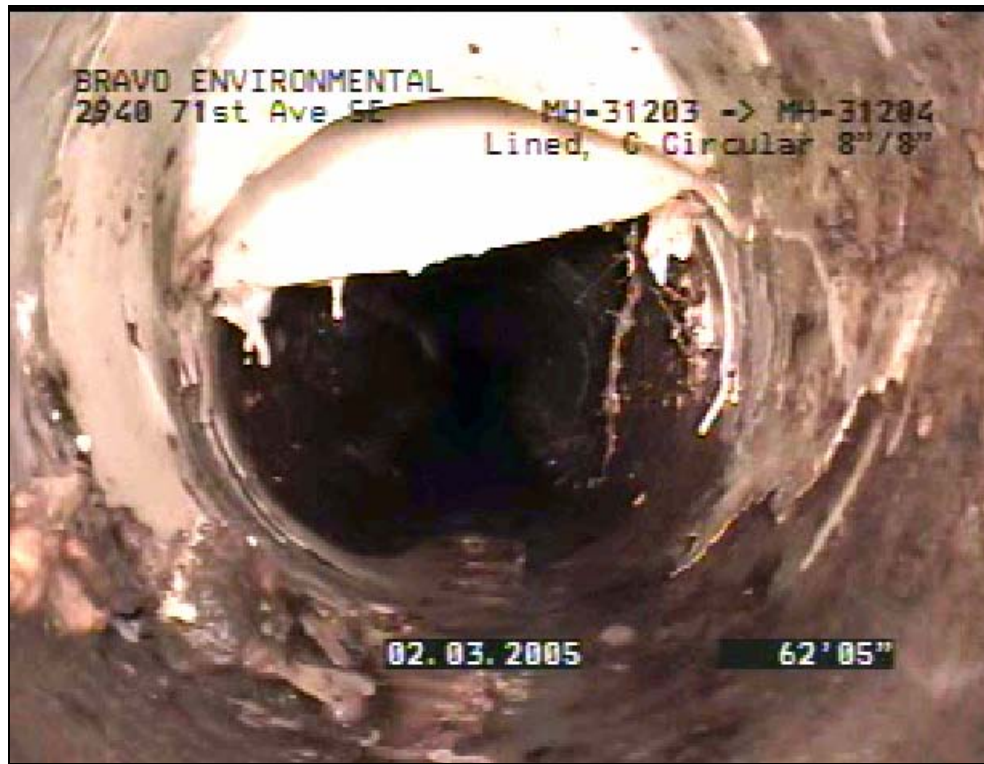
Figure 1 – Homeowner installation of CIP liner in lateral

Another issue noted was homeowner repair of a side sewer using a CIP liner. The liner projects into the sewer main, as seen in Figure 1. Although not a warranty issue, it is an example of a

Note that the CIP liner blocks the sewer main and the TOP HAT™ has been partially destroyed and is no longer effective.

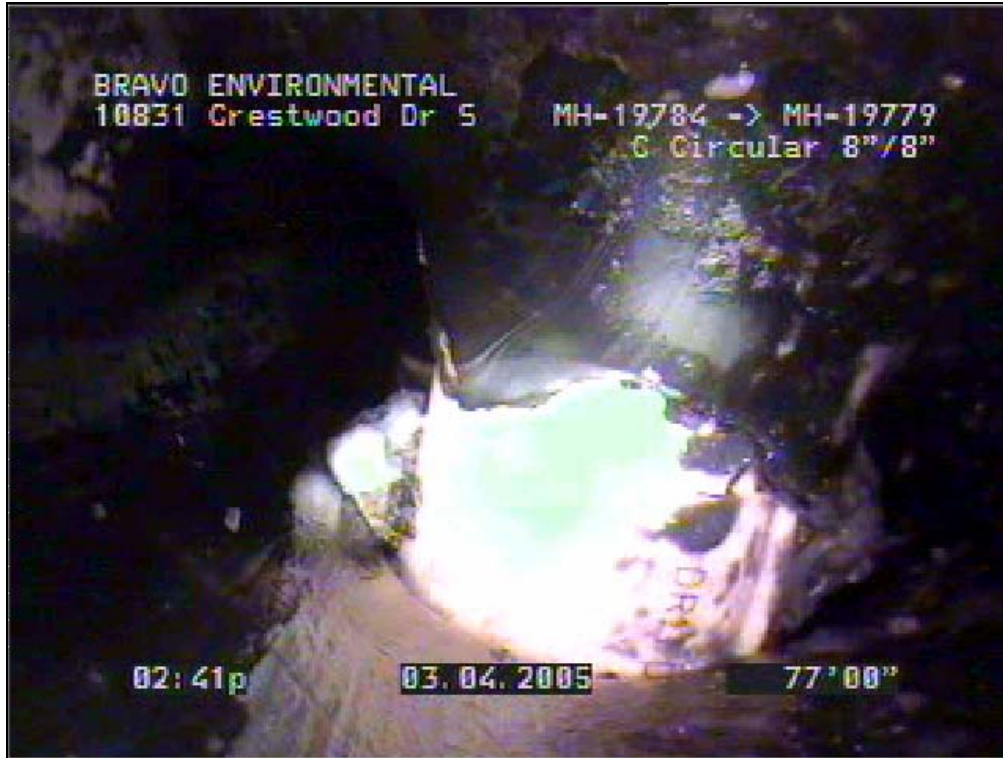
Figure 2 – Irrigation pipe bored through a side sewer in Skyway

The Skyway pilot project consisted of new manholes, pipe burst mains, and pipe burst or dig-and-replace laterals and side sewers. Only two defects involving leaks were noted in the work done in Skyway: two connections between an HDPE sewer main and a lateral were actively leaking. See Figure 3 for a picture of one of these leaks. Other issues noted were an illicit yard drain connection to the system and the new irrigation system pipeline bored through the new side sewer. See Figure 2 for a picture of the new irrigation system pipeline bored through the new side sewer.

Picture was taken with a push camera so orientation is unknown.

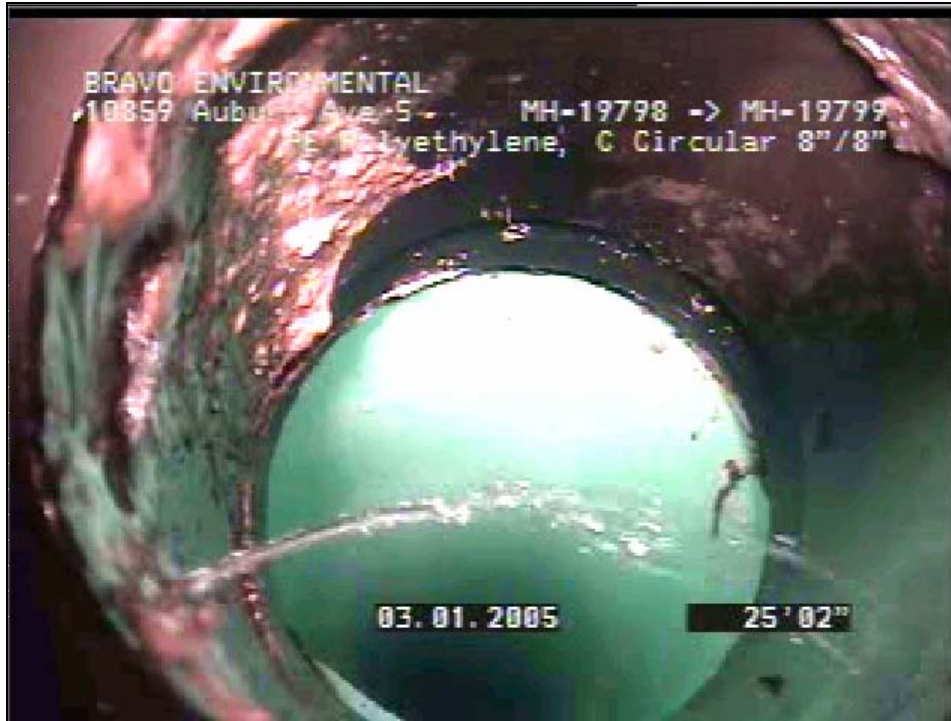
In Skyway, leaks were noted in two connections between an HDPE main and a lateral. See Figure 3 for a picture of one of these defects. These leaks were observed at the bottom edge of two welded saddle connections. It is likely that there was an insufficient seal between the main and the saddle when the saddle was welded in place. These connections were made by hand by first placing the curved heater plate between the main and the saddle, then removing the heater plate before the saddle was pressed against the main using a 6-foot-long pry bar. The connections were not tested before drilling the hole in the main.

Figure 3 – Leak at the bottom of a welded saddle connection in Skyway
Picture was taken looking up the lateral from inside the sewer main.

- Perform either an air or water pressure test of the welded lateral connection before cutting into the main.
- Select a welding method that forces the main to be round before the lateral connection weld is made. This is basically a clamping system that controls the fit between the main and the saddle during the process.
- Consider using a small amount of controlled density fill around the connection prior to backfilling to avoid problems with the compaction of soils around the connection.
- In the future, consider electrofusion-welded couplings for joints immediately outside the manhole.

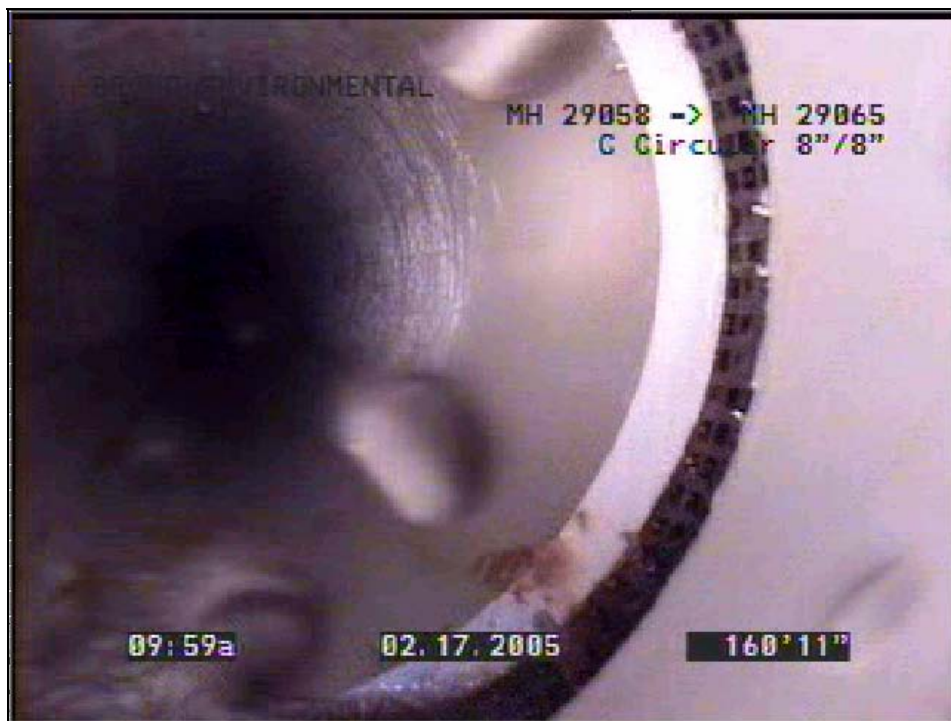
Another potential problem included two separated joints where non-HDPE couplings were used for the joint immediately outside the manhole. See Figure 4. Although the work was not considered to be a warranty defect since the work was not in violation of the specifications and there was no visible leakage, there appears to be a potential for future failures of these joints. The ends of each pipe were cut with a chain saw and then stabbed into the coupling. Ragged edges were visible inside the pipe. Future evaluations should consider how well a rigid coupling seals against flexible HDPE pipe, and electrofusion-welded couplings should be considered for joints immediately outside the manhole.

Figure 4 – Non-HDPE coupling used during pipe busting
Used for the joint immediately outside a manhole in Kirkland.

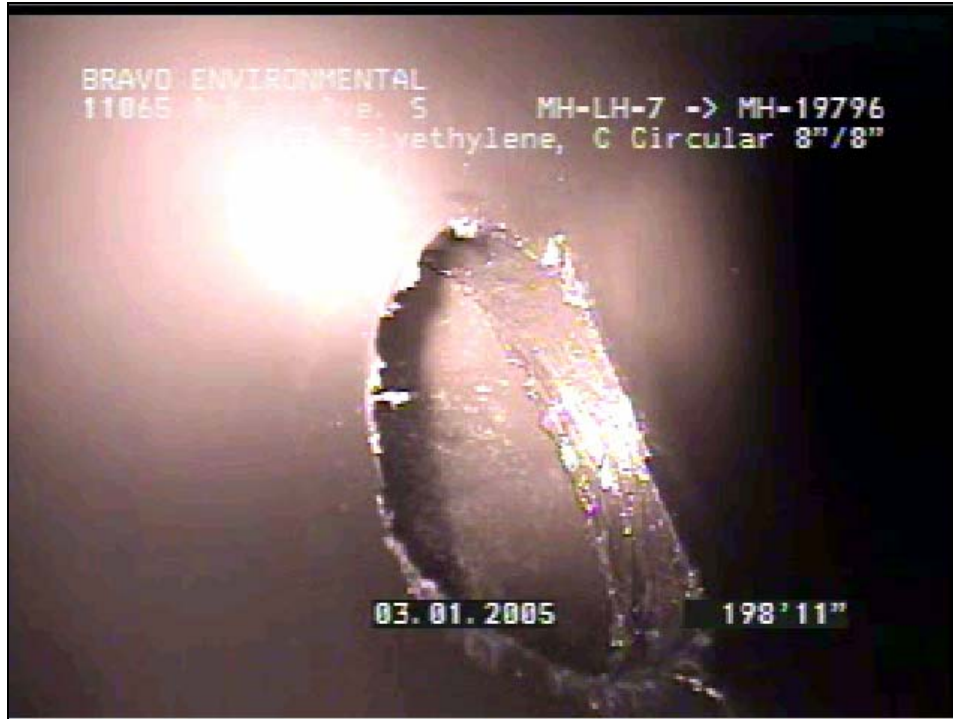
Figure 5 – Black HDPE pipe in Skyway

Another interesting comparison is the difference between black and gray HDPE pipe. See Figures 5 and 6 for pictures. Gray pipe reflects light better than black and is recommended.

Pipe is visible only when light from the camera is aimed at it. The photograph also shows a lateral cut through the sewer main.

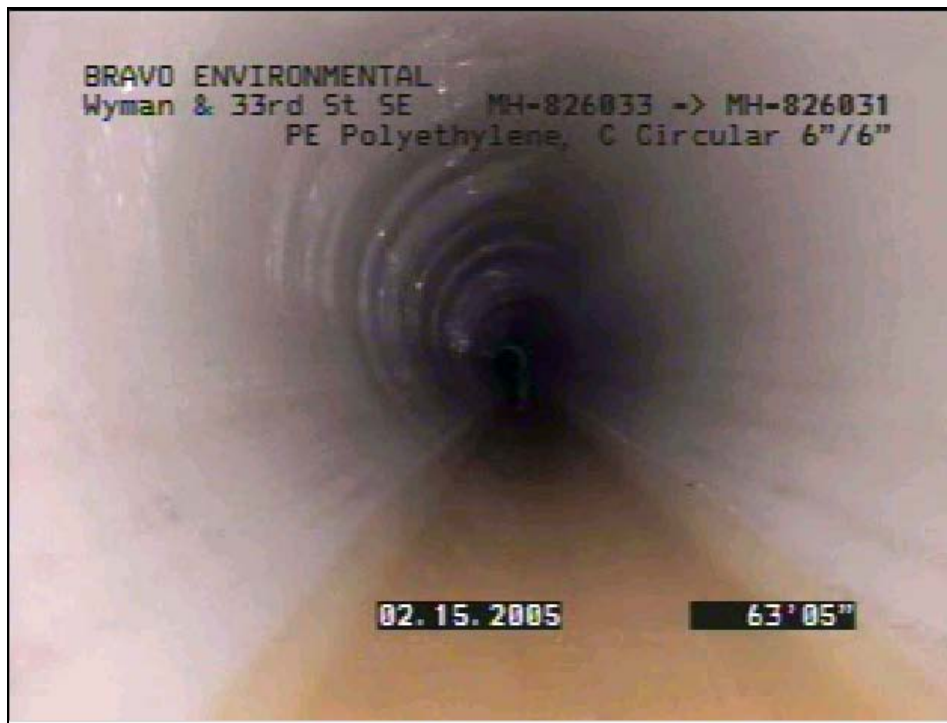
Figure 6 – Gray HDPE pipe in Auburn

Pipe reflects light from the camera better than black HDPE pipe.

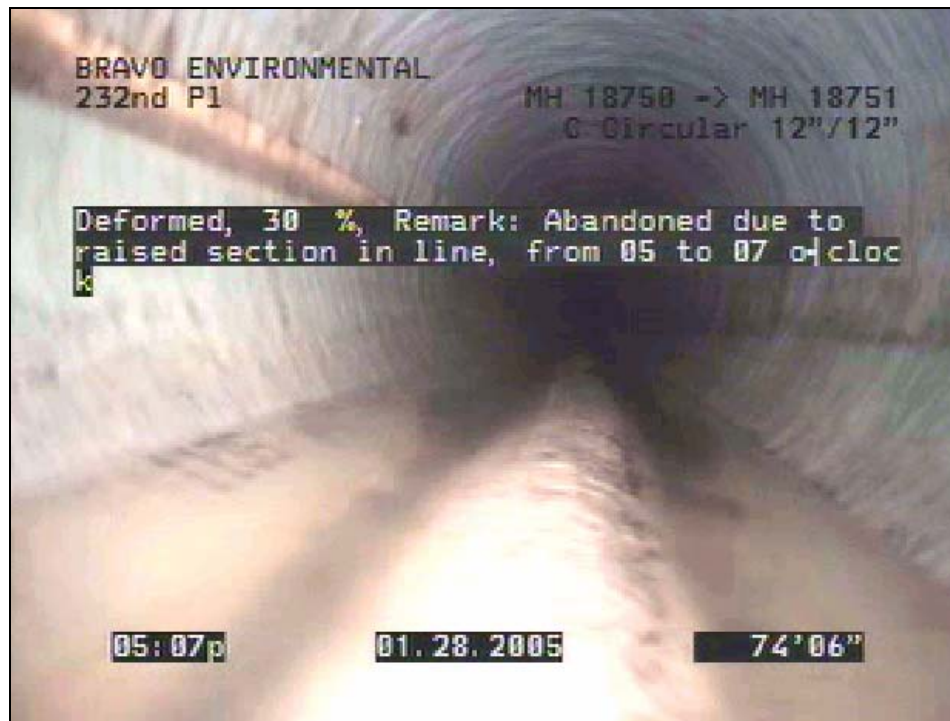
In Brier, there was a curing failure in the bottom portion of a 12-inch-diameter CIP liner. It was not observed in the August 2004 post-construction video. This area was first seen during the March 2005 warranty inspection as a long bubble about 3 inches wide in the bottom of the 12-inch-diameter pipe. The bubble protruded upward approximately 1-1/2 to 2 inches. The bubble occurred only in the flow line of the pipe and extended approximately the last 60 feet in the 135-foot-long section of pipe. The cause of this bubble is believed to be: (a) an inadequate liner curing process (inadequate heat from the steam), and (b) the long length of the liner (a 600-foot length of 12-inch-diameter CIP liner was installed in one piece through three sections of pipe). According to the inspector's field notes, the contractor had several problems with this section of liner during construction. The initial problem was discovered the day the liner was installed. The contractor reapplied air pressure and steam the following day. A 3-foot section of the liner was removed and a spot repair was installed inside the pipe at the downstream manhole several days later.

The reason that the bubble was not seen in the late summer post-construction video, but was seen in the springtime warranty inspection, could be due to changes in groundwater pressure; that is, higher groundwater levels could have pushed up this portion of the liner. Figure 7 shows a portion of the defect.

Figure 7 – Defective CIPP in 12-inch-diameter sewer main in Brier

In March 2006, the contractor inserted a liner with no resin and used it as a bladder to reheat and pressurize the bubble in the bottom of the pipe. This appears to have removed the bubble.

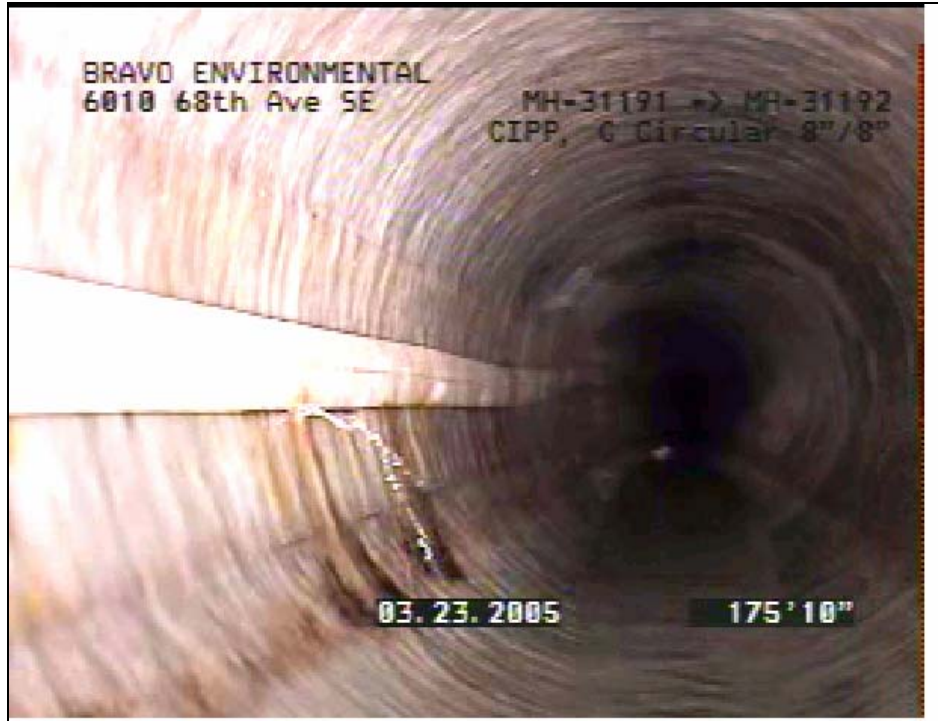
In Mercer Island, leaks through holes in the liner were noted at stitched and taped seams and at some random spots. Active leakage, staining, and debris buildup on the liner indicated the location of holes. The contractor installed six spot repairs during the warranty period to fix this type of defect, in addition to the four spot repairs installed as part of the punch list during construction. There were also numerous minor linear wrinkles. Although the wrinkles are not a warranty issue and do not appear to cause flow problems, they caused minor difficulties in getting the CCTV camera through the pipe. Figure 8 shows an example of an active leak through a CIP liner.

Figure 8 – Active leak through CIP liner in Mercer Island

The white stripe is plastic tape covering the seam and is part of the liner. Behind the tape is the stitched seam in the felt.

The warranty repairs were re-inspected in April 2006 and all leaks appeared to have been successfully plugged. The Top Hats™ also appeared to be securely attached to the CIP liner and were not leaking. However, the CCTV videos taken for the second warranty repairs filmed the entire length of each pipe, not just the repaired portion. For one section of pipe, the videos showed two small squirting leaks in portions of the pipe that were no longer covered by a warranty. Other portions of the inspected pipes had deposits on the walls, which were considered to be indications of potential leaks. The leaks indicated that there was groundwater pressure outside the pipe and there was a route for the water to get to the hole in the liner, either directly through a crack in the old pipe or by flowing through a void between the old pipe and the liner.

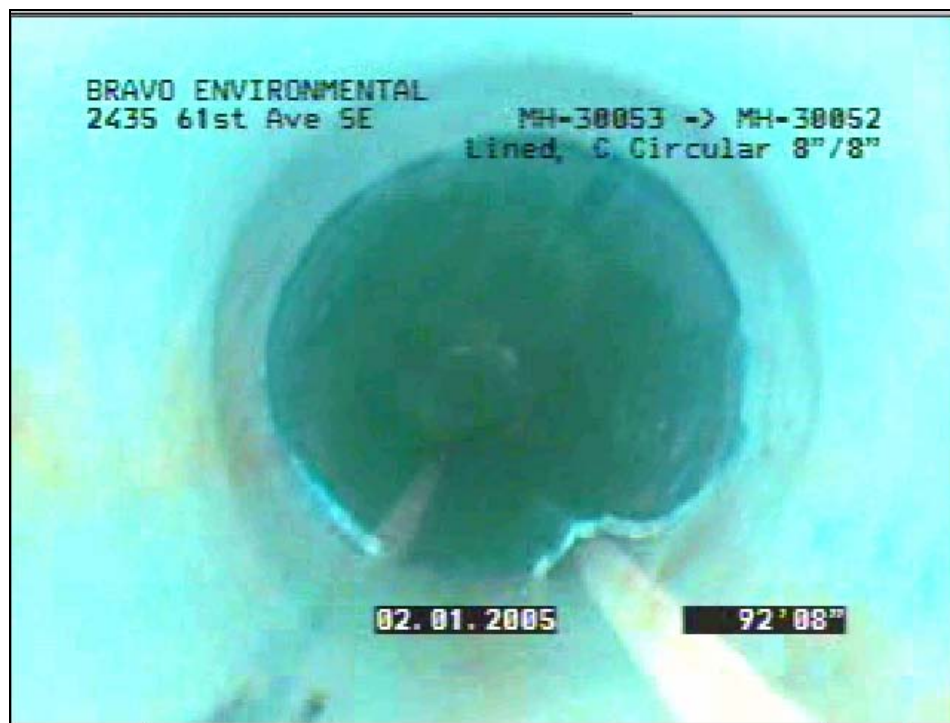
The pilot projects that included CIPP spot repairs inside sewer mains were Redmond, Brier, and Mercer Island. All of the CIPP spot repairs installed in Redmond and Brier remained in place. One of the Mercer Island spot repairs had a raised lip on the upstream end (see Figure 9). A second spot repair was installed during the warranty period to fix the defect. None of the spot repairs that were observed during the warranty inspection showed evidence of failure or leakage. There was also no indication that leaks had migrated to nearby defects.

Figure 9 – Curled edge on the upstream edge of a CIPP spot repair in Mercer Island

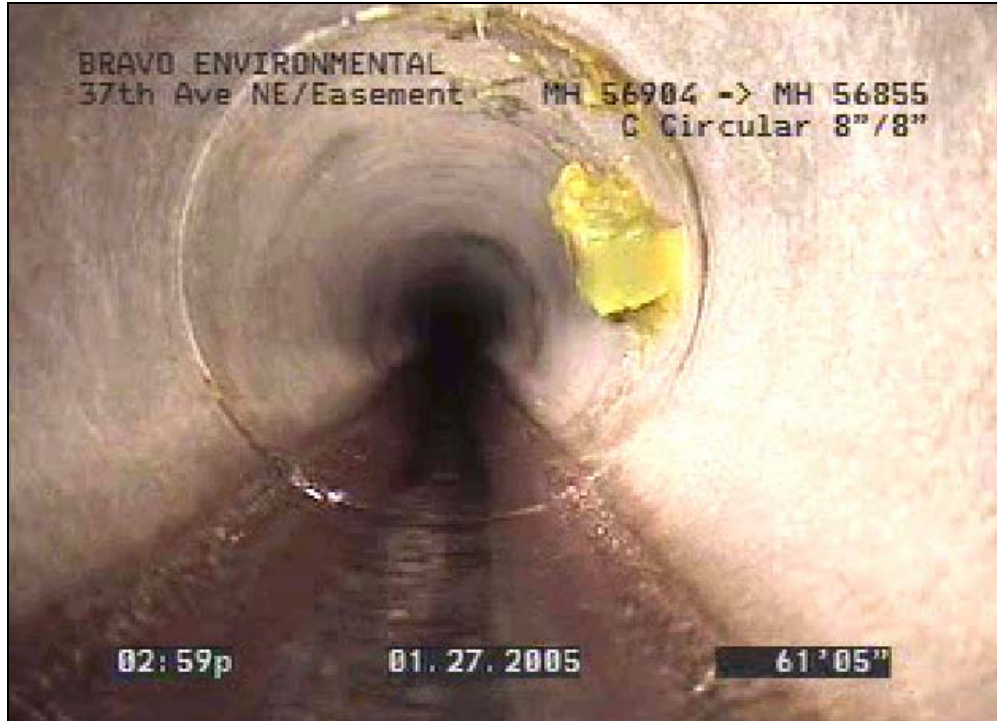
Lake Forest Park was the only pilot project where grouting of pipe joints was used as the rehabilitation method. Joint grouting was used for one pipe because the pipe could not be lined with a CIP product. No defects in the grouting were noted. Figure 10 shows the remnants of grout remaining inside the pipe after grouting the joint. The grout has remained in place over a year.

Figure 10 – Photo of pipe in Lake Forest Park
Remnants of grout remain inside the pipe after grouting the joint.

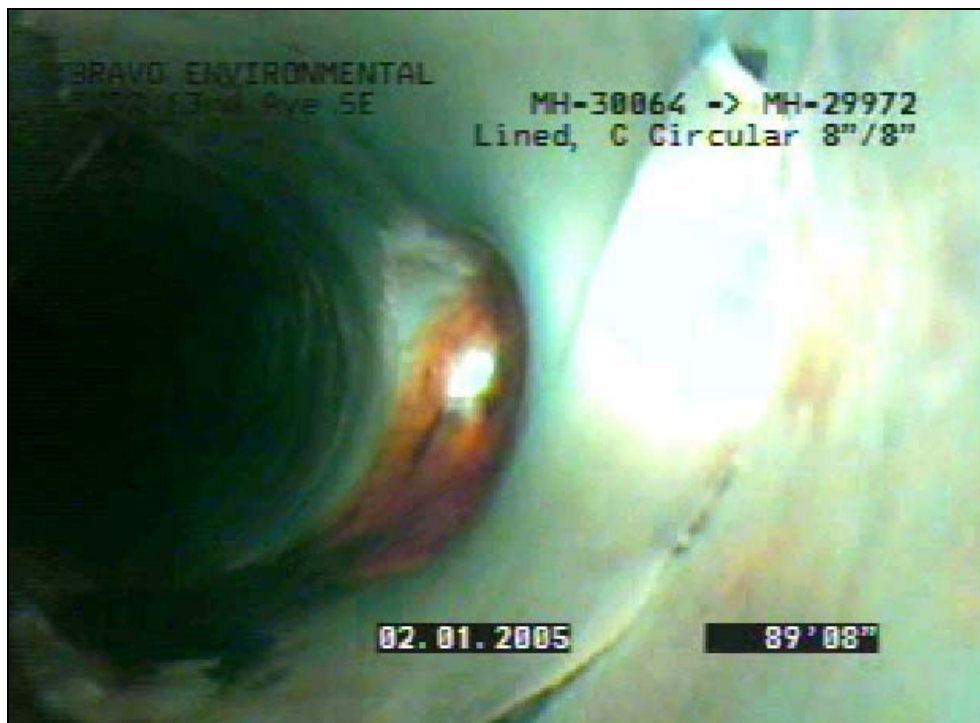
Figure 11 – Photo of a Mercer Island TOP HAT™

In Mercer Island, the TOP HATs™ showed various defects. Some TOP HATs™ showed varying degrees of loose edges inside the CIPP sewer main and some failed to seal to the CIPP sewer main, as evidenced by staining and leaks through the seal. Eight repairs were made during the warranty period in addition to the 11 repairs made as part of the punch list during construction. There were a total of 229 TOP HATs™ installed during construction; therefore, 8 percent of the TOP HATs™ had defects. See Figures 11 and 12 for photographs of the portion of a TOP HAT™ inside the sewer main. Figure 13 shows a TOP HAT™ in Lake Forest Park that had no defects.

Note that the edge of the TOP HAT™ brim is not attached to CIP liner in the sewer main. In this case there is no evidence of leakage.

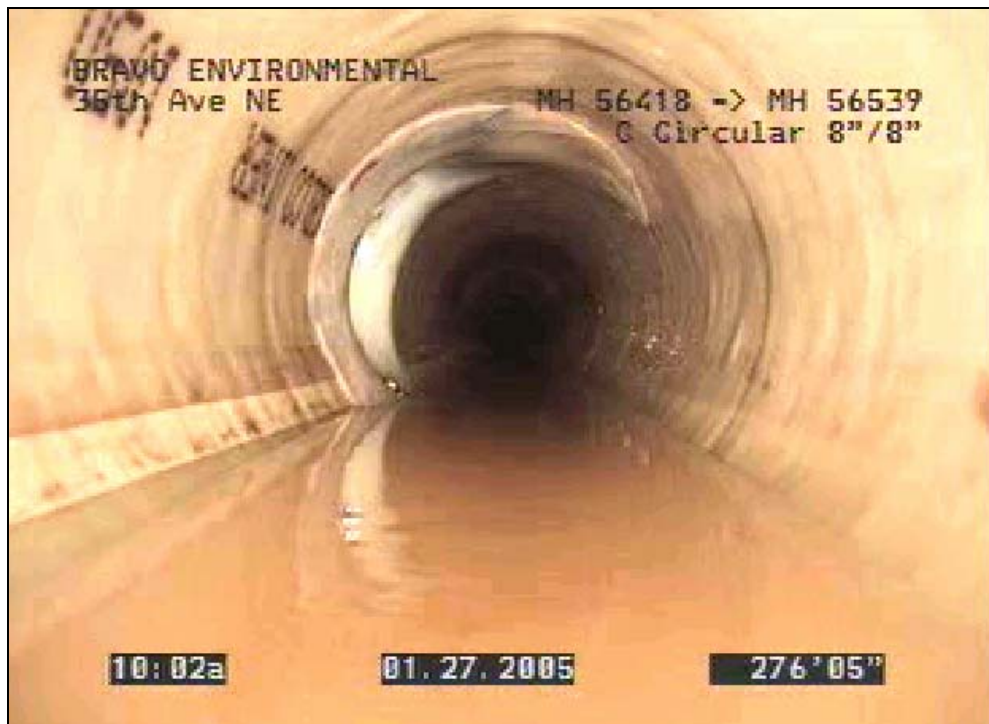
Figure 13 – TOP HAT™ in Lake Forest Park that has no defects

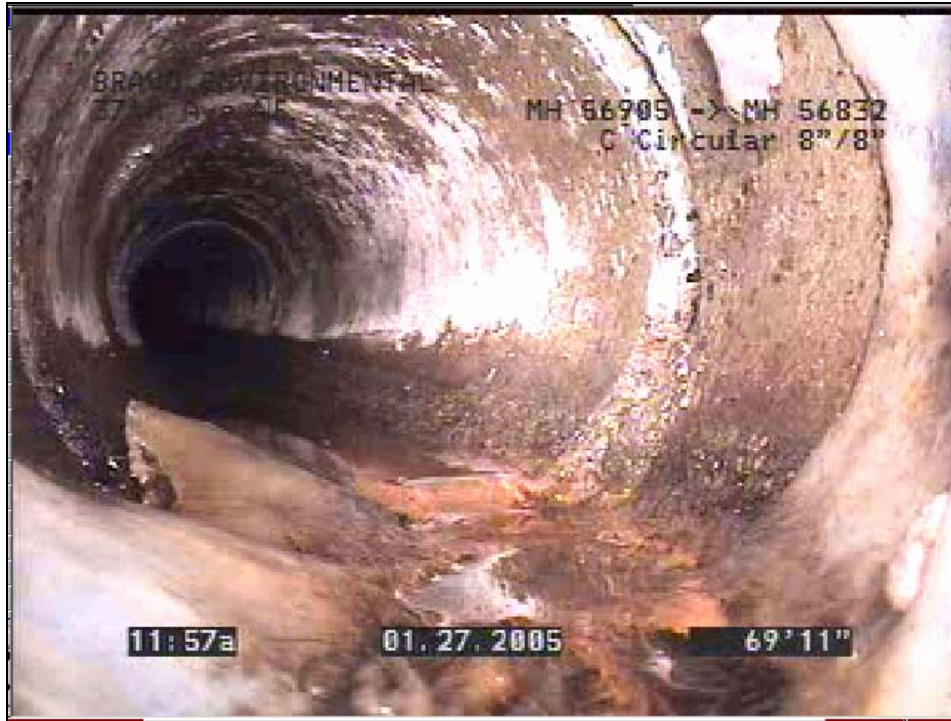
Figure 14 – Photo of a Mercer Island TOP HAT™

In addition to the potential incompatibility between the TOP HAT™ and the CIP liner, King County sees an additional drawback with TOP HATS™ in that they usually do not extend far enough up the lateral to seal the first joint. If the mainline CIP liner and TOP HATS™ seal leaks in mains and connections, the next place for water to enter the line is the first side sewer joint. Although not a warranty defect, leaks and roots were observed at this first joint. See Figure 14 for a photograph taken up inside a lateral.

Photo is looking up inside a lateral. Top edge of TOP HAT™ is white. Note that the first joint in the concrete pipe is not covered by the TOP HAT™.

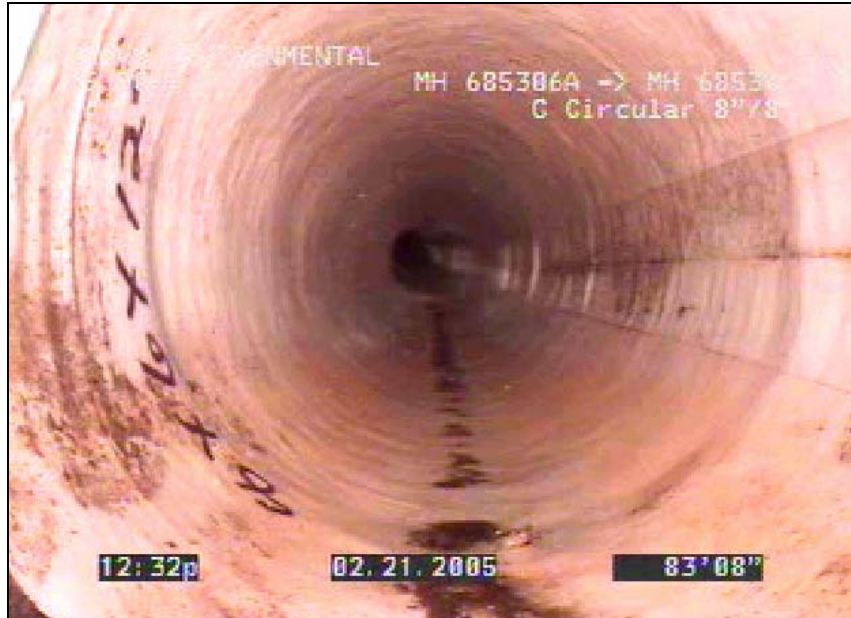
Figure 15 – Photo of T-Liner® from Redmond

photos in Figures 15 and 16 were taken in Redmond. The photos show T-Liners® with no defects.

Photo was taken from inside the sewer main looking up a lateral lined with a T-Liner®.

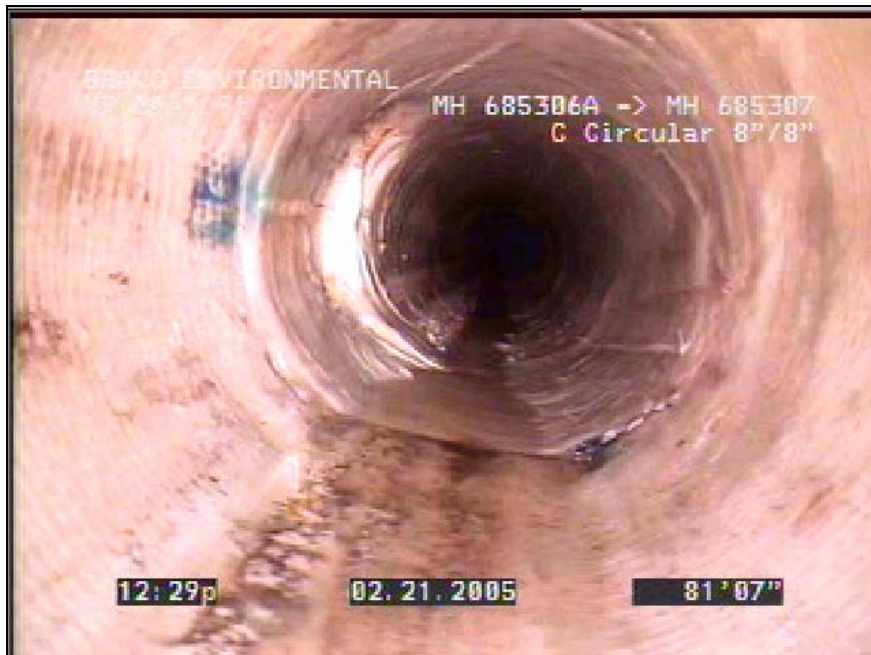
Figure 16 – Photo of T-Liner® from Redmond

Photo was taken inside the sewer main and shows the portion of T-Liner® inside the main.
