King County

Restoring the West Point Treatment Plant

Mark Isaacson, Director
Wastewater Treatment Division
March 22, 2017

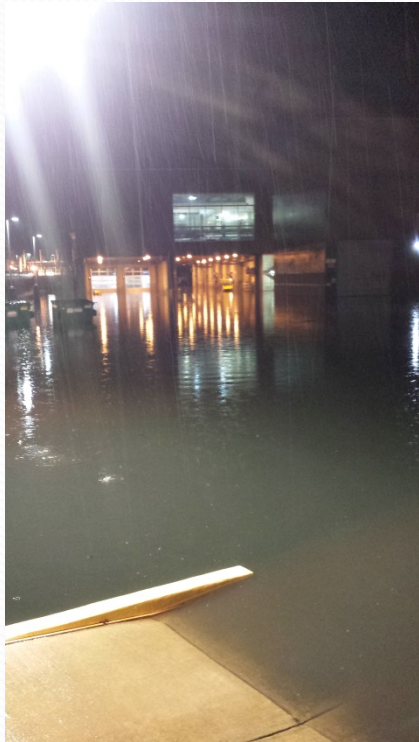
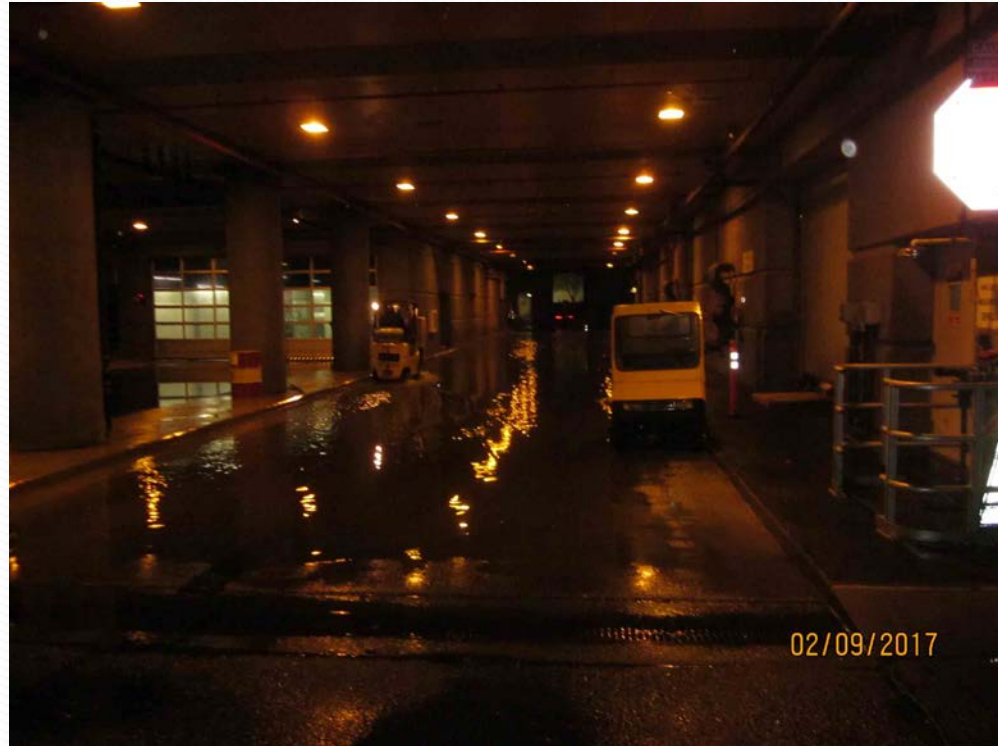
Flooded galleries

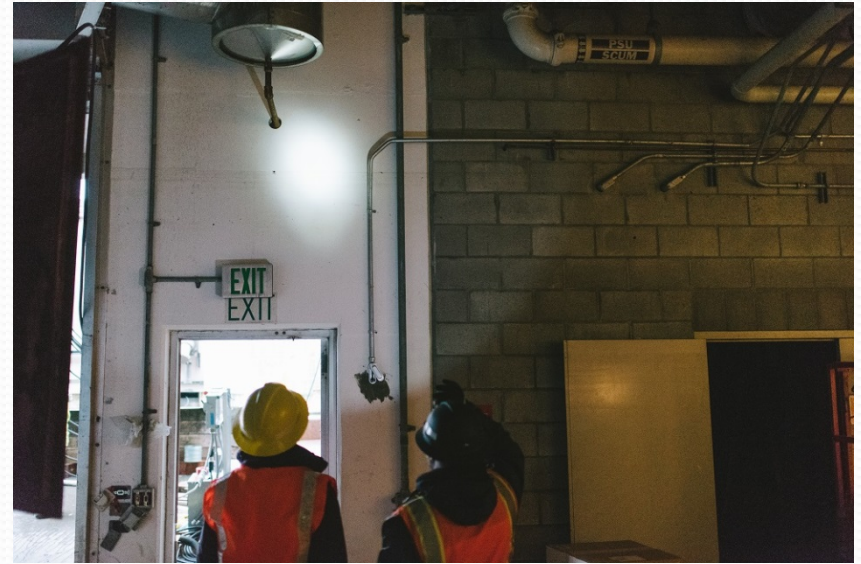
Flashlight shows water line

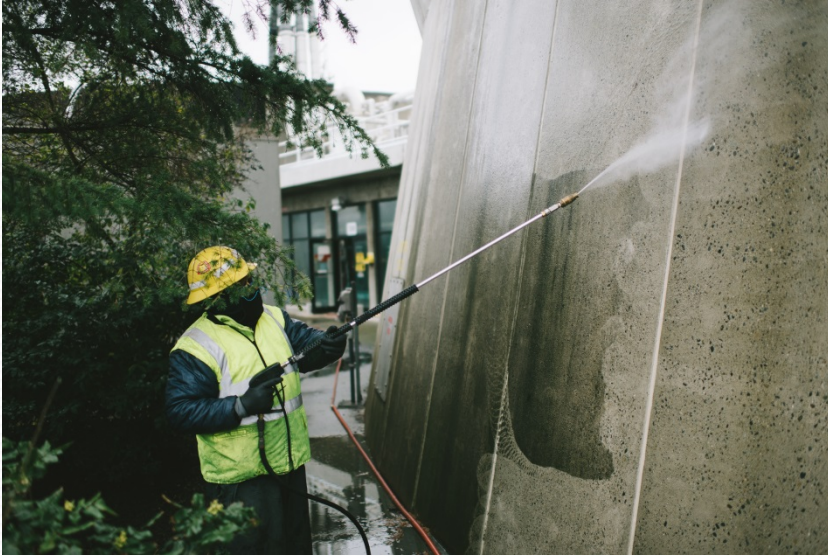
Pressure washing a digester

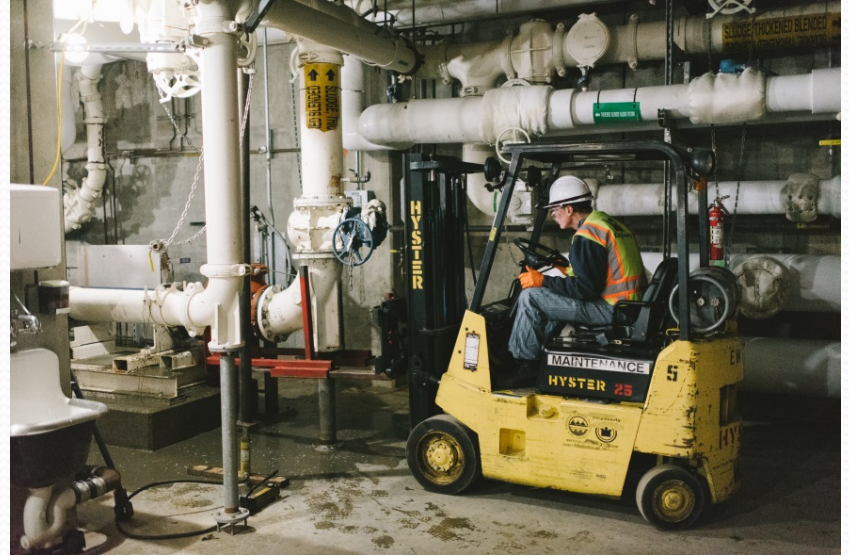
Underground gallery

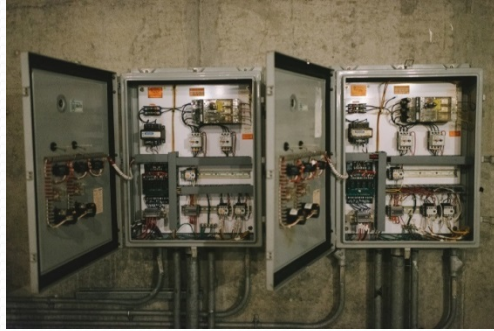
Twin Equipment
Control Panels –
Cleaned, inspected, and
ready for
repair/replacement

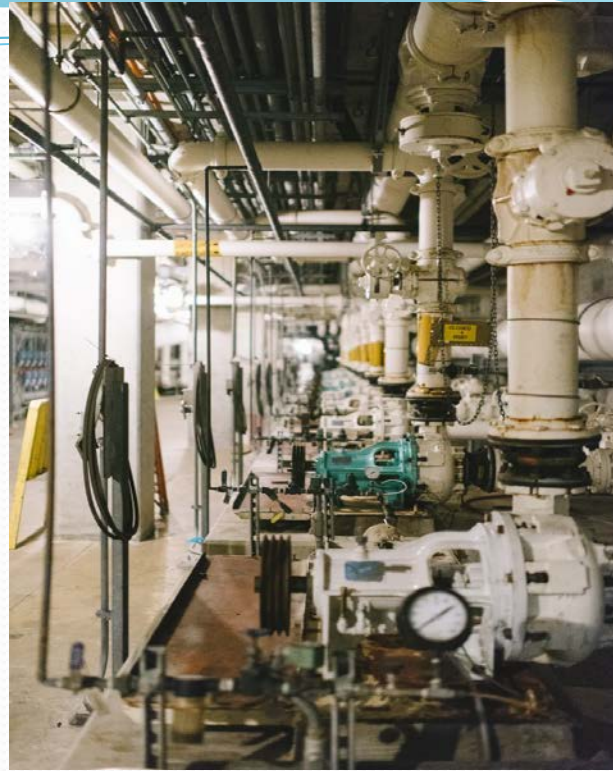
Gravity Belt Thickener Feed
Pumps - Ready for
replacement motors

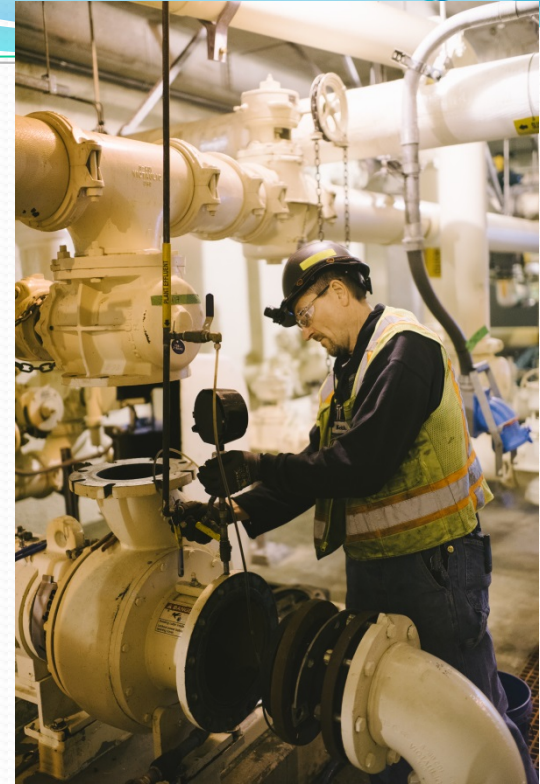
Pumps for Biosolids
being repaired

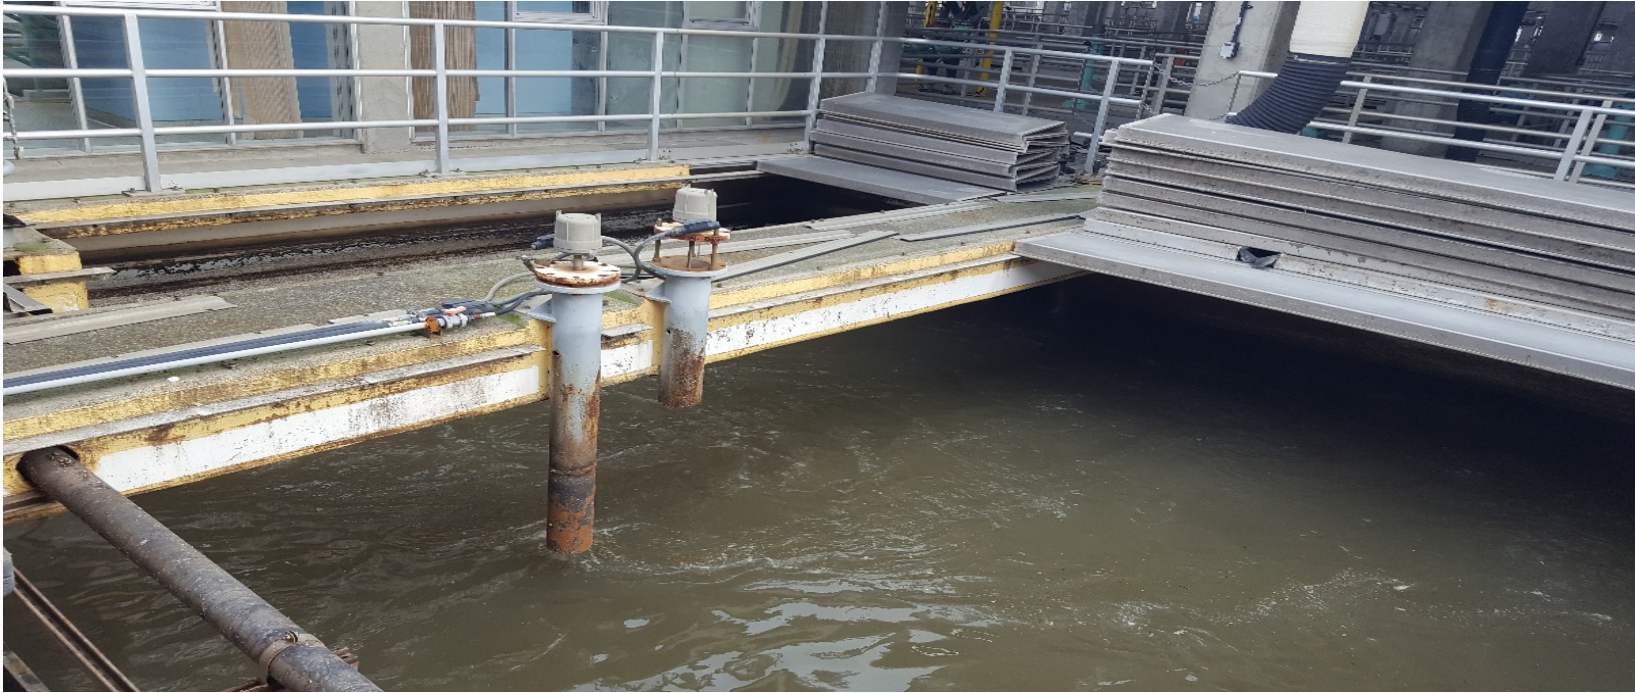
Primary Sedimentation Tanks High and High-High Float Switches

Findings –High & High-High Float Switch Failures
