February 9, 2016

Re: Boise Creek Arch Bridge  
King County Parks - Foothills Trail  
Task 300.4 Structural - Boise Creek Arch Bridge  
DRAFT Structural Recommendations Report  
Exeltech Project No. 1527

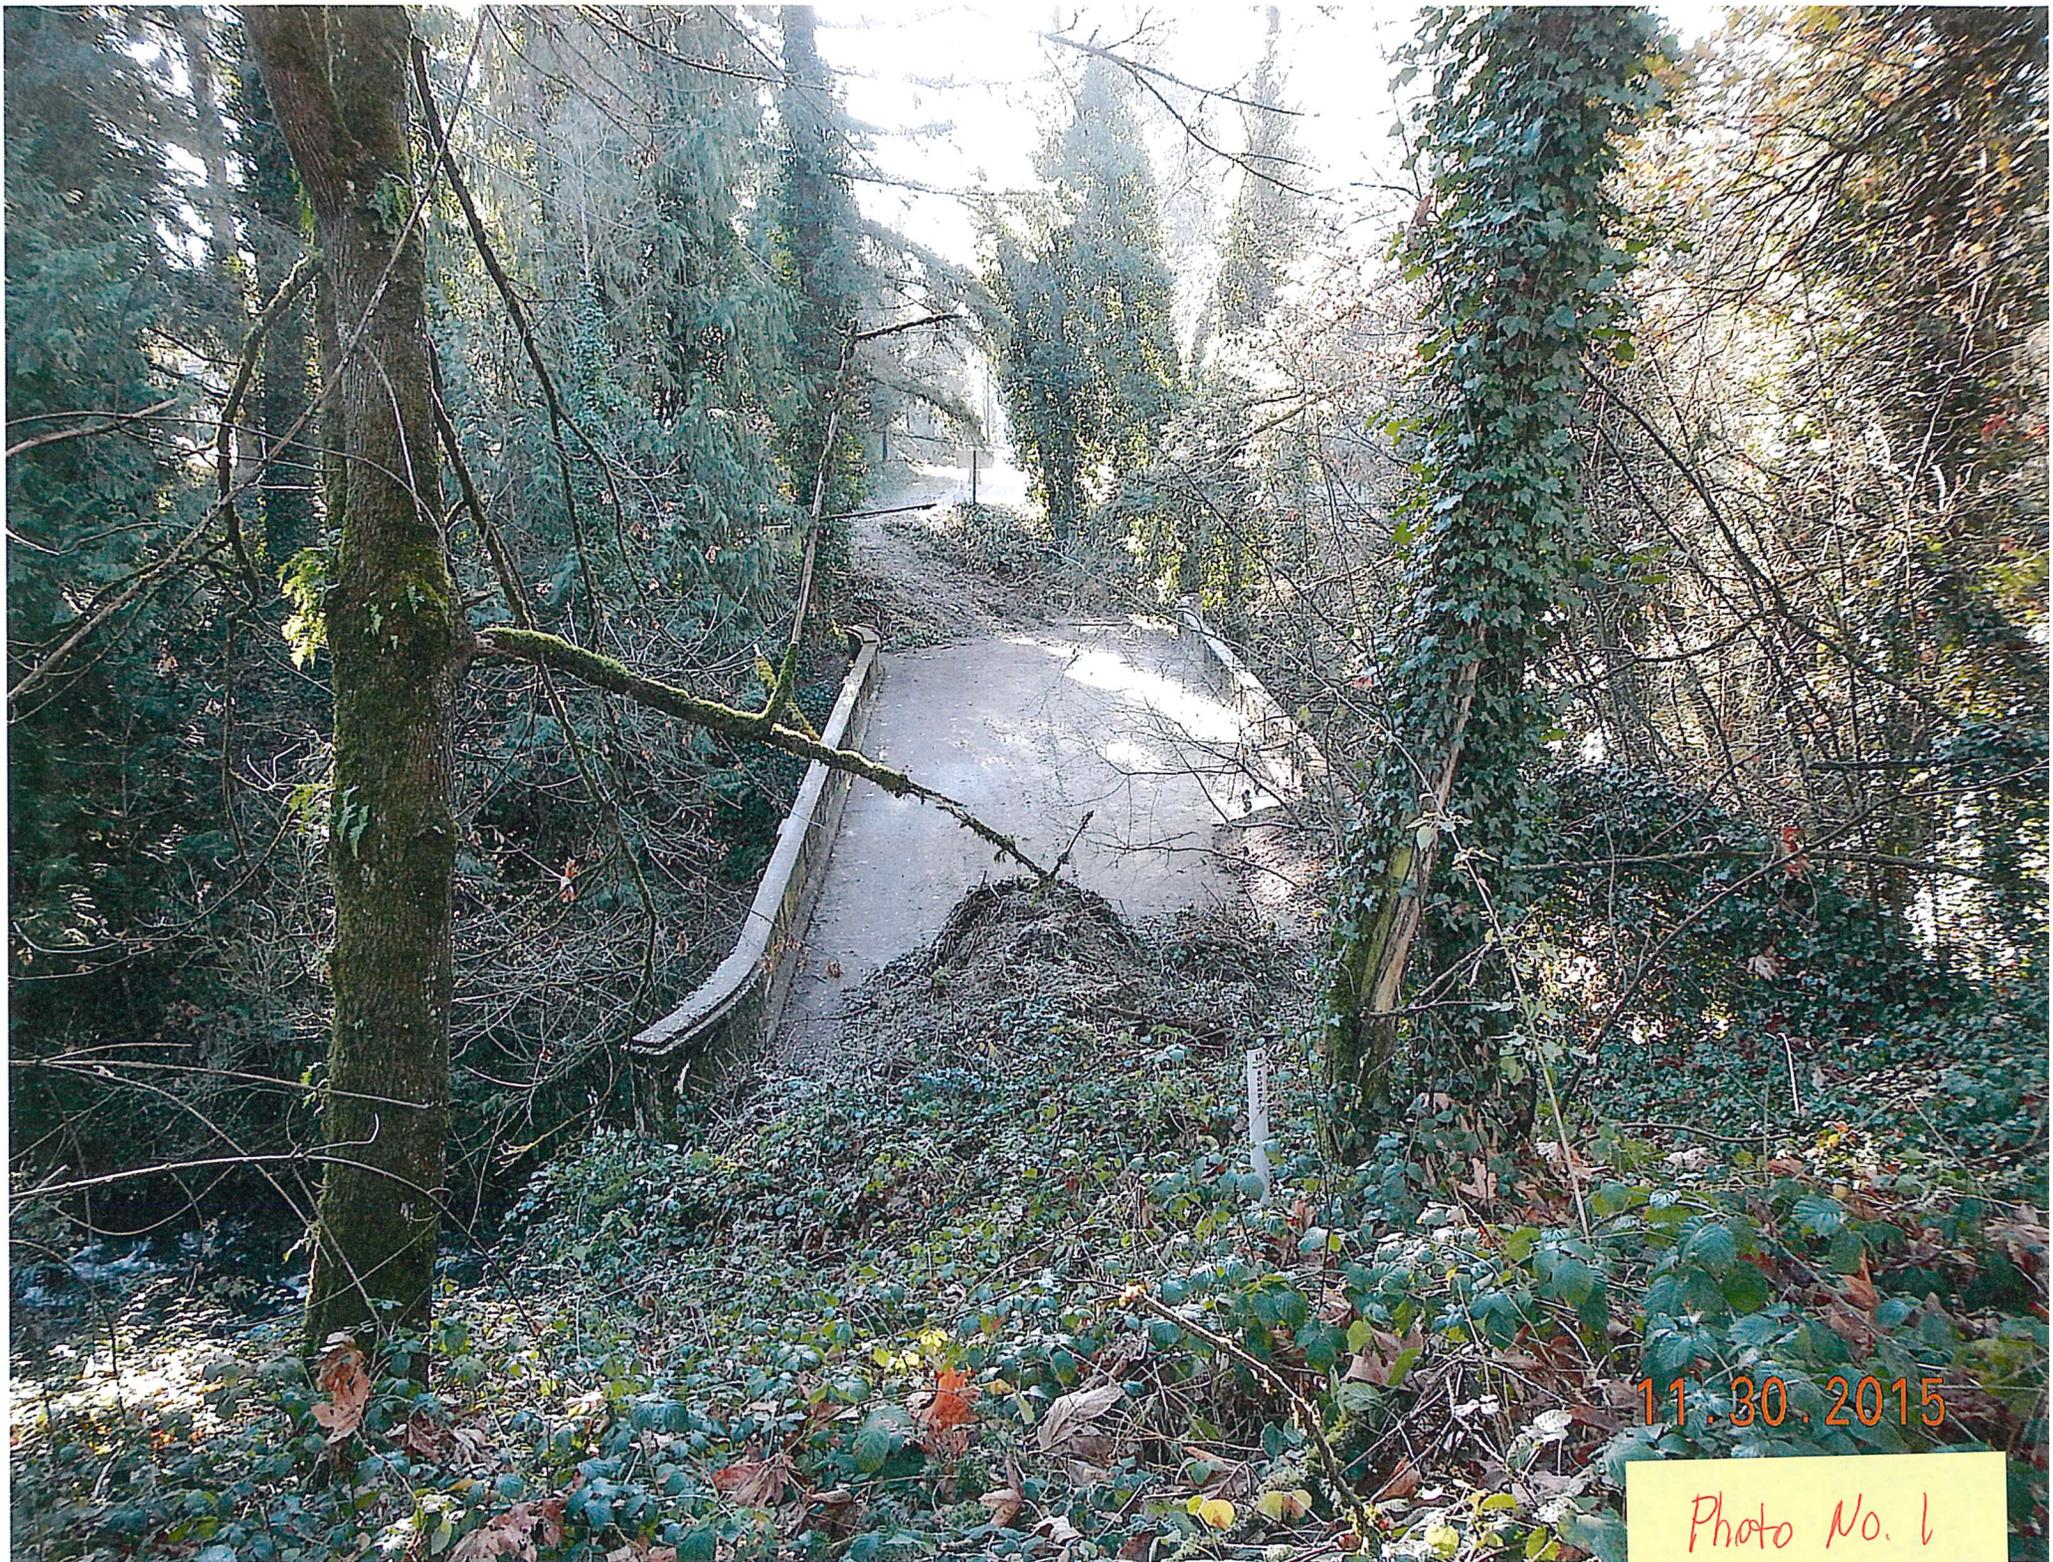
Photo No. 1

The bridge had recently been rough cleaned, to remove a majority of the overgrown vegetation and soil accumulation from the wall faces and bridge roadway deck, which had made the bridge virtually inaccessible. See enclosed photo No. 1.

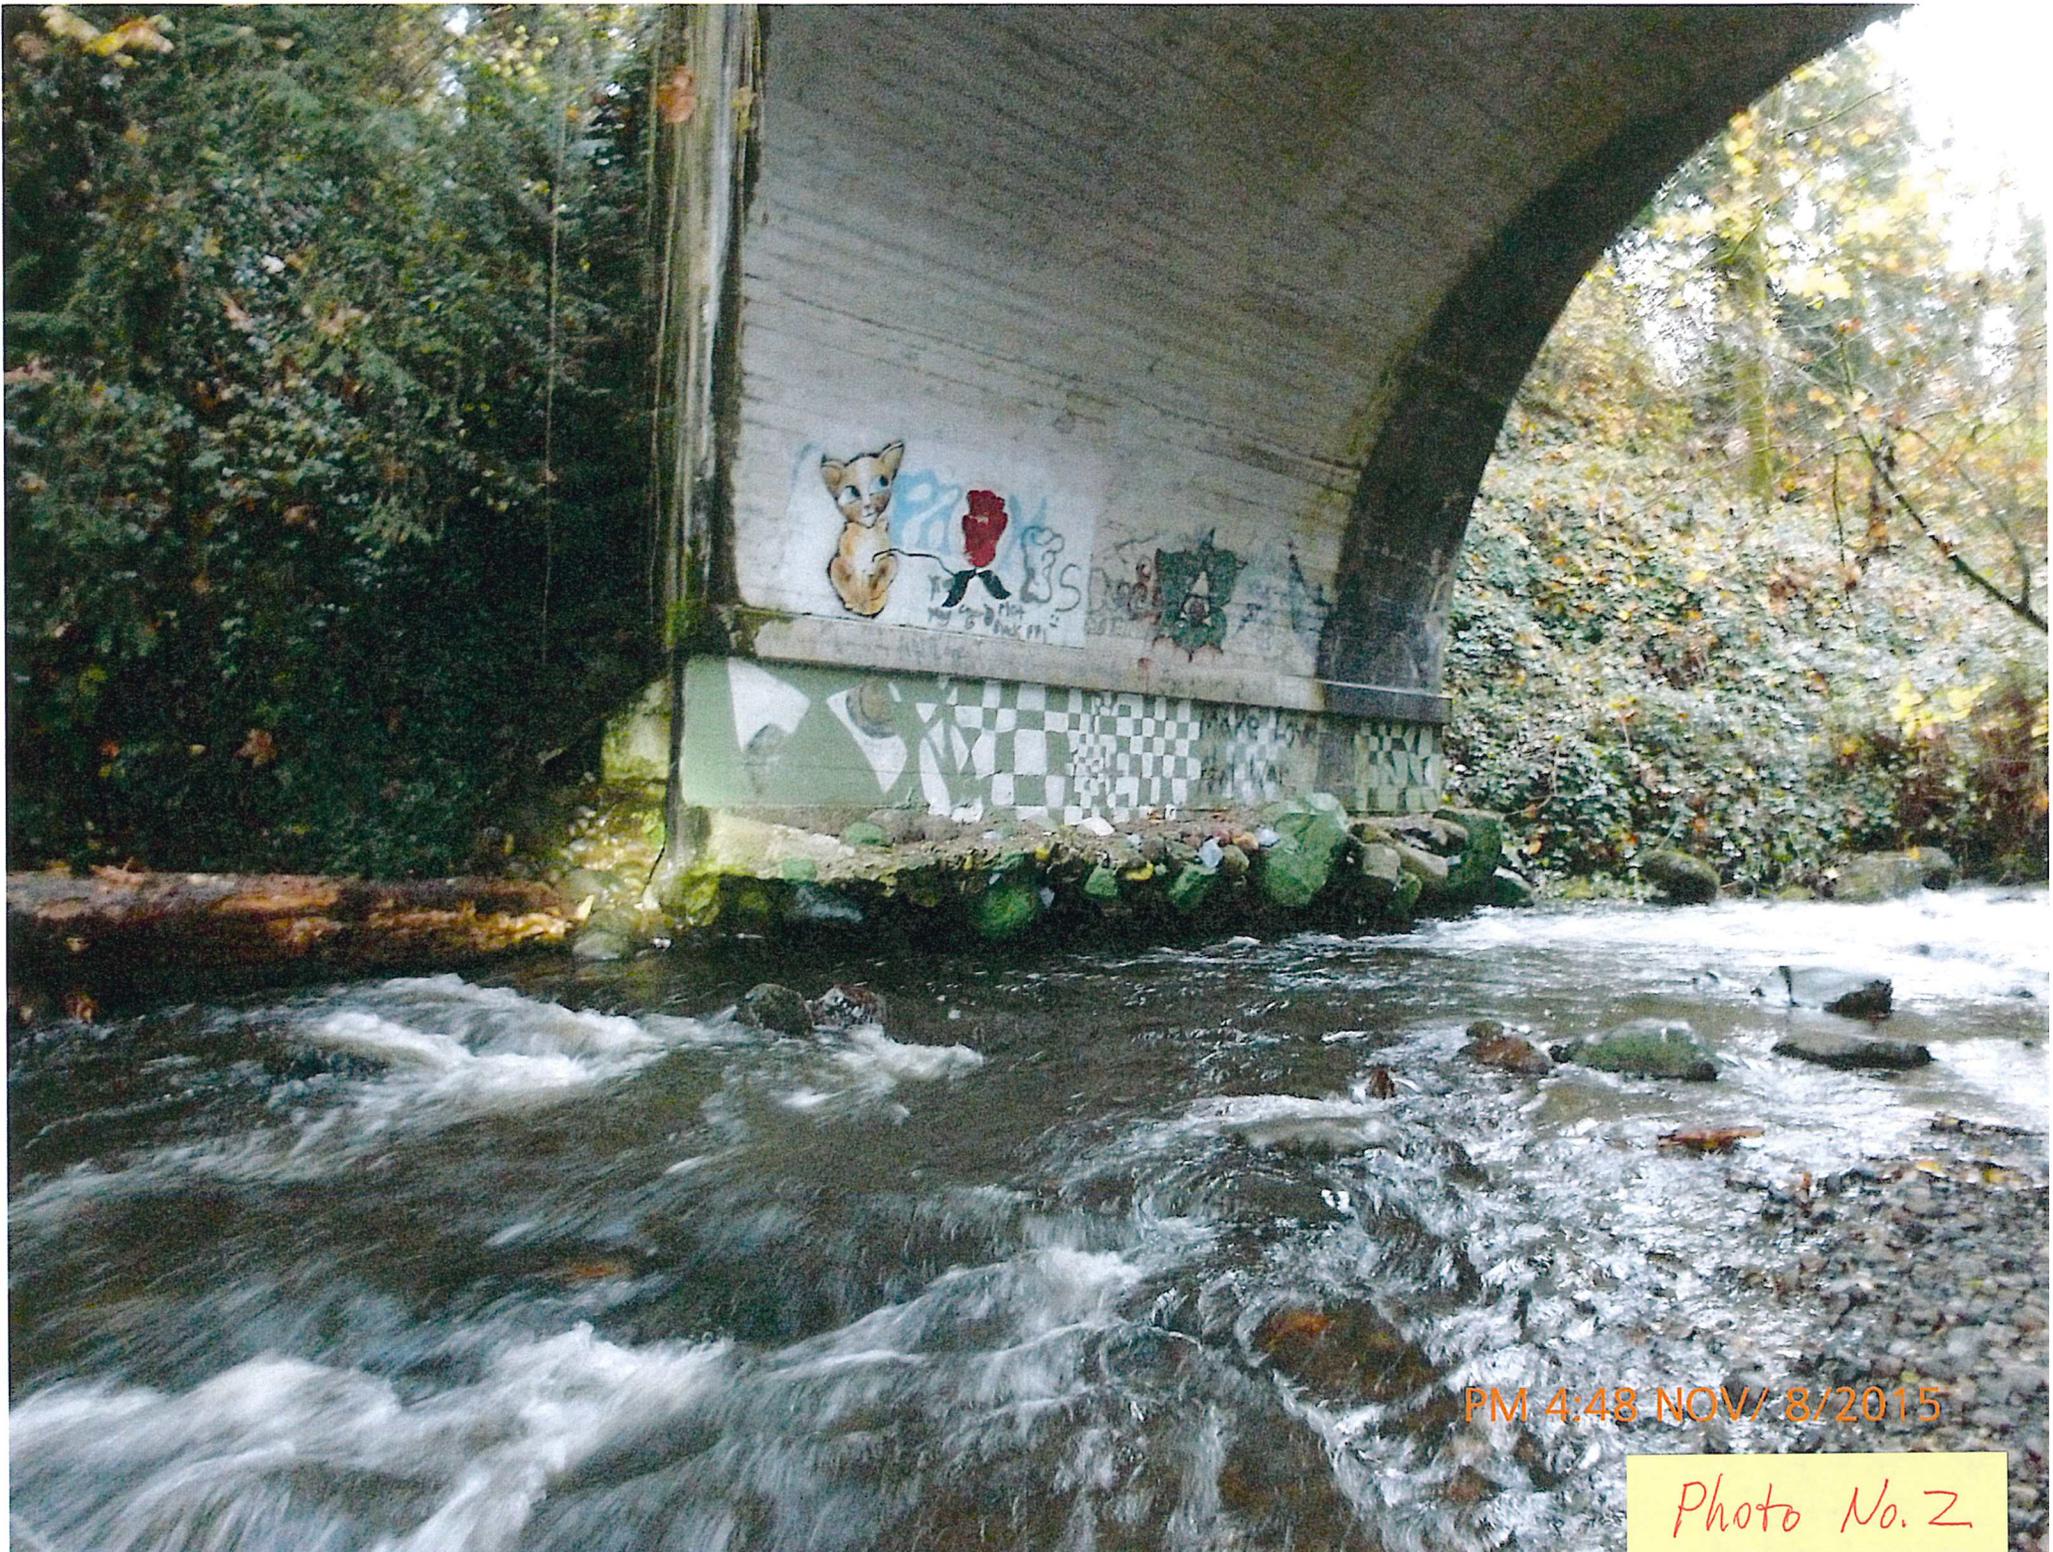
Photo No. 2

We took approximate field measurements to spot check some dimensions shown on the existing bridge plans. We found the basic dimensions of the bridge to be within a reasonable tolerance, of a few inches, from what is shown on the two 1915 bridge drawings, except for the depth of the North Abutment foundation. According to the existing bridge plans the foundations were to be set at 7 feet 0 inch below the Spring Line, however our field observations show the South Abutment is set at 6 feet 7 inch below the Spring Line and the North Abutment is set at approximately 4 feet 5 inch below the Spring Line. This observation is important because along the North Abutment is where significant scour undermining of the North Abutment is taking place. See enclosed photo No. 2.

The most noticeable observation was that the North Abutment foundation of the bridge has been significantly undermined and the South Abutment is showing initial signs of being undermined by the action of Boise Creek. At the North Abutment there is a scour hole under the foundation extending along the entire 30 foot length of the bridge foundation approximately 2 feet in depth and extending under the foundation from 1 feet to 7 feet. This is a significant observation because 7 feet is the full width of the bridge foundation.

- Construct a structural foundation under the North Abutment where it has been undermined by scour. The following is a description of the construction sequence for Repair Phase No. 1:

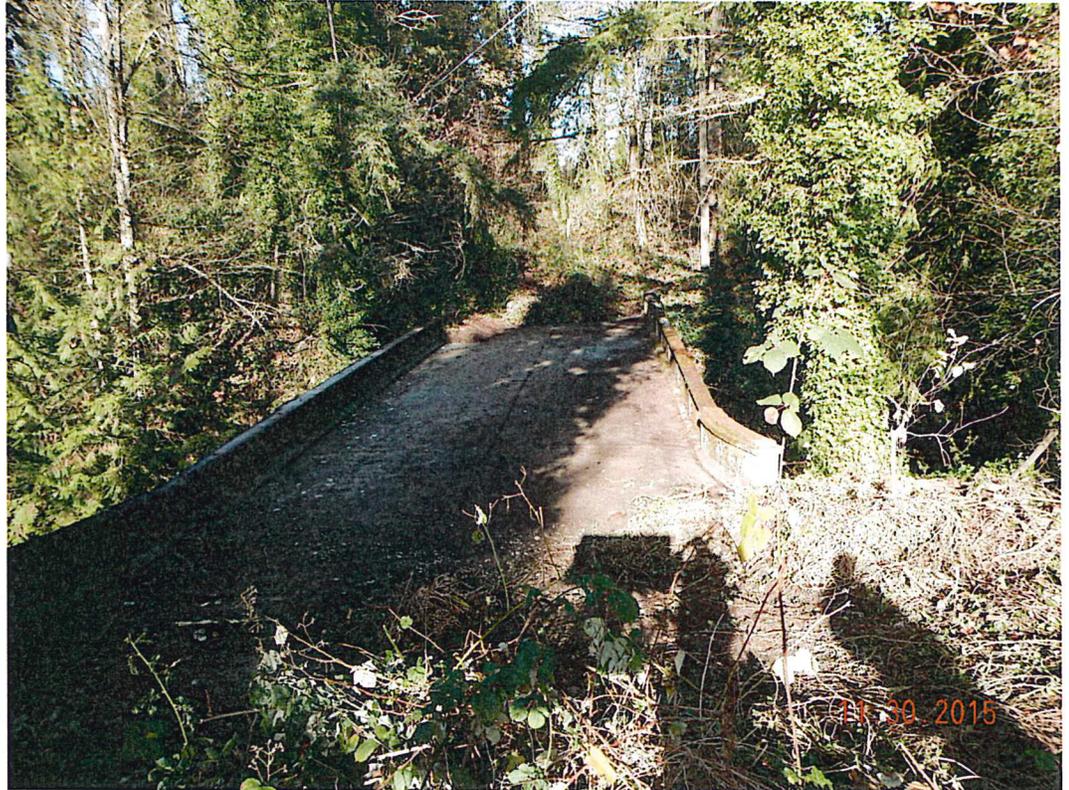
## DSCN0605

- Deck Overall: Coded “3” for serious condition due to the settling of the deck panel at the NW corner. The panel is undermined from erosion caused by runoff from the approach embankment.
- Superstructure Overall: Coded “6” for satisfactory condition. The concrete cracks were considered to be minor.
- Substructure Overall: Coded “2” for critical condition due to the scour at the North Abutment footing.

Deck

- Remove and replace the deck panel at the NW corner of the bridge that has settled due to being undermined from erosion caused by runoff from the approach embankment.

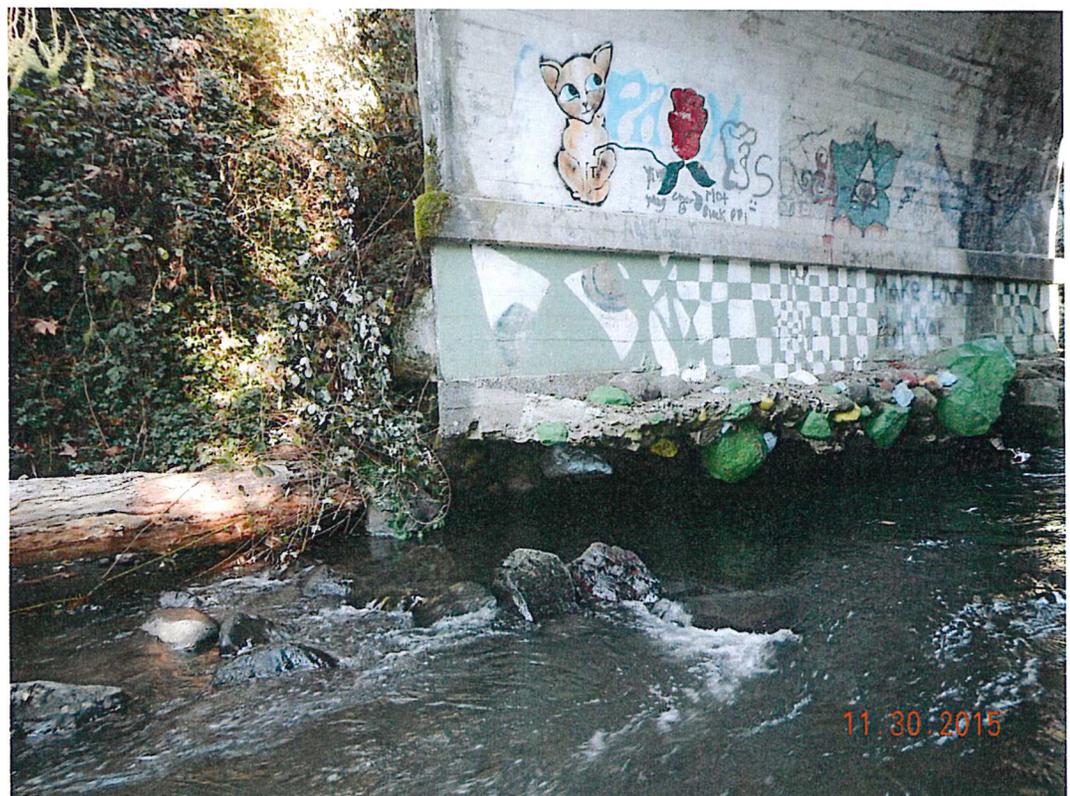
## DSCN0603

361	The north footing is undermined 7' horizontal x 4' vertical starting at the west end. This degree of scour extends the length of the west half of the footing and then decreased to approx. 2' horizontal x 4' vertical at the east end. A large log is wedged under the footing near the east end. The south footing is undermined 2' horizontal x 1' vertical for 4' starting at the west end.
663	The deck is coded "3" due to the settling that has occurred to the NW panel.
676	The substructure is coded "2" due to the scour at the north footing.

Photographs  
Photo Type: S - Scour  
Orientation: N  
Dates: 11/30/2015  
Repairs: 10000  
Scour - North footing west end

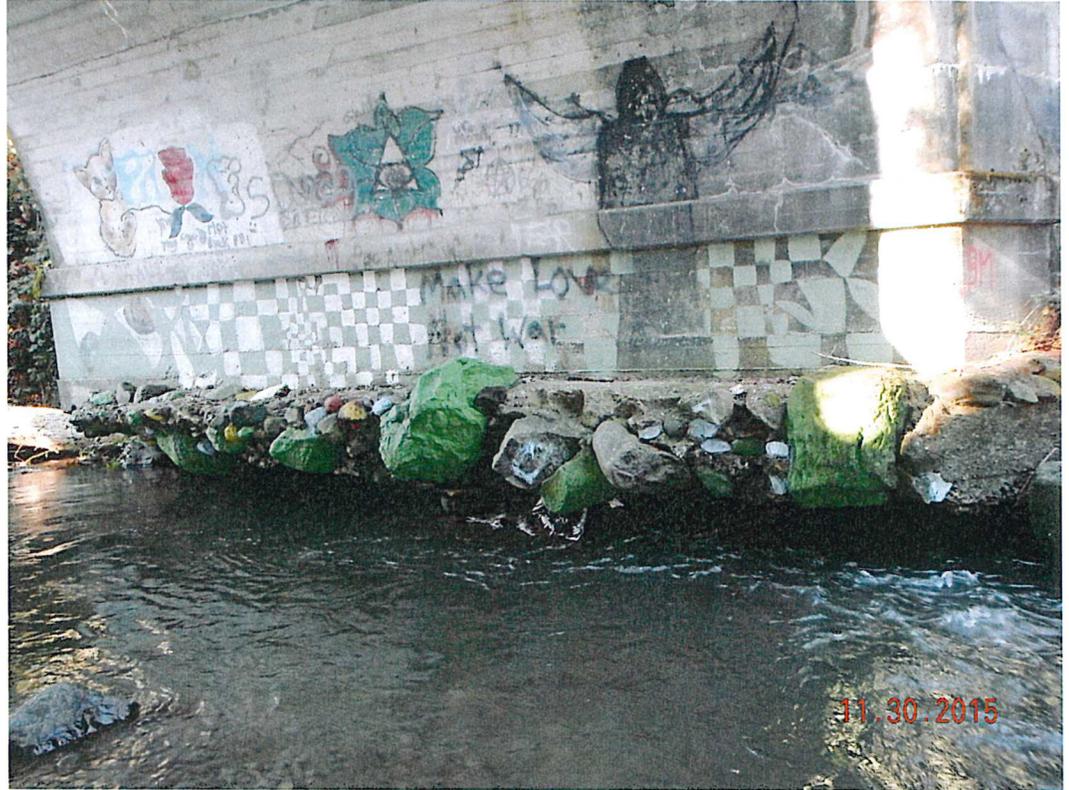
## DSCN0602

Scour - North footing east end
