## **Appendix G – Wetland Correspondence**

**RE: Wetland Reconnaissance for Bow Lake Transfer Station and WSDOT Property, Tukwila, WA**

**RE: Stream Bank Flagging, Bow Lake Transfer/Recycling Station – King County  
Solid Waste Division**

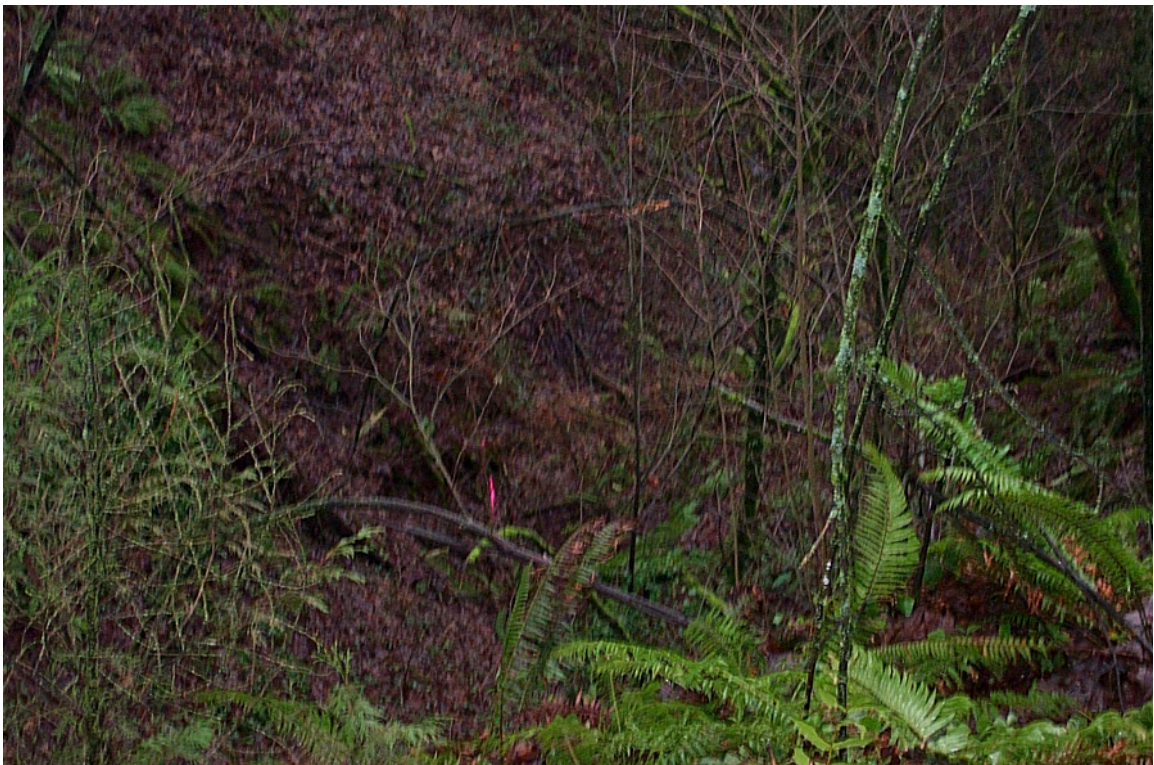
In addition, it was also noted that a stream appears to cross the northern portion of the WSDOT property (King County GIS; Figure 1). The stream exists within a steep slope forested ravine north of the disturbed area and is currently receiving stormwater runoff from I-5 (Photo 4). It appears that the discharge area has created landslides in the past, and has created dangerous undercut banks at the top edge of the slope. Wetlands may be associated with the bottom of this ravine near the stream; however, this area was not surveyed. It appears that both the stream and associated steep slope buffer are located on the WSDOT property.

**PHOTO 4. Ravine w/stream and steep slopes just north of WSDOT property (1/15/04).**

Sensitive areas within the proposed improvements to the Bow Lake Transfer Station are regulated by Tukwila Municipal Code (TMC) Title 18 - Zoning. According to TMC 18.45.020, the ravine area containing a stream, steep slopes, and landslide evidence is likely considered an Area of Potential Geologic Instability with a ranking of Class 3 or 4. According to TMC 18.45.040 (Sensitive Area Buffers), a geotechnical report may be required to identify appropriate buffer widths in relation to activities proposed pursuant to the requirements of TMC 18.45.060 and 18.45.080E.4. Standard stream buffers in the code range from a 15-foot-wide buffer for a Type III stream to a 70-foot-wide buffer for a Type I stream.
