2021

Annual Bridge Report

King County
Department of Local Services
Road Services Division

AUGUST 2022

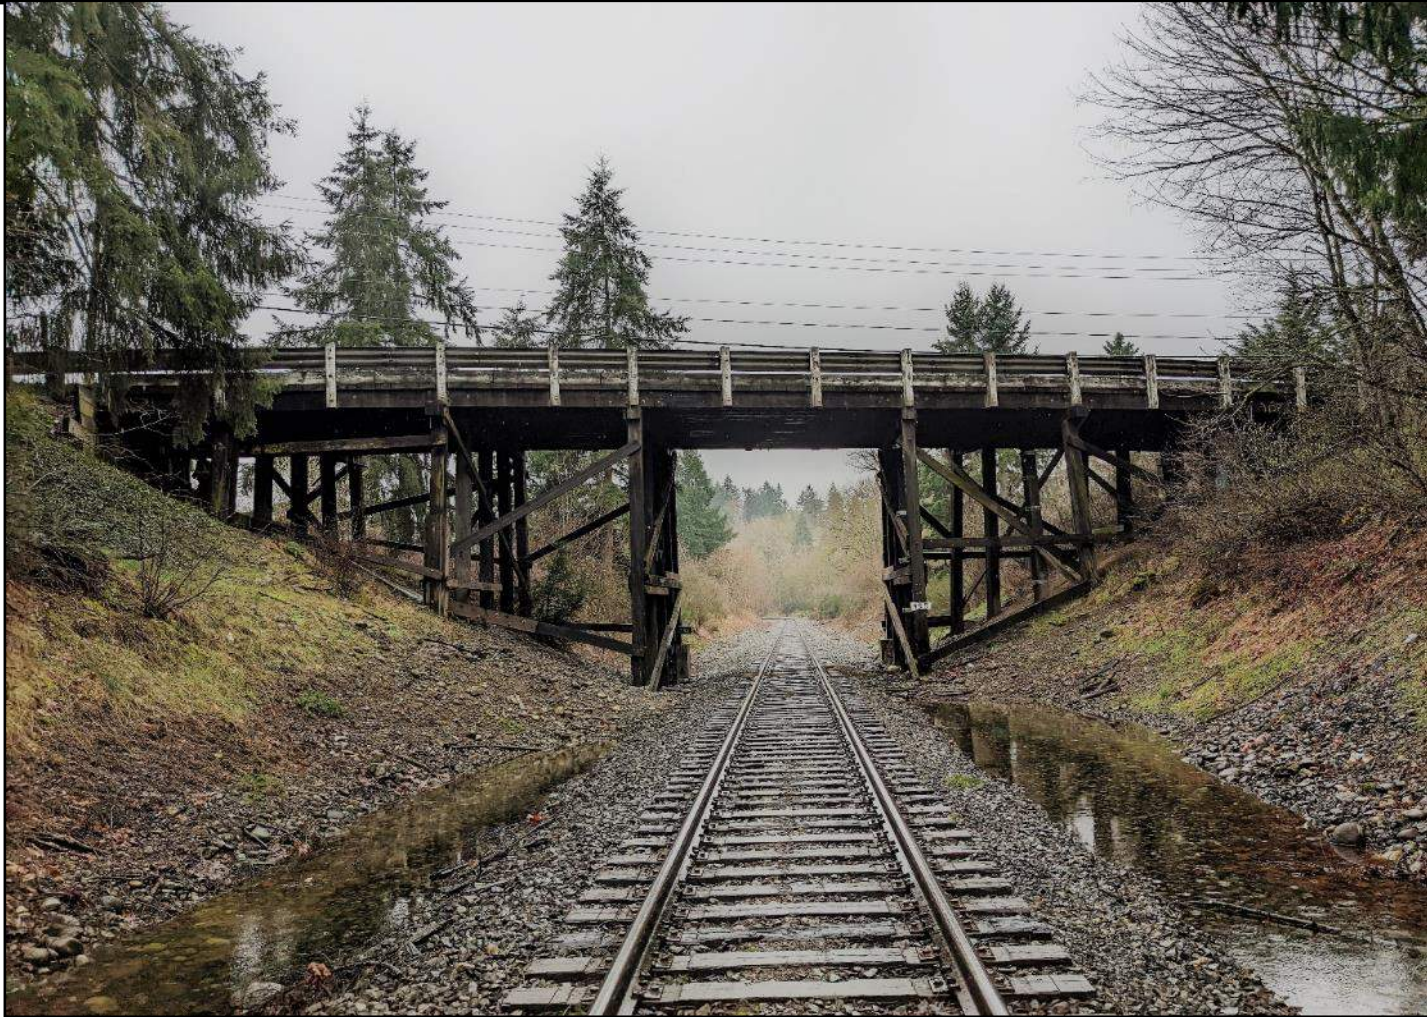
Cover Photo: Berrydale Overcrossing No.3086OX, a timber trestle built in 1931 spanning the BNSF Railroad near the community of Black Diamond, Washington.

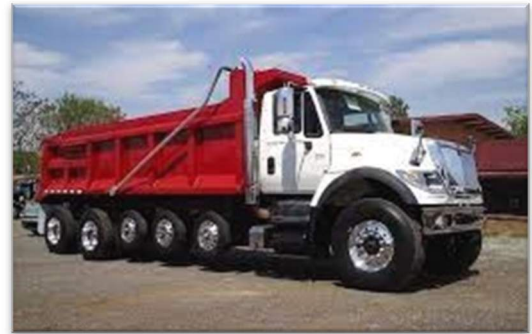
Specialized Haul Vehicle SU6

Another set of requirements were added in November 2016, when FHWA issued a memo that provided guidance on compliance with Section 1410 of the “Fixing America’s Surface Transportation Act” (FAST Act) law signed in 2015. Section 1410 includes bridge load rating and posting requirements for Emergency Vehicles on the Interstate System and within reasonable access to the Interstate System. FHWA has established two emergency vehicles (EV2 and EV3) to be included in the bridge load rating reports and posting requirements. These vehicles can create higher load effects compared to AASHTO legal loads (i.e. Types 3, 3S2, 3-3, and SU4 to SU7).

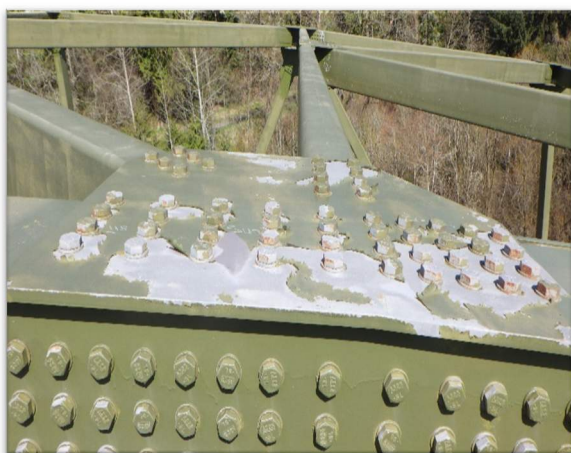
*Peeling paint on upper gusset plate at
Tolt Bridge No. 1834A*

corrosion which can significantly reduce the strength of the bridge. Keeping up with a painting program will help to preserve the bridges and will extend its useful life before a major rehabilitation or replacement is warranted. The condition of the paint is assessed and recorded during the routine bridge inspections. Painting is restricted to summer months due to weather conditions and the permitting process.

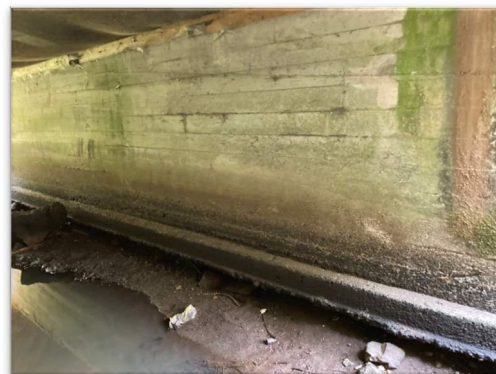
*Scour under abutment footing at SE
408th Street Bridge No. 3056A*

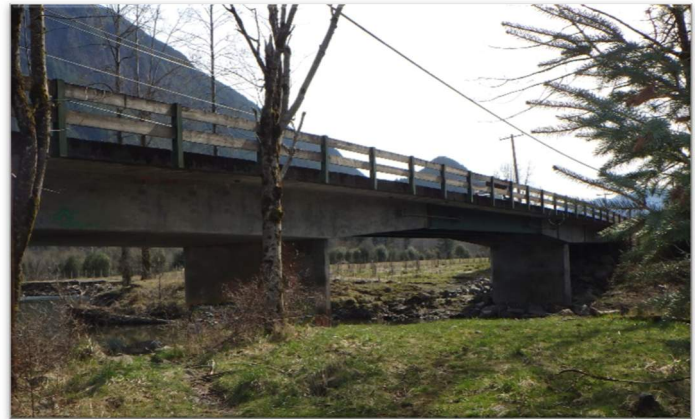
North Fork Bridge No. 122i

The North Fork Bridge is located north of the city of North Bend. It carries 428th Avenue SE over the North Fork of the Snoqualmie River. This road serves about 240 homes as well as a variety of commercial and recreational activities including access to Alpine Lakes Wilderness trailheads in the Upper Snoqualmie Valley. During a flood event with a two-year recurrence interval, North Fork Bridge becomes the sole access road for communities north of the bridge.

The North Fork of the Snoqualmie River is a dynamic and active river as it transitions from the mountains to the valley floor. The Shake Mill Left Bank owned by KC DNRP started to deteriorate around 2008 and the upstream channel started to migrate south.

Scour issues at the North Fork Bridge became a great concern in 2013, due to exposed substructure elements. County forces conducted urgent repairs in 2013. This initial repair was followed up in 2017 when the Flood Control District provided early action funding to provide additional scour mitigation around the intermediate piers of the bridge.

The King County Department of Natural Resources and Parks, Water and Land Resources Division, completed construction of a buried revetment further upland along the left (southern) bank of the North Fork Snoqualmie River, immediately upstream of the bridge to assist in the prevention of further lateral migration in 2019. This buried revetment replaced the levee, originally built in the 1960s. The Flood Control District contributed funds to complete this project.

The Flood Control District also approved funding in 2019 to conduct a feasibility study to mitigate the risk of scour and neighborhood isolation due to roadway overtopping in the North Fork Bridge vicinity. This study was completed in April 2022. The alternatives analysis determined that the preferred alternative at this site is to replace the existing 252-foot-long bridge with a new 375-foot-long structure. Additionally, to address the geomorphic and hydrologic features of the site, a new revetment along the right (north) bank of the river is proposed to protect the new abutments and raising the road alignment north of the bridge to decrease the frequency of roadway flooding and neighborhood isolation.

The next steps at this location are to identify sources for funding the full design and construction of the preferred design alternative. Coordination with other projects in the vicinity continues to ensure successful improvements to reduce or eliminate flooding across the valley.

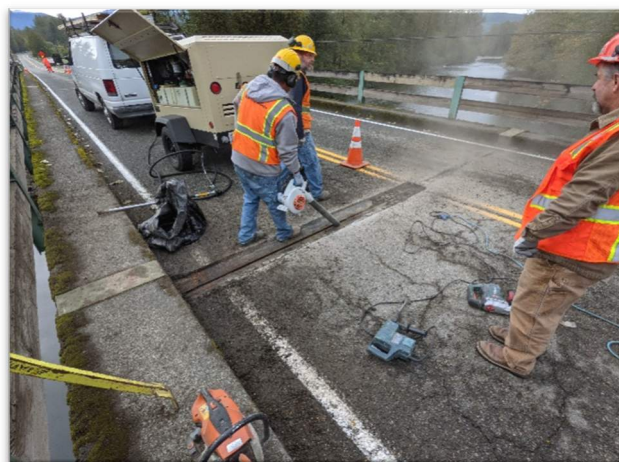
Expansion Joint Repairs at North Fork Bridge No. 122i

substantially extend the amount of time the bridge can be used before rehabilitation (more extensive repair) or replacement is needed.

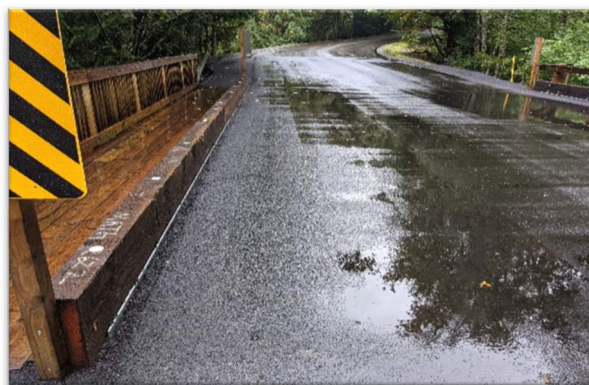
4 Creek Ranch Bridge No. 5044

One 3-foot-wide deck plank had failed from rot and was split in half, the rest of the 38-year-old decking

was determined to be in various stages of decay and a full deck replacement was needed. The project was planned for August 2020 but supply line disruptions from the Covid-19 pandemic resulted in lengthy timber order delays. The timber arrived in December 2020 and the repair project began work in January 2021.

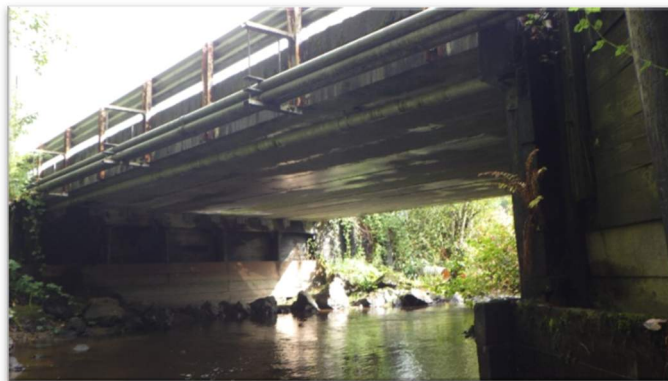
Issaquah Creek Bridge No. 83D

A 6-foot-deep sinkhole was found behind a bridge wingwall during the routine 2021 bridge inspection. Further investigation found significant scour below an abutment backwall and another large void behind the backwall. An urgent repair was performed to use specially designed concrete bags to fill the void behind the abutment and seal off the scour below the backwall. The large void behind the wingwall was then filled in with gravel and the roadway shoulder rebuilt. The quick response to this issue was able to address the repair before the scour voids collapsed downwards and caused the roadway to settle, which would have required a much more extensive repair and a roadway closure.

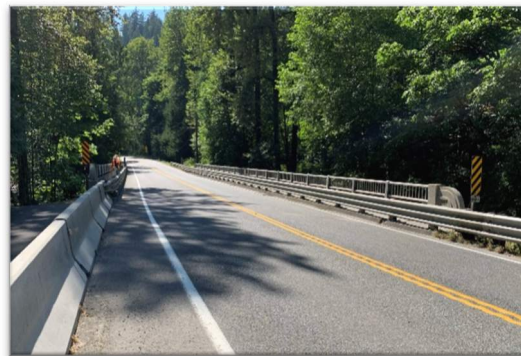
Raging River Bridge No. 1008G

Many of the bridge rail anchor bolts along the north rail were found to be loose. The epoxy used to anchor the rail posts to the concrete curb had failed and over 50 bolts could be pulled out by hand. This repair involved pulling the failed bolts out, reaming out the anchor holes, then re-installing new bolts with high strength epoxy.

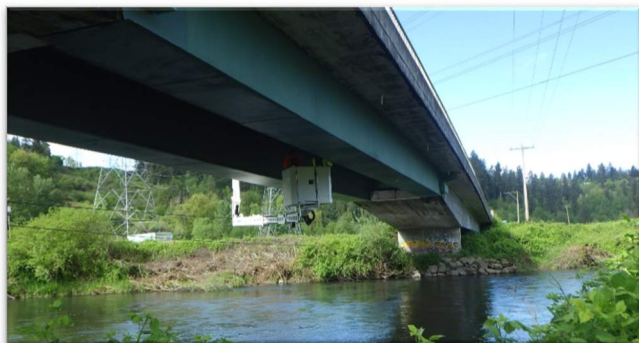
Patton Bridge No. 3015

A large concrete spall (3 cubic feet) in the deck soffit was found during the 2021 routine bridge inspection. The deck thickness above the spall was reduced to as thin as 3". An urgent repair was performed to add new rebar across the spalled area, then new concrete was poured to fill the spall.

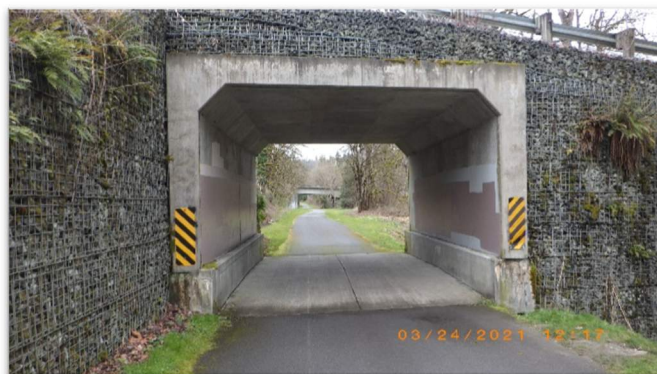
Cedar Mt. Ramp No. 3165A

The west abutment had been undermined up to 4 feet by uncontrolled rainwater runoff eroding the slope alongside the end of the abutment.

This repair added a concrete extension to the undermined section of abutment footing. The abutment extension made the footing 12" deeper along the area of erosion and filled the void underneath. The bank along the abutment was regraded to channel runoff away from the abutment footing and the eroded bank was rebuilt with quarry spalls.

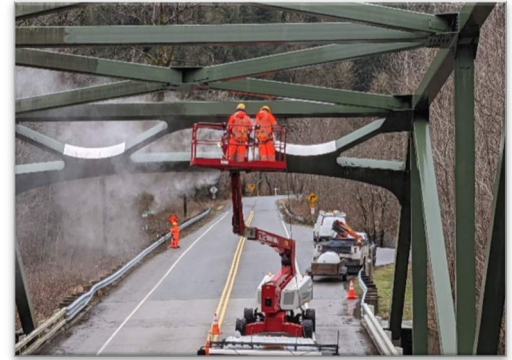
Washing at Edgewick Bridge No.617B

The first two listed are steel truss bridges on a routine five-year washing cycle; the last three are concrete bridges that are washed as needed when dirt and moss accumulation obstruct the ability to visually inspect the concrete components.

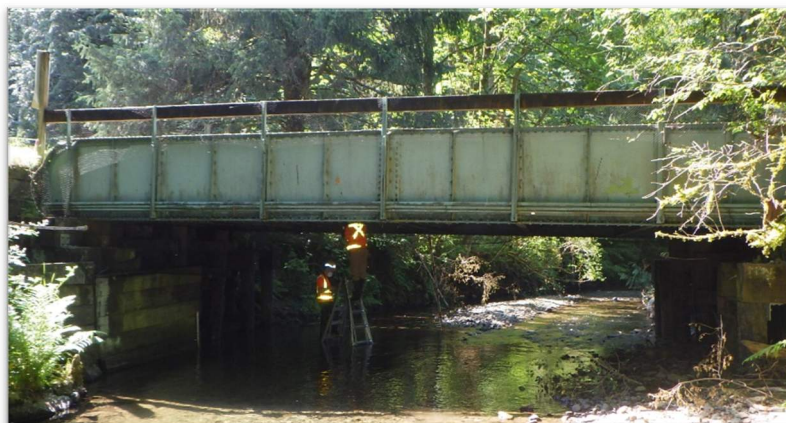
Coal Creek Bridge No.3035A

Approximately 1.5 miles southeast of Veazie-Cumberland Road SE, the Coal Creek Bridge is located near the city of Black Diamond along SE Lake Walker Road at Coal Creek.

The bridge is 18 feet wide. The steel girders and floor beams of this bridge are over 100 years old; they were originally in place at another bridge location in 1912 and moved to this site in 1958. In addition to the severely corroded steel and limited load capacity, other deficiencies include deteriorating creosote timber piles, rotten timber backwall planks, substandard rails, and downstream bank erosion. The sufficiency rating is 6 out of a possible score of 100. The bridge is scheduled to be inspected every three months to monitor the advanced section loss progression.

Roads was awarded federal funding in November 2017 and funding was obligated and authorized in May 2018 to proceed with design for the project. The project design was completed in January 2021. The Project Plans, Specification, and Engineer's Estimate was approved, and Right-of-Way acquisition was certified by WSDOT in March. Permitting approval was received from King County Permitting Division in May. The project construction contract was advertised in May and executed in July. Due to the extended time of procuring materials for the project, major construction will occur in 2022.

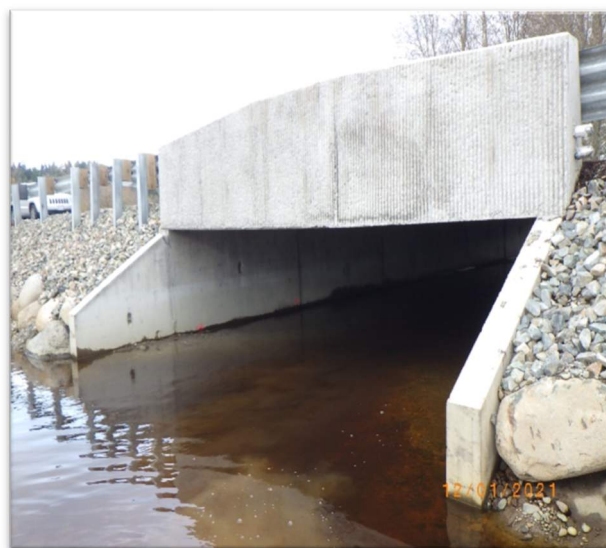
The new S. 277th Street Bridge No.3126

The replaced bridge, built in 1950 was 64 feet wide measured out to out. The bridge was load restricted and unable to support certain types of fire engines used by the adjacent fire districts, along with typical full-size garbage trucks, dump trucks, and concrete mixers.

The structure was approaching the end of its useful life, had a narrow hydraulic opening constricting the water flow, and the bridge abutments were constructed of creosote timber, which can leach into the water and impact water quality, fish, and wildlife. It was not feasible to repair or rehabilitate the bridge to meet current standards for structural, geotechnical, hydraulic, and environmental requirements.

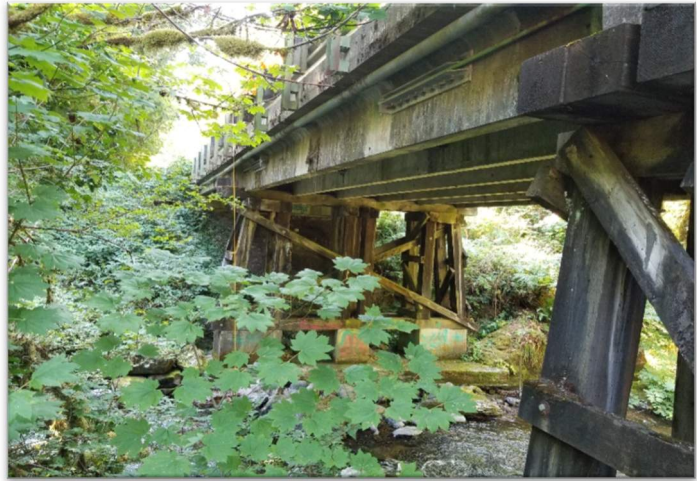
Upper Tokul Creek Bridge No.271B

The bridge has a constricted hydraulic opening and seasonal high flows on Tokul Creek cause scour under the footings at the intermediate piers.

In 2021, the 90 percent design of the project was completed. A Technical Information Report was completed and permitting approvals were received from Washington State Department of Fish and Wildlife and Department of Ecology. No permit was required by the U.S. Army Corps of Engineers. Construction is planned for 2022.

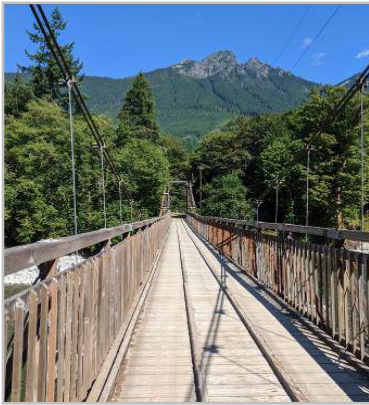
Baring Bridge No. 509A

Built in 1930, this timber suspension bridge spans the South Fork Skykomish River at Northeast Index Creek Road, near the community of Baring.

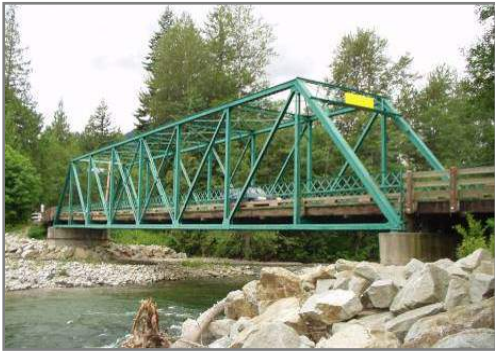
Miller River Bridge No. 999W

Built in 1922, it carries the Old Cascade Scenic Highway over Miller River. This riveted Pratt truss is located near the community of Skykomish. Designated in 1999.

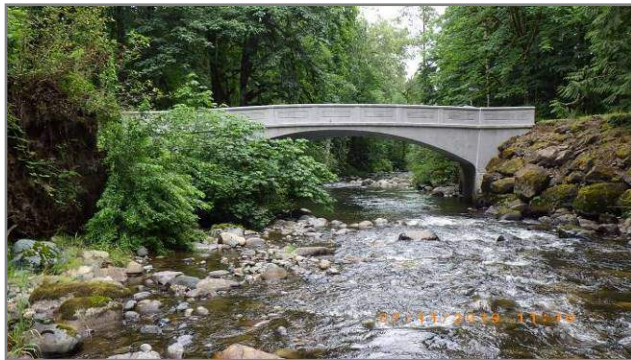
Raging River Bridge No. 1008E

Built in 1915, this bridge spans the Raging River between the communities of Fall City and Preston. It is a concrete earthen-filled arch structure, originally built to carry the Sunset Highway across the Raging River. Designated in 1997.

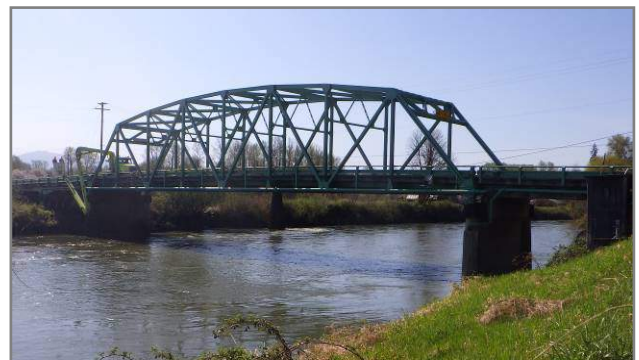
Stossel Bridge No. 1023A

Built in 1951, spanning the Snoqualmie River, this riveted Warren truss is located north of the community of Carnation. Listed on the Washington Historic Registry in 2002. Designated in 1997.
