TECHNICAL INFORMATION REPORT

RAGING RIVER ROCK QUARRY

KING COUNTY, WASHINGTON

Project Manager: Prepared by: Date: Core No.: Kevin Vanderzanden, PLS Stacia Bloom, PE August 2016 10001R

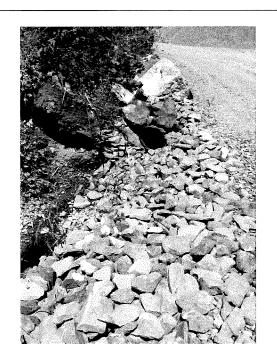
Culvert Conveyance: The mining operation conveying storm waters towards the settling/detention ponds.

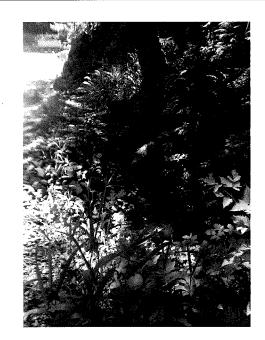
Ponds A-C: Stormwater settling in the first of three ponds that parallel the drive aisle.

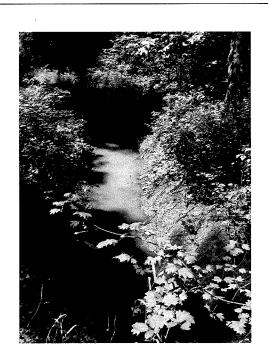
Pond E: Storm water detention Pond E.

Type of Facility	: Infiltration	n Pond E
Side Slope:	2.00	H:1V
Pond Bottom Length:	80.00	ft
Pond Bottom Width:	9.00	ft
Pond Bottom Area:	720.	sq. ft
Top Area at 1 ft. FB:	3162.	sq. ft
_	0.073	acres
Effective Storage Depth:	4.50	ft
Stage 0 Elevation:	0.00	ft
Storage Volume:	7331.	cu. ft
	0.168	ac-ft
Vertical Permeability:	6.00	min/in
Permeable Surfaces:	Bottom & Side	es
Riser Head:	4.50	ft
Riser Diameter:	18.00	inches
Top Notch Weir:	None	
Outflow Rating Curve:	None

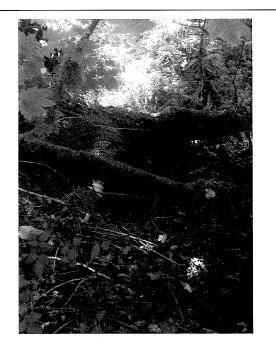
Discharge after Pond H: Culvert discharge after the series of settling/detention ponds, directed towards the 200-foot river setback.

RGI understands the Site stormwater ponds have existed for decades and have functioned well in managing/infiltrating Site stormwater runoff. We also understand that the Site stormwater ponds in this area have an outfall from Pond H into the 200 foot buffer between mining operations and the Raging River. The current Site owner indicated there has not been any stormwater outfall from Pond H to the river buffer during the history of Site operations with all of the stormwater infiltrating in the stormwater pond system.
