TECHNICAL INFORMATION REPORT

RAGING RIVER ROCK QUARRY

KING COUNTY, WASHINGTON

Project Manager: Prepared by: Date: Core No.: Kevin Vanderzanden, PLS Stacia Bloom, PE August 2016 10001R

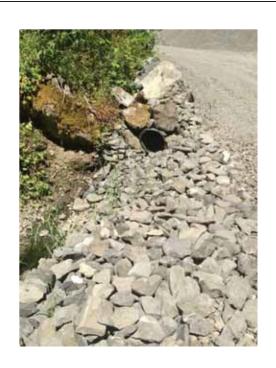
Culvert Conveyance: The mining operation conveying storm waters towards the settling/detention ponds.

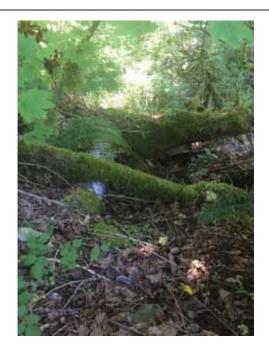
Discharge after Pond H: Culvert discharge after the series of settling/detention ponds, directed towards the 200-foot river setback.

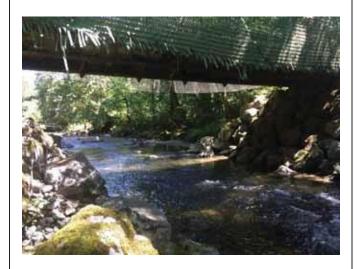
Raging River: A view looking north under the vehicle bridge along the Raging River, stabilized bank.

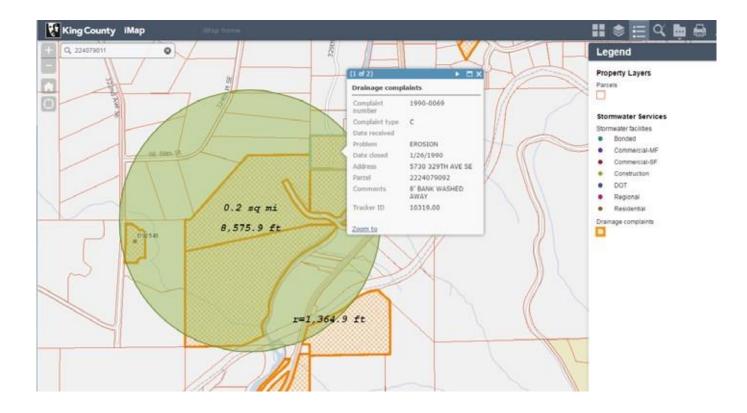
- Complaint: #199020069
- ProblemType: C,ActionRequest
- Problem: Erosion

$\label{eq:complaint} This complaint was an erosion complaint. Complaint was addressed and closed. This complaint shows that there is a nerosion potential.$

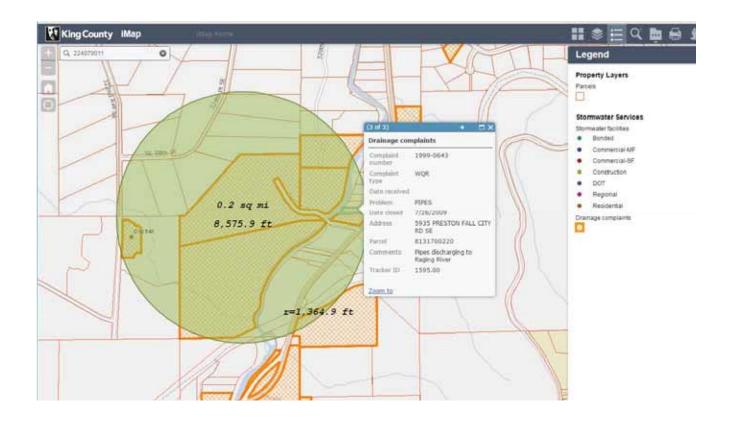
Complaint: #199920643

This complaint was a water quality complaint. This complaint indicates that pipes were discharging to Raging River. Complaint was addressed and closed.

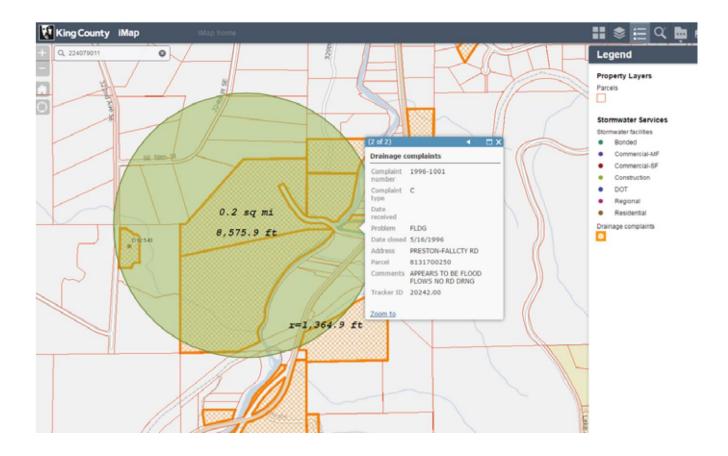
Complaint: #199621001

$\label{eq:complaint} This complaint appears to be flood related. Complaint was addressed and closed.$
