CRITICAL AREAS SITE RECONNAISSANCE STUDY

BRC, Inc.
Attention: Ron and Ronda Shear
PO BOX 1373
Enumclaw, WA 98022

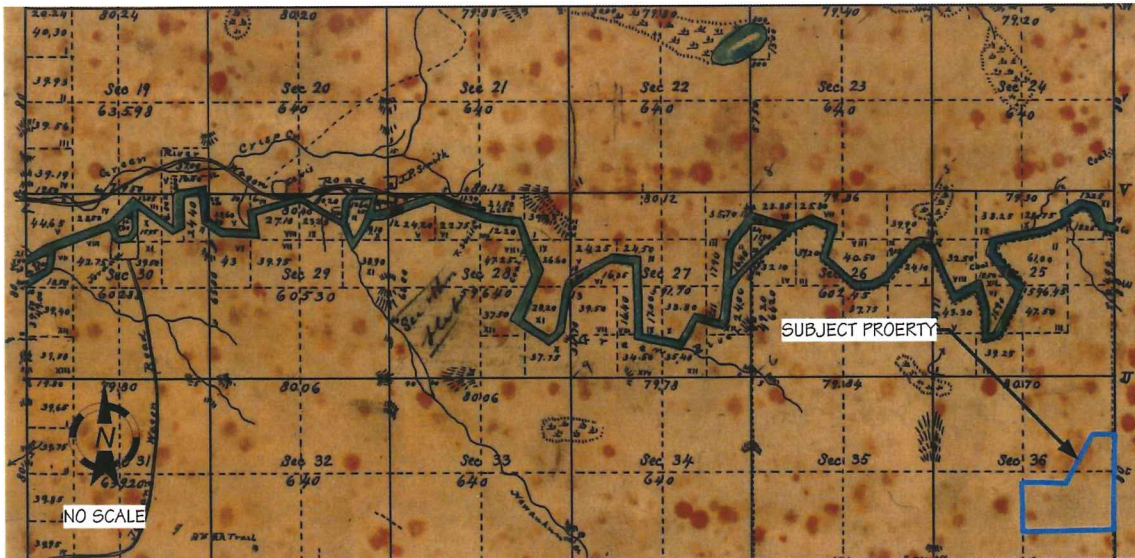
Figure 6 - From the 1874 Land Office Map T21N R6E (Sec 36)

It should be noted that NO historic map (including King County iMAP) or current USGS topographic map suggests that wetland areas are present on the subject property, including the 1874 Land Office Map (Figure 6) and the 1913 USGS topographic map of the Cedar Lake Quadrangle (Figure 7) Even the United States Fish and Wildlife Service (USFWS) Wetland Inventory Map does not suggest any wetland areas or streams are present on the subject property (Figure 8).

Regardless, there are no wetland areas shown to be present on the subject property for a reason, because wetland hydrology is not present. Although King County suggests that the manmade pond to the east of the subject property is a wetland, it is clear that this is a manmade feature that did not exist in the historic maps and is not shown to be a wetland on the Wetland Inventory Map (most likely because it is manmade). It is also clear that there were no natural ponds or wetlands located in this area since 1874 (the Land Office Map – Figure 6).

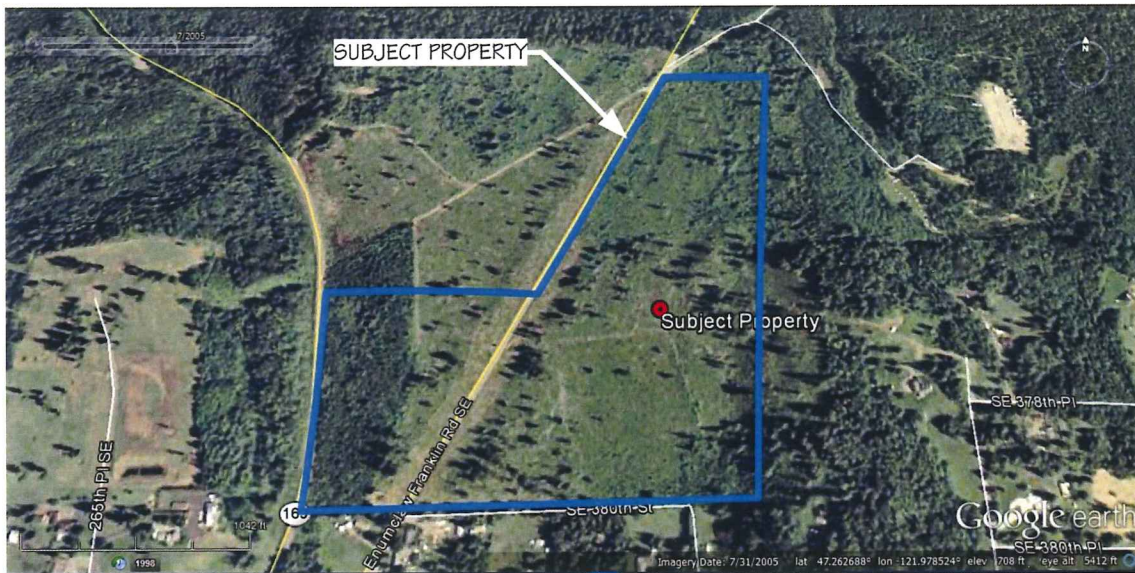
Figure 13 - July 2005 Air Photograph from Google Earth, 2016

As can be seen in the historic air photographs the subject property and vicinity was subject to clear cut tree harvesting activities at different times in different areas, with the western portion of the subject property being clear cut before the eastern portion of the subject property was clear cut.

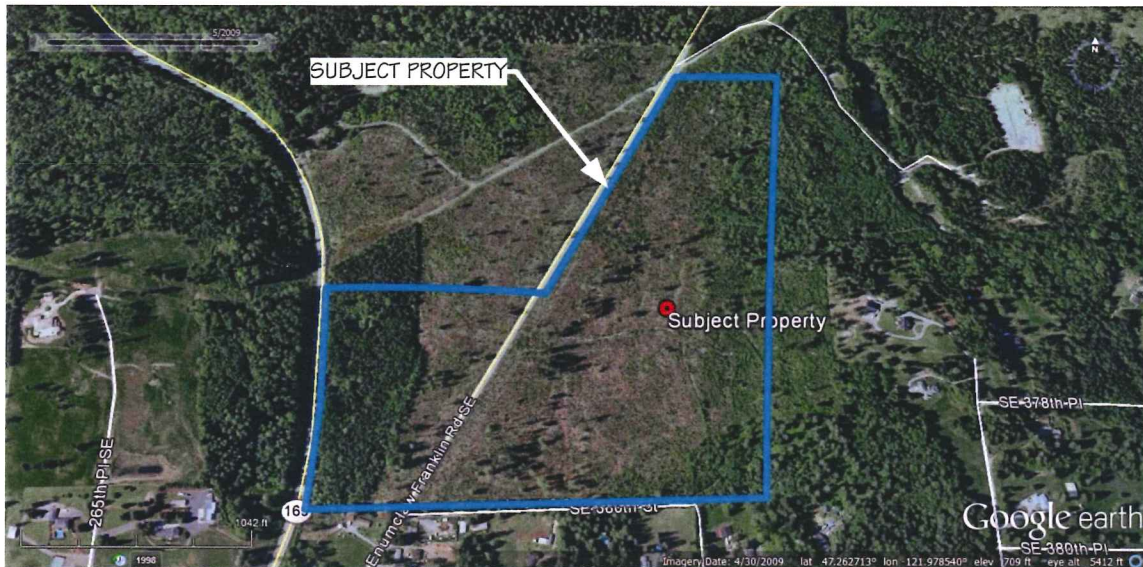
Figure 15 - May 2009 Air Photograph from Google Earth, 2016

It should be noted that the air photographs can be deceiving regarding the vegetation. The most recently harvested area appears to be less vegetated than it really is on the ground. The site reconnaissance activities clearly indicate that the majority of the subject property is well vegetated, although the tree canopy in the eastern portion of the subject property is still relatively sparse and the trees are obviously relatively young.

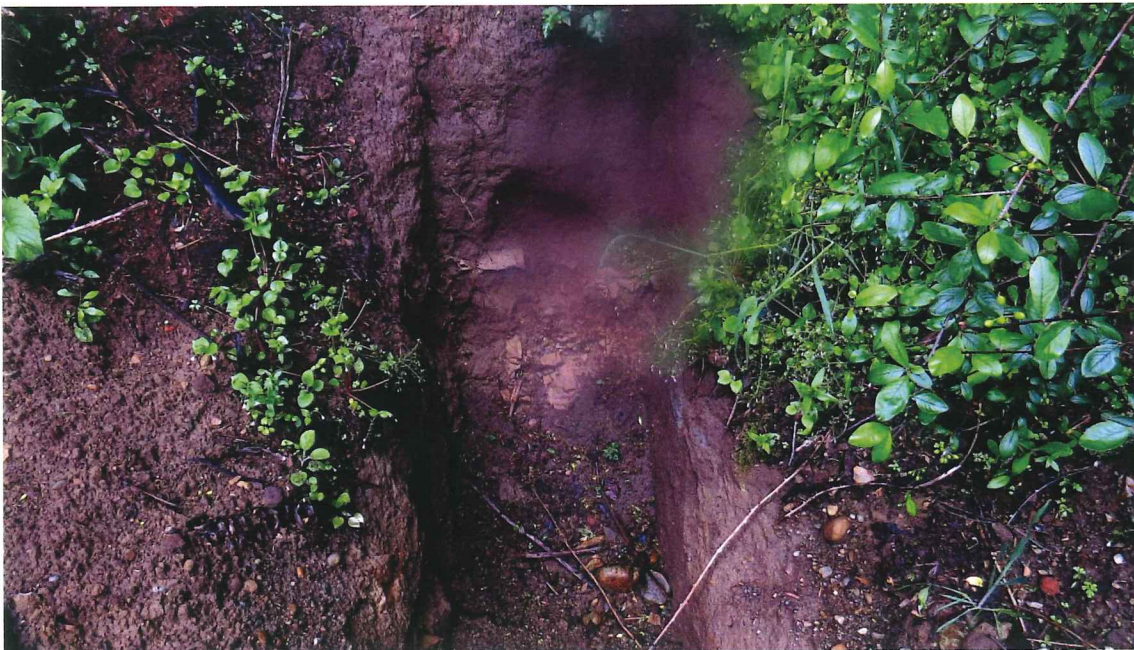
Figure 25 - Exploratory Excavation into Bedrock Material

It is unclear why the small exploratory test pits observed during the site reconnaissance were conducted for, but the materials observed in the test pit were interpreted to be older, “bedrock” deposits that were moderately metamorphosed. These were covered with very gravelly, poorly sorted materials that could be associated with historic lahar deposits based on the elevation of these test pits, however, it is also possible that this is a thin veneer of recessional outwash deposits.

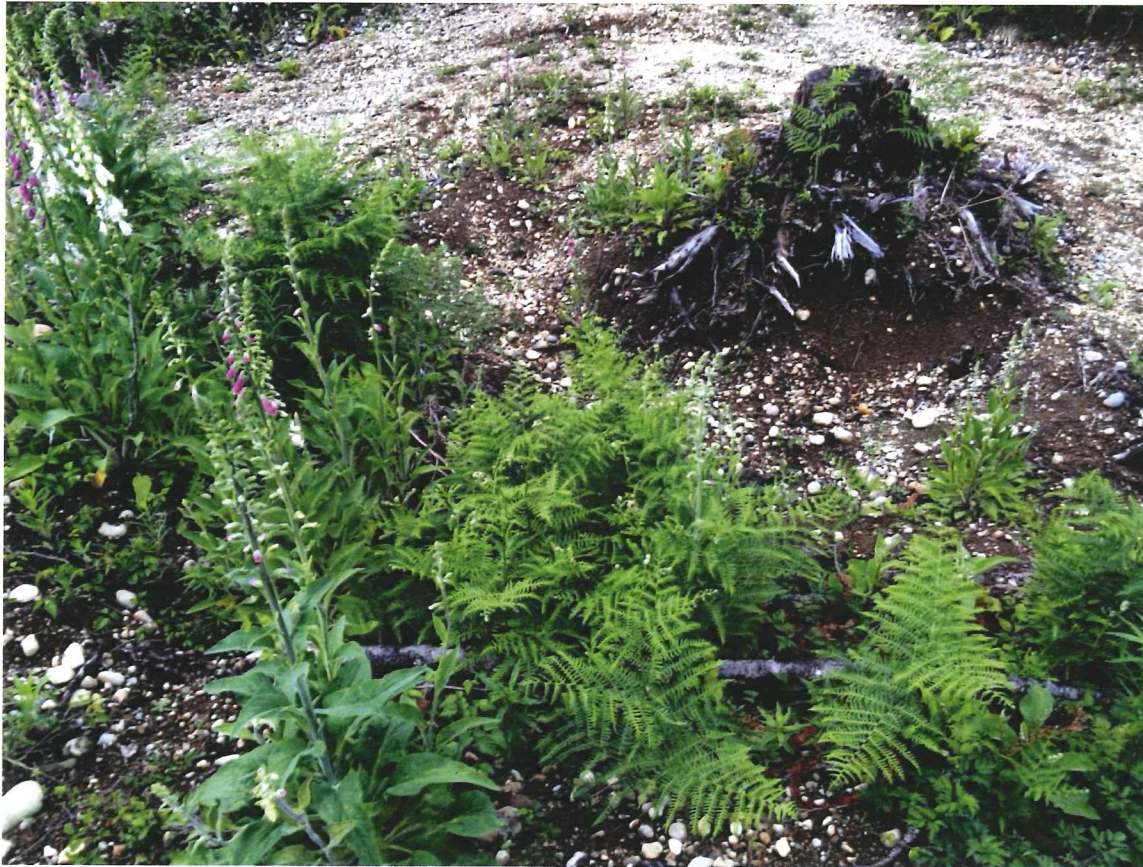
The round anomaly could not be interpreted because there was insufficient time and lack of equipment to conduct some exploratory test pits. It is clear that a moderately sized tree was located in the center of this anomaly, but what is somewhat puzzling is the presence of what appears to be bedrock materials that had been crushed and placed around this anomaly and on an access road to this area. It is possible that this area was used as a landing area during the more recent clear cut tree harvesting activities in the eastern portion of the subject property. The larger anomaly located south of this round anomaly was not studied due to lack of time and equipment, however, it appears that part of the hillslope has been separated due to possible folding and faulting in this structurally complex area.

Figure 26 - Photograph of small, round anomaly observed on LiDAR imagery

This led to an area where some minor exploratory test pit excavations had been made and a somewhat unusual mound around a historic tree stump (Figure 26) associated with a relatively small anomaly (which appeared to be a small, round depressional area), located north of a much larger structural anomaly, that appears to be fault induced.

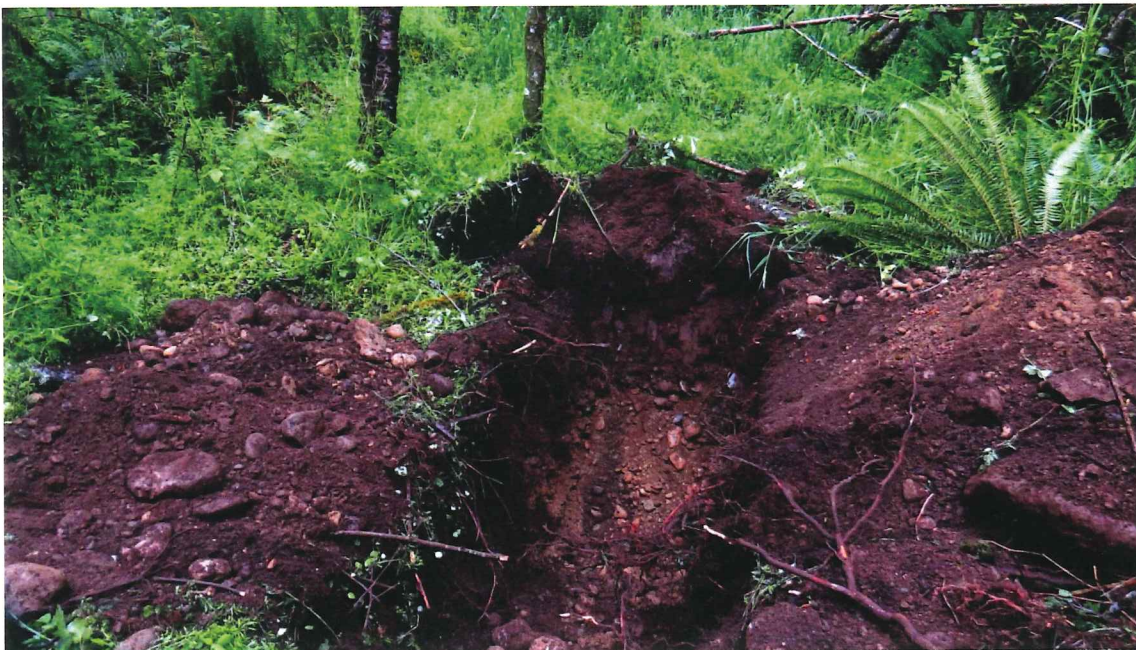
The soils in this area are formed in gravelly, cobbly, silty, moderately sorted medium to coarse sands that were well drained. This is located at one of the lowest elevations on the subject property.

Figure 28 - Test Pit 1

SNR's site reconnaissance studies covered as much of the property as possible in one day and SNR did observe one test pit in the oldest forested portion of the subject property in an area that was well vegetated with third growth forest vegetation. This included the area located west of Enumclaw Franklin Road Southeast, in an area where a stand of young cottonwood were observed to be present, however, the dominant ground cover was forest upland plants, with significant coverage by trailing blackberry (*Rubus ursinus*) – FACU. The transects and test pit(s) locations are shown on Figure 27 and a photograph of the test pit excavated as Test Pit 1 is shown as Figure 28.

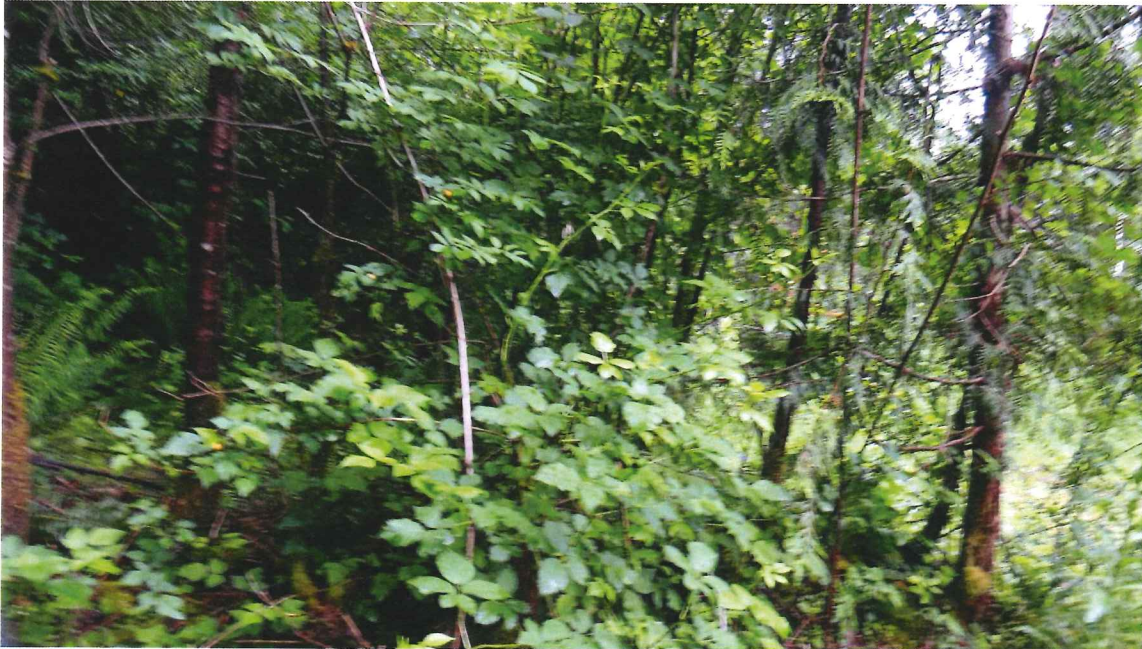
Figure 29 - Photo of shrubs and trees in southwestern portion of the Subject Property

As previously discussed, the western portion of the subject property is maturing into a relatively well diverse forest as shown in the photographs taken in this area shown as Figures 29 – 31.

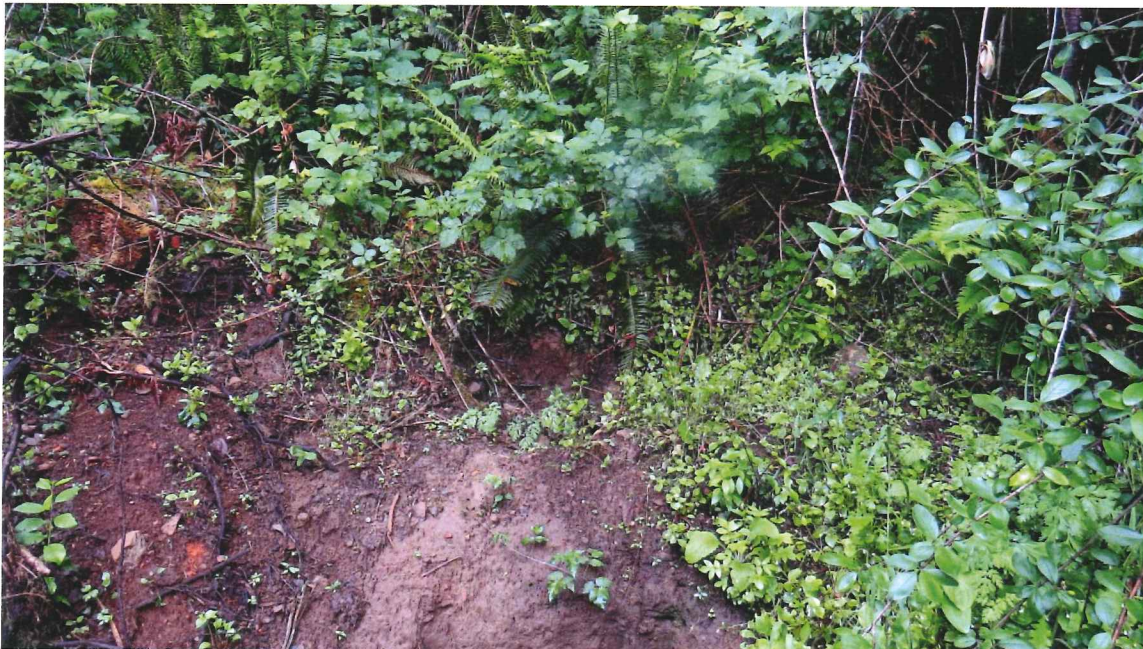
Figure 30 - Photo taken in southern portion of the subject property showing shrub and herbs

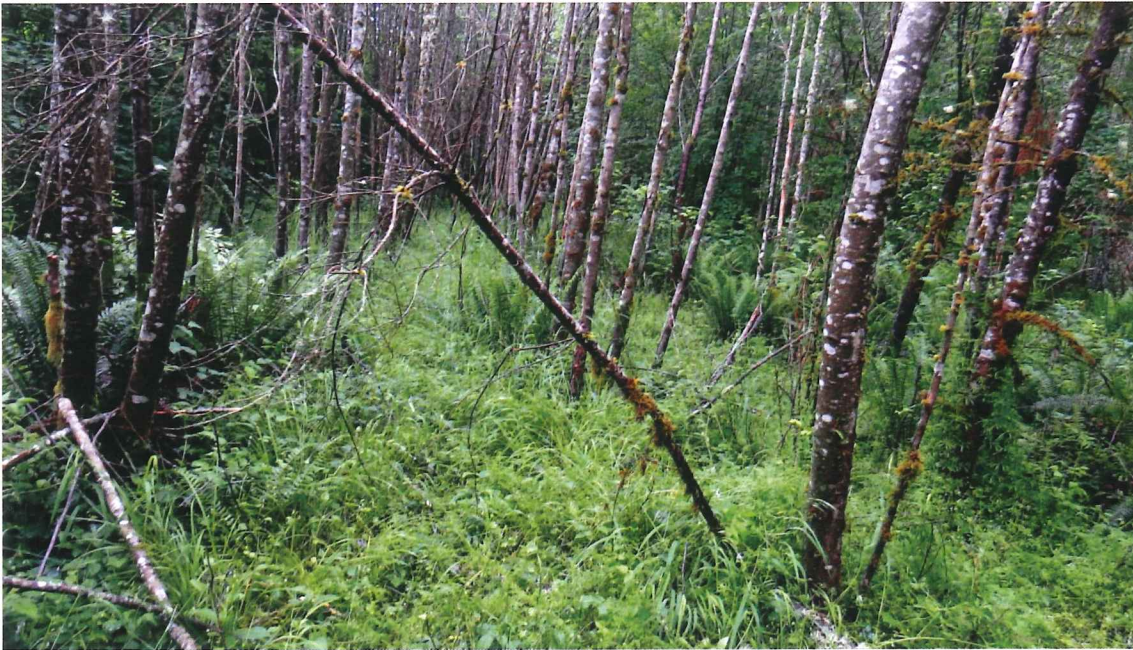
Figure 31 - Photo taken in western portion of the subject property showing canopy and understory
