KING COUNTY SEDIMENT MANAGEMENT PLAN 2018 UPDATE

King County Department of Natural Resources and Parks Sediment Management Program
Sediment Management Plan Update Project

Anchor QEA, LLC

September 2018

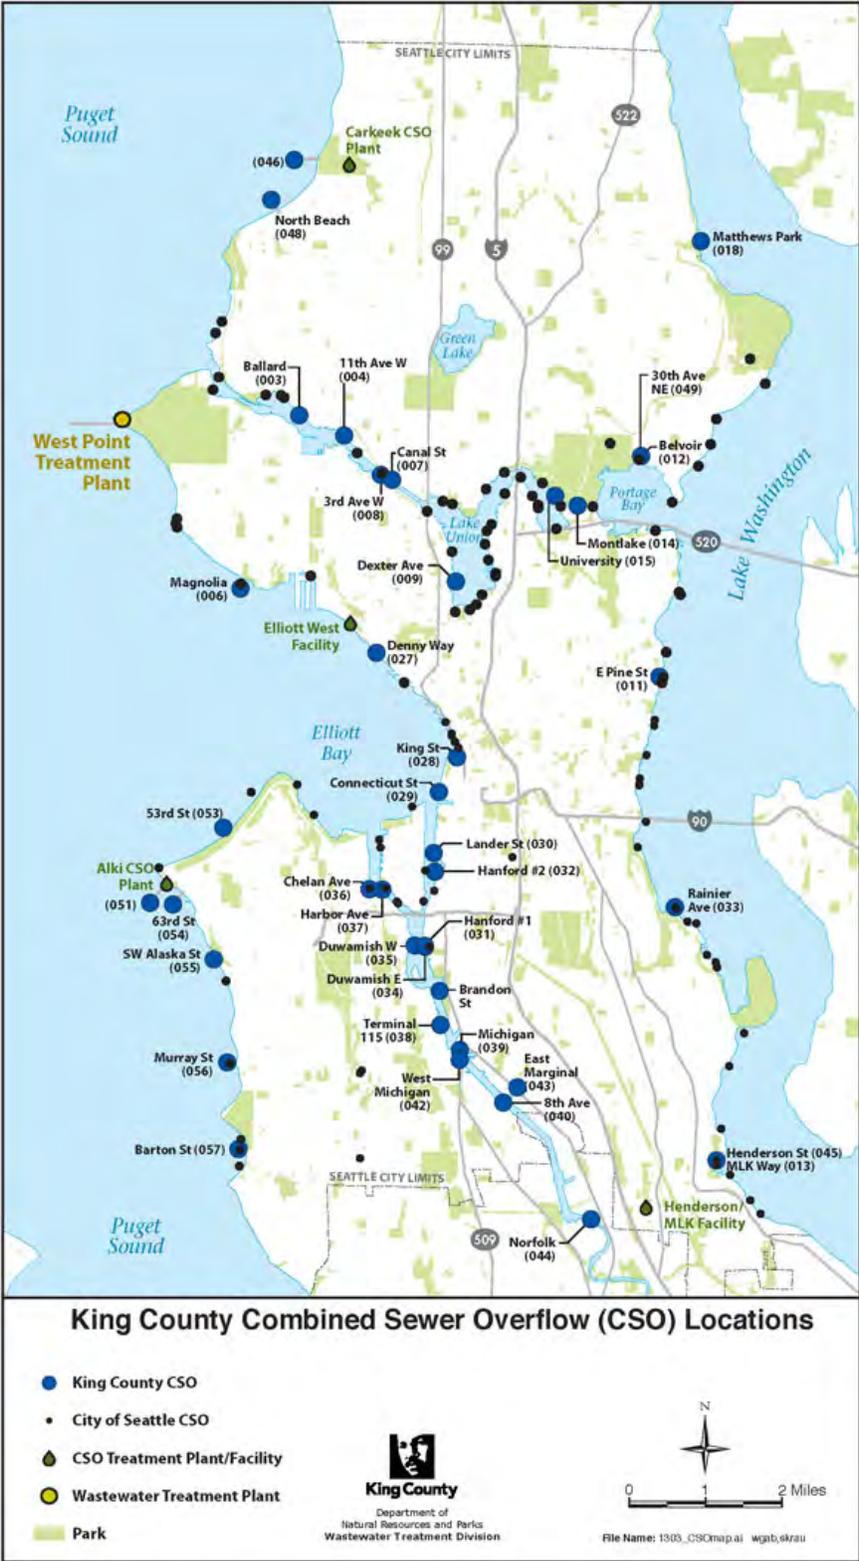
Figure ES-1
King County CSO Discharge Locations

This SMP update has been developed by King County's Sediment Management Program in coordination with the CSO Control Program. CSO discharges have been reduced substantially in the last 20 years with significant CSO control capital projects and reduced loadings to the CSO system via upland land use changes and chemical management practices. However, persistent contaminants in sediments in some locations continue to pose a potential risk to aquatic life, wildlife, and human health. Figure ES-1 shows the King County CSO discharge locations.

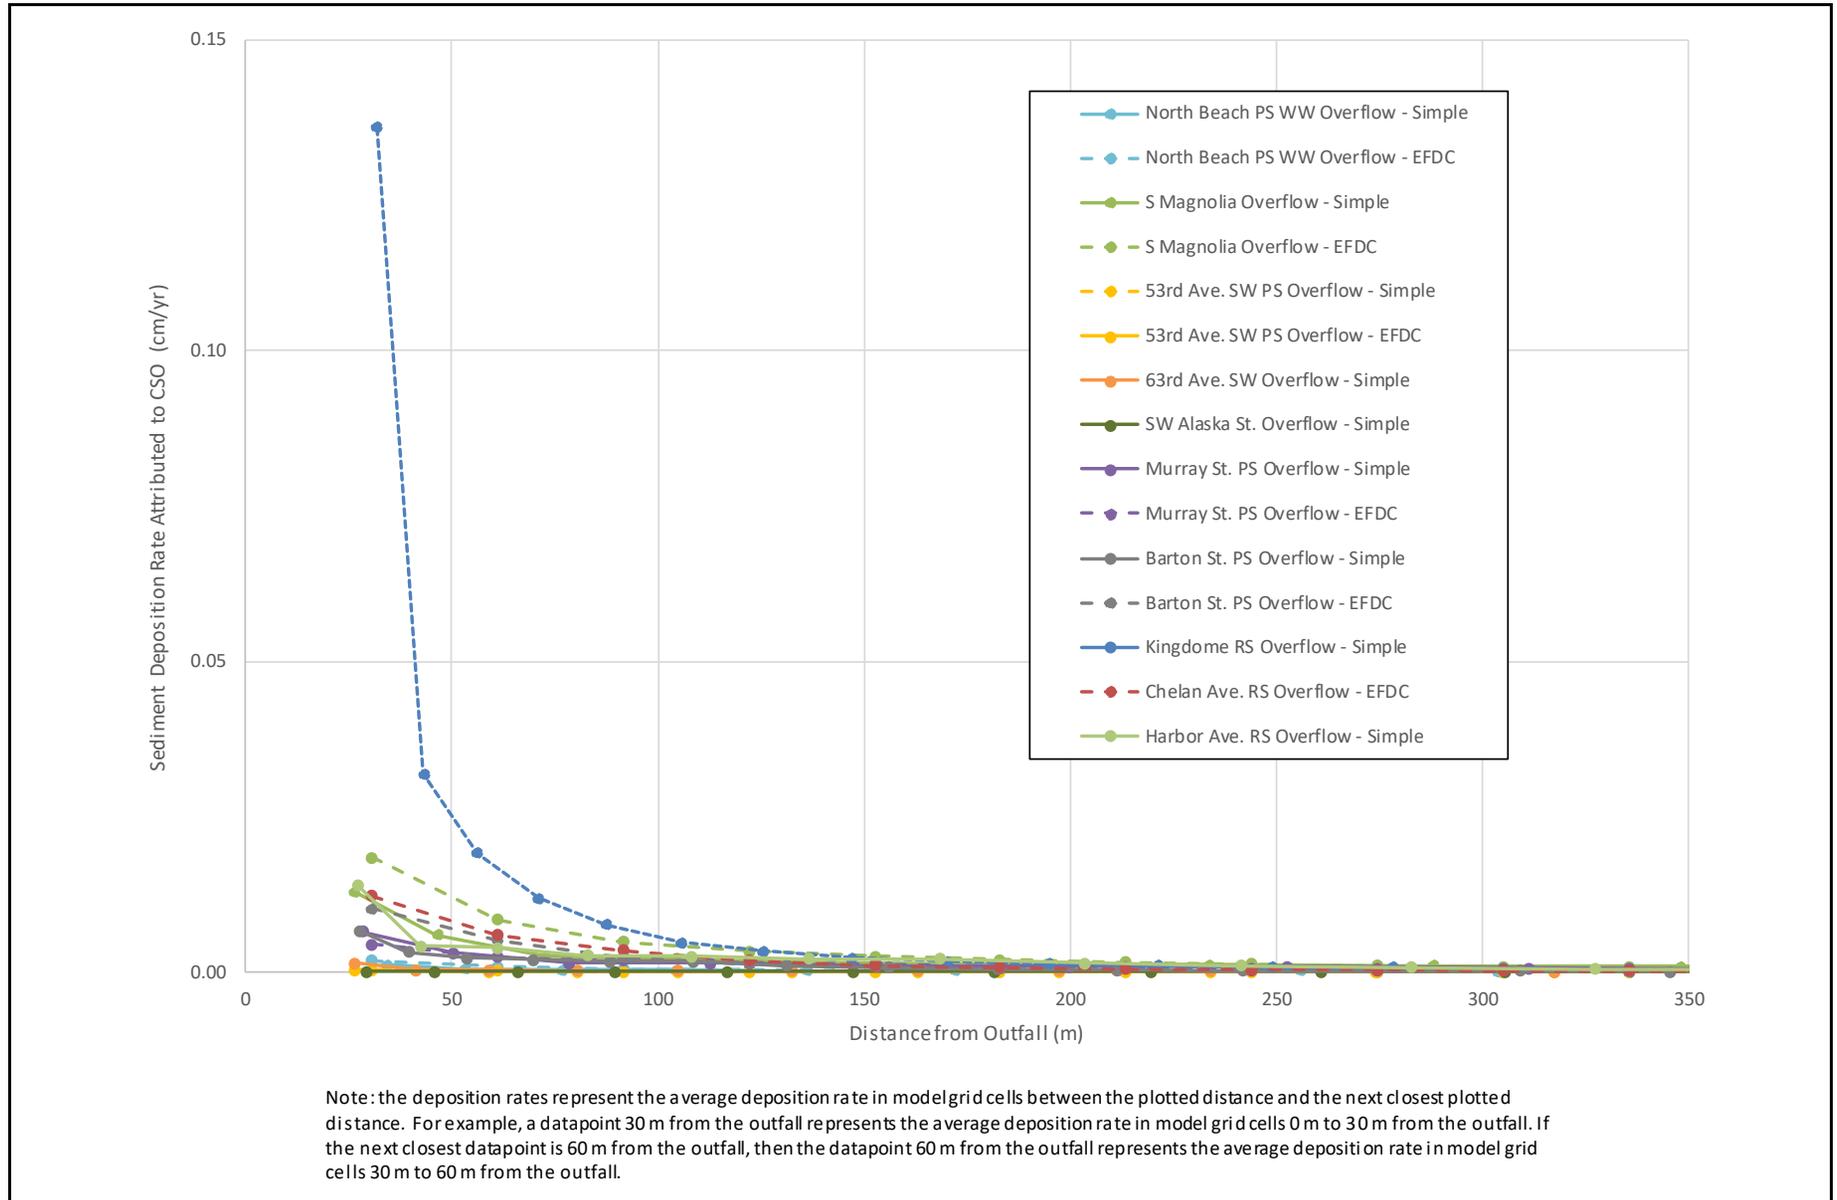
Figure 2-1
 Estimated CSO Sedimentation Rates for Marine CSOs

³ Note that the deposition rates represent the average deposition for model grid cells over each successive range of distances moving away from the outfall (see Figure 2-1 note). For example, at Kingdome, the average deposition rate exceeded 0.1 cm/year in the 79 to 117 feet band from the outfall. The exceedance area presented is based on the maximum distance that average deposition rate is predicted to exceed 0.1 cm/year (i.e., 117 ft).

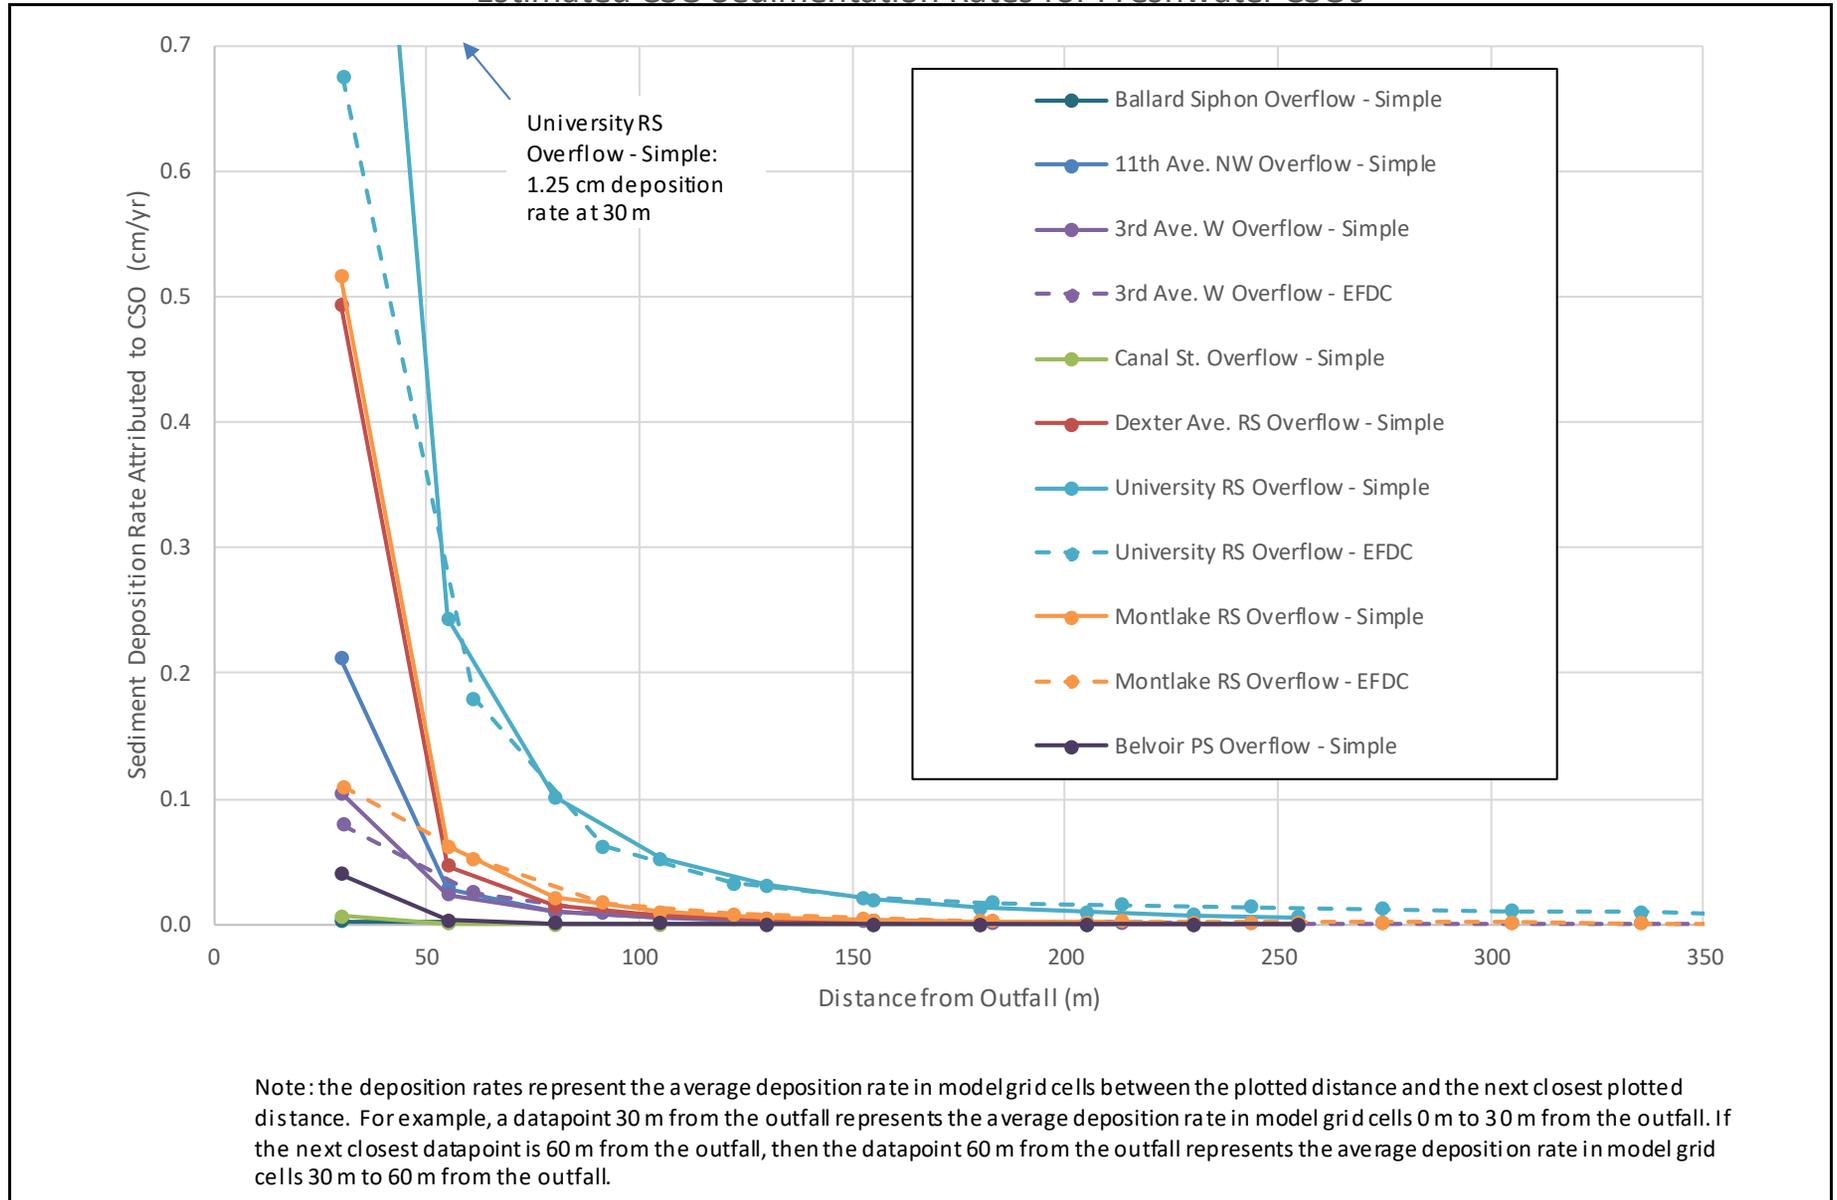
Figure 2-2

EFDC and the simple model to compare the results of the two models for CSOs with recent sediment quality data. Four other CSOs (11th Ave. NW Overflow, Ballard Siphon Regulator, Canal St. Overflow, and Dexter Ave. RS Overflow) were modeled with the simple model because they did not have recent sediment quality data. In Lake Washington, Belvoir PS Overflow and 30th Ave. NE Overflow were modeled as one discharge with the simple model, and the other overflows into Lake Washington were not modeled because they are all controlled and have no observed discharge frequency.

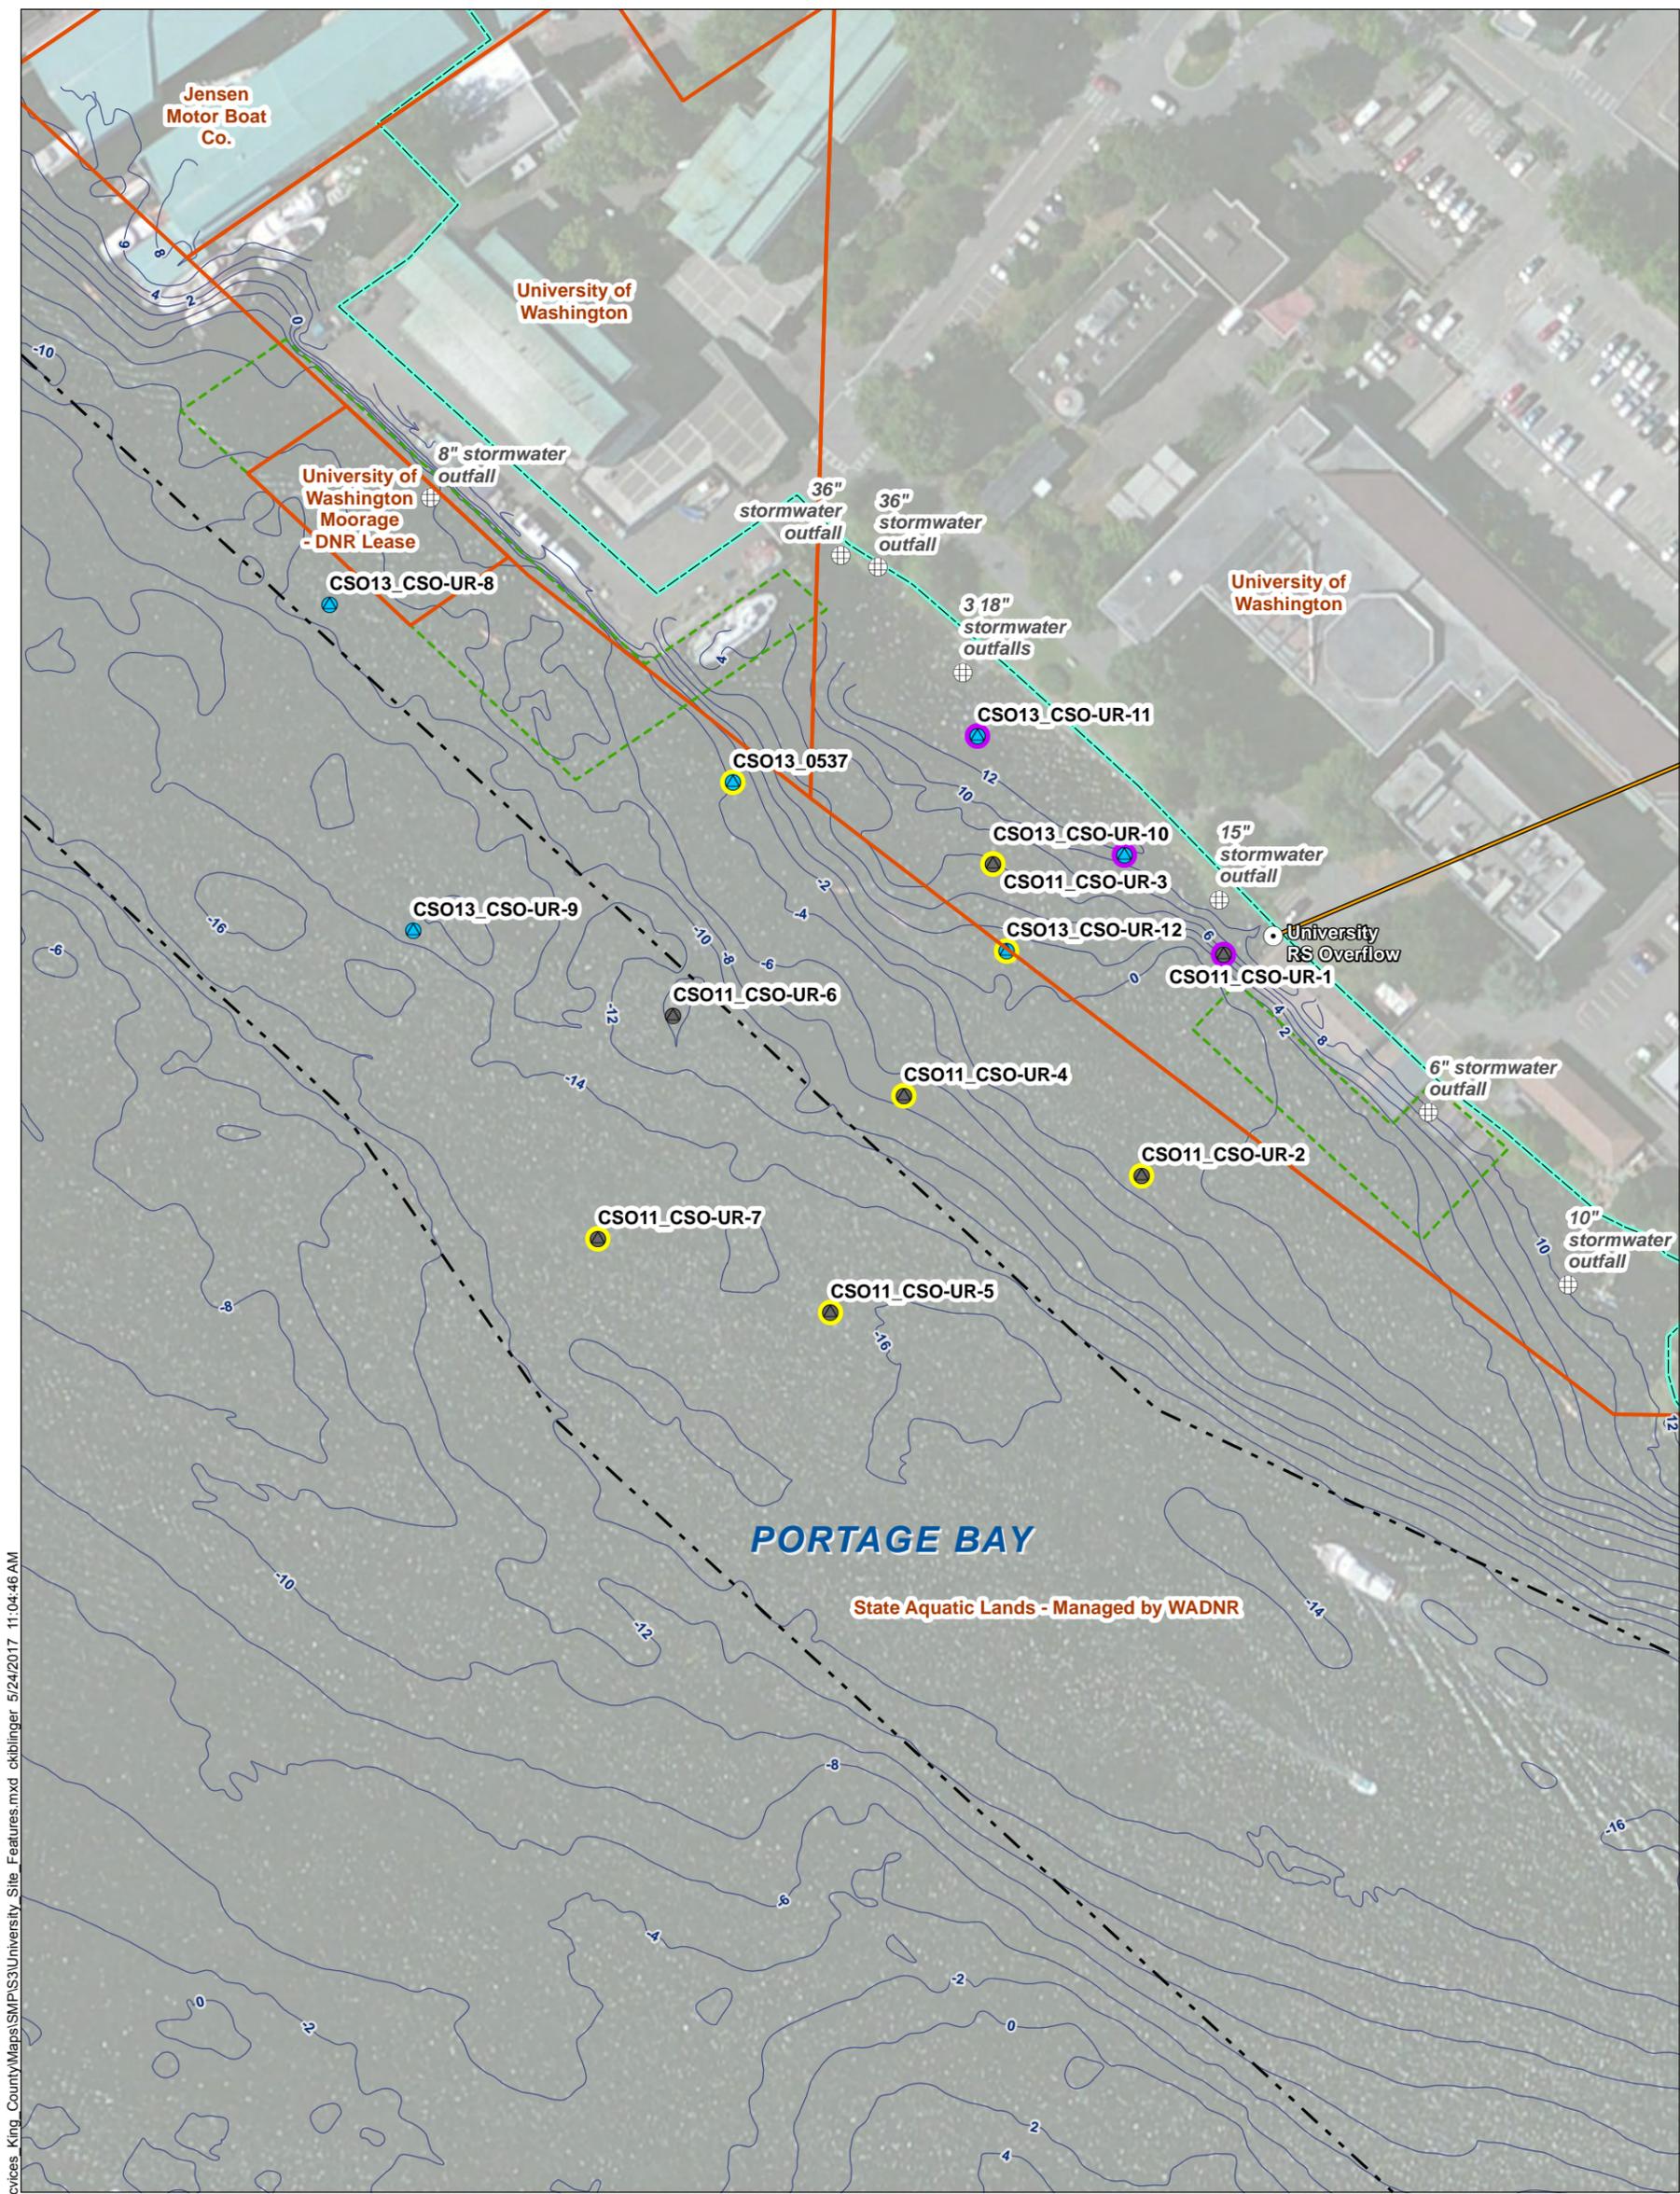
Figure 3-1
Site Features
University RS Overflow
King County Sediment Management Plan

NOTE:
Berthing areas and outfall locations are approximate.

University RS Overflow was identified as a cluster of potential concern from recent sampling and has been identified for further evaluation in the SMP update. The lines of evidence suggest that a hazard assessment is needed and identification of a cleanup site is likely per WAC 173-204-530. The CSO is uncontrolled and influenced by adjacent pathways and potential sources. However, there is an area of elevated concentrations that suggests a site can be clearly defined, and the County anticipates that cleanup will be required at this location.
