CONFLUENCE

Marymoor Park Stormwater Facility Improvements CRITICAL AREAS STUDY

Prepared for:
King County
June 17, 2022

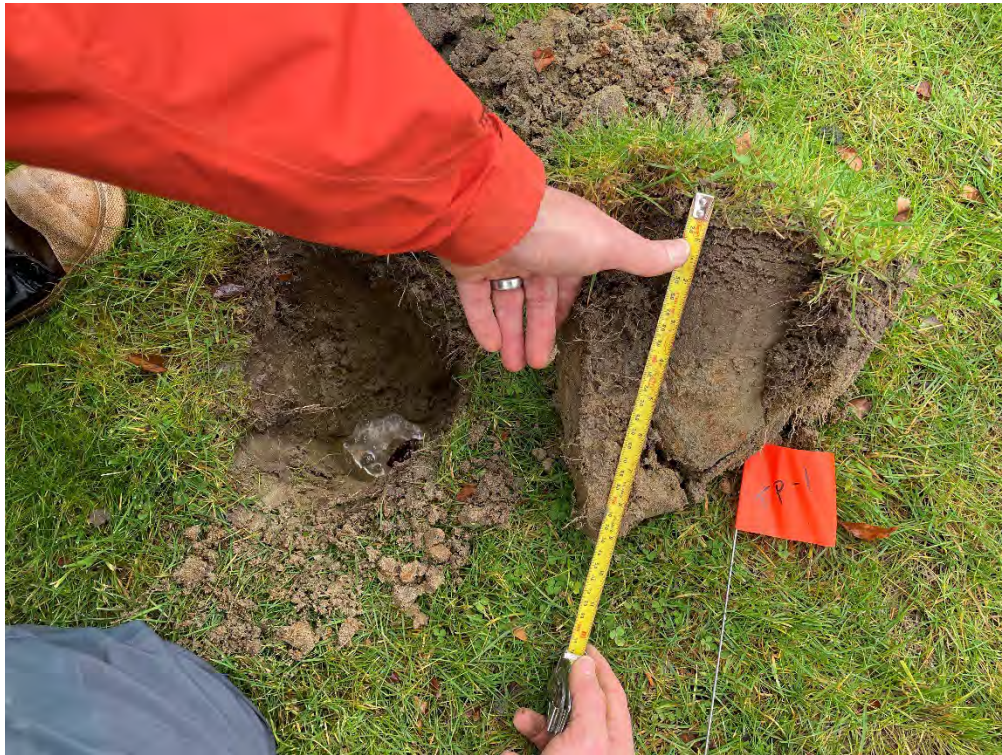
Photo 1—Soil profile at TP-1.

Test Plot 1 (TP-1) was located in the channel improvements project area, in a mowed lawn area of the park. Grass species could not be identified to species and thus were lumped together as “mowed lawn” and given a conservative indicator status of facultative. Vegetation within TP-1 passed the Dominance Test and therefore met the wetland vegetation criterion. Soil in the top layer (0-3 inches) was a dark brown (10YR 3/3) sandy silt loam. Soil in the second layer (3-16 inches) was a very dark grayish brown (2.5Y 3/3) sandy loam with 6% gray (10YR 5/1) depletions in the matrix and 10% dark yellowish brown (10YR 4/6) redoximorphic concentrations in the matrix. The soils did not meet any hydric soil indicator; therefore, the hydric soil criterion was not met. Two primary hydrology indicators—High Water Table (A2) and Saturation (A3)—were observed. The presence of at least 1 primary or 2 secondary indicators meets the wetland hydrology criterion. The observed hydrology indicators may have been a result of recent heavy rains and are generally not good indicators of wetland conditions during the wet season. The absence of oxidized rhizospheres in the upper soil horizon together with the absence of hydric soil indicators suggests that the observed saturation likely does not persist long enough during the growing season for wetland conditions to develop. Since TP-1 did not meet all 3 criteria, the area represented by TP-1 is not a wetland.

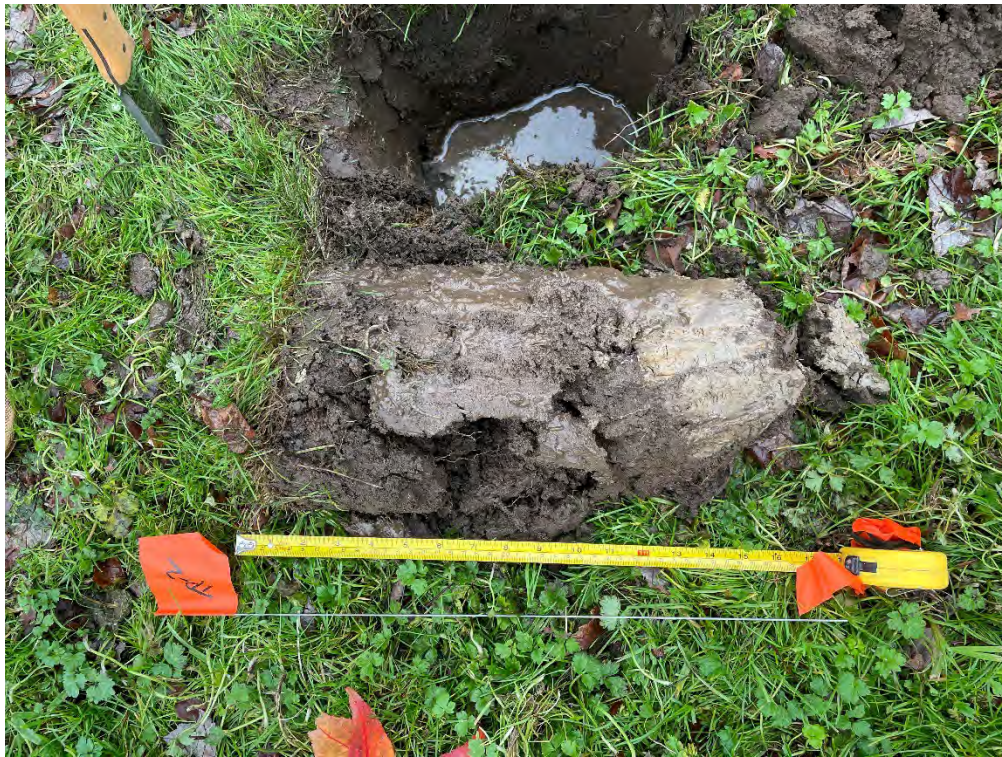
Photo 5—Soil profile at TP-2 in Alternative 6A study area.

TP-2 was located in the channel improvements project area, in an area dominated by mowed lawn and creeping buttercup (*Ranunculus repens*). Vegetation within TP-2 passed the Dominance Test and therefore met the wetland vegetation criterion. Soil in the top layer (0-6 inches) was a very dark grayish brown (10YR 3/2) loam. Soil in the second layer (6-10 inches) was a very dark grayish brown (10YR 3/2) loam with 1% dark yellowish brown (10YR 3/4) redoximorphic concentrations in the matrix. Soils in the third layer (10-16 inches) was a gray (10YR 5/1) silty clay with 10% dark yellowish brown (10YR 4/6) redoximorphic concentrations in the matrix. Soils met the Depleted Matrix (F3) and Depleted Below Dark Surface (A11) hydric soil indicators; therefore, the hydric soil criterion was met. Two primary hydrology indicators—High Water Table (A2) and Saturation (A3)—were observed. The presence of at least 1 primary or 2 secondary indicators meets the wetland hydrology criterion. Since TP-2 met all 3 criteria, the area represented by TP-2 is a wetland, identified as Wetland A.

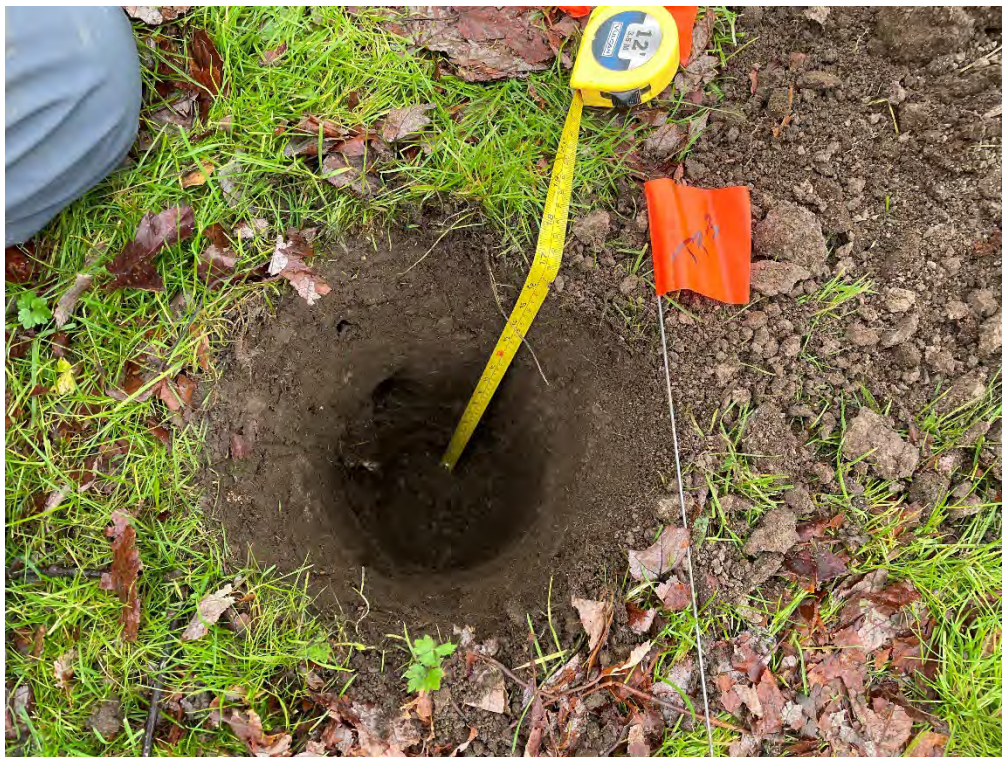
Photo 10—Soil profile at TP-3 in Alternative 6A study area.

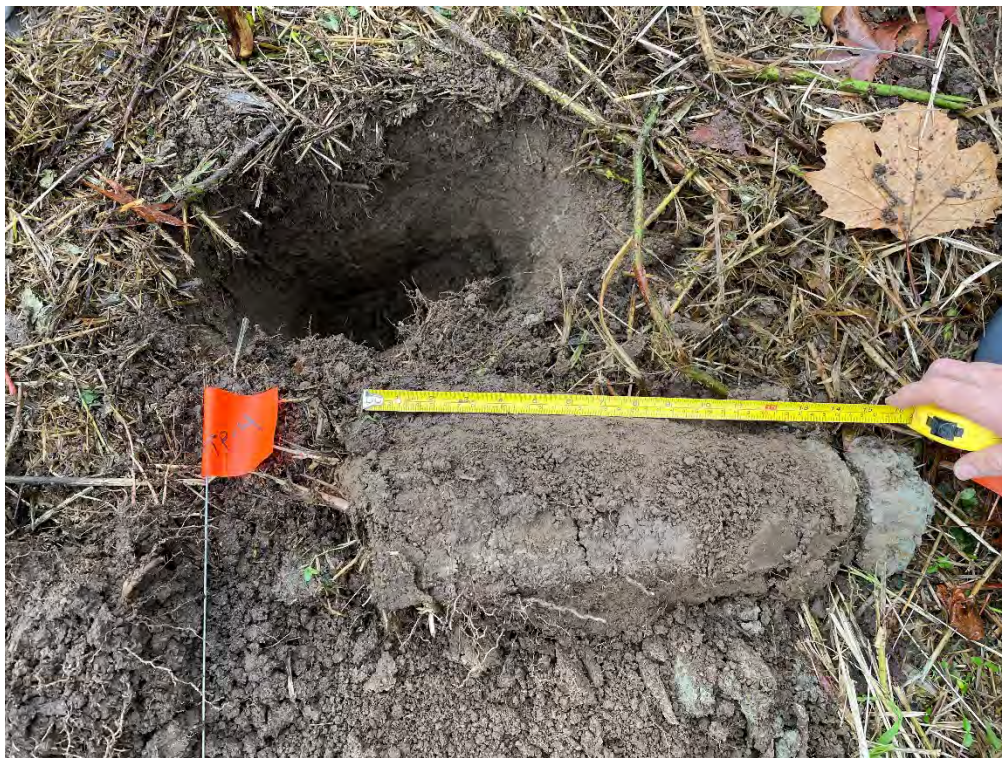
Photo 14—Soil profile at TP-4 in Alternative 6A study area.

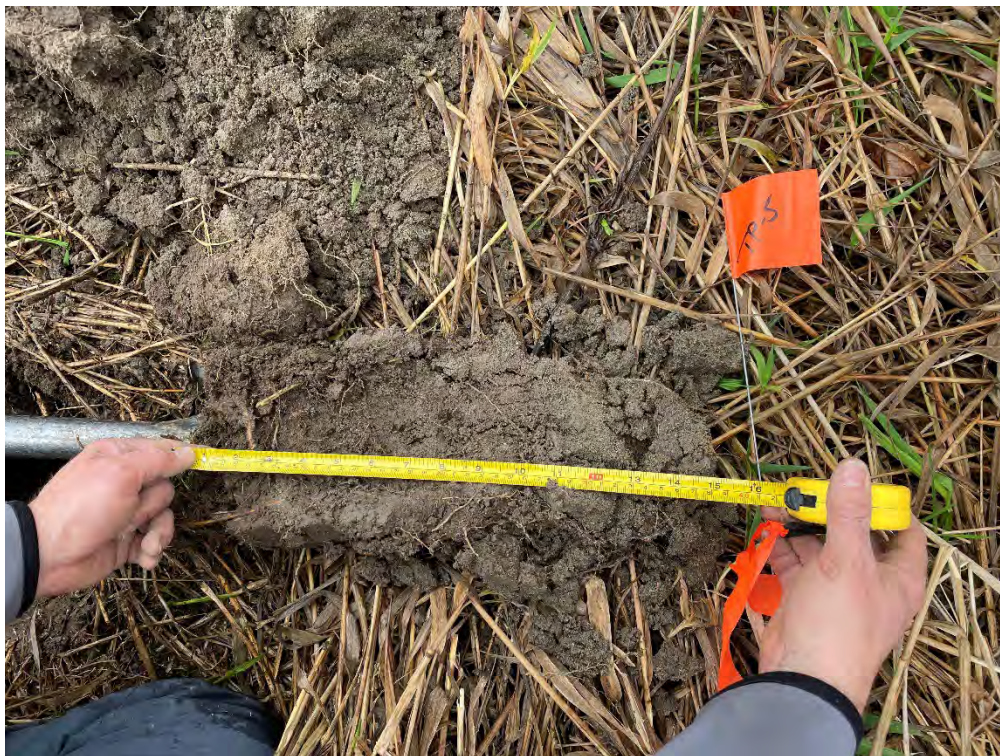
Photo 18—Soil profile at TP-5 in Alternative 6A study area.

hydric soil criterion was not met. Two primary hydrology indicators—High Water Table (A2) and Saturation (A3)—and one secondary indicator—FAC-Neutral Test (D5)—were observed. However, the presence of primary hydrology indicators with the presence of non-hydric soils indicated the hydrology indicators observed were likely a result of the recent heavy rains and would not likely persist into the growing season. Since TP-5 did not meet all 3 criteria, the area represented by TP-5 is not a wetland.

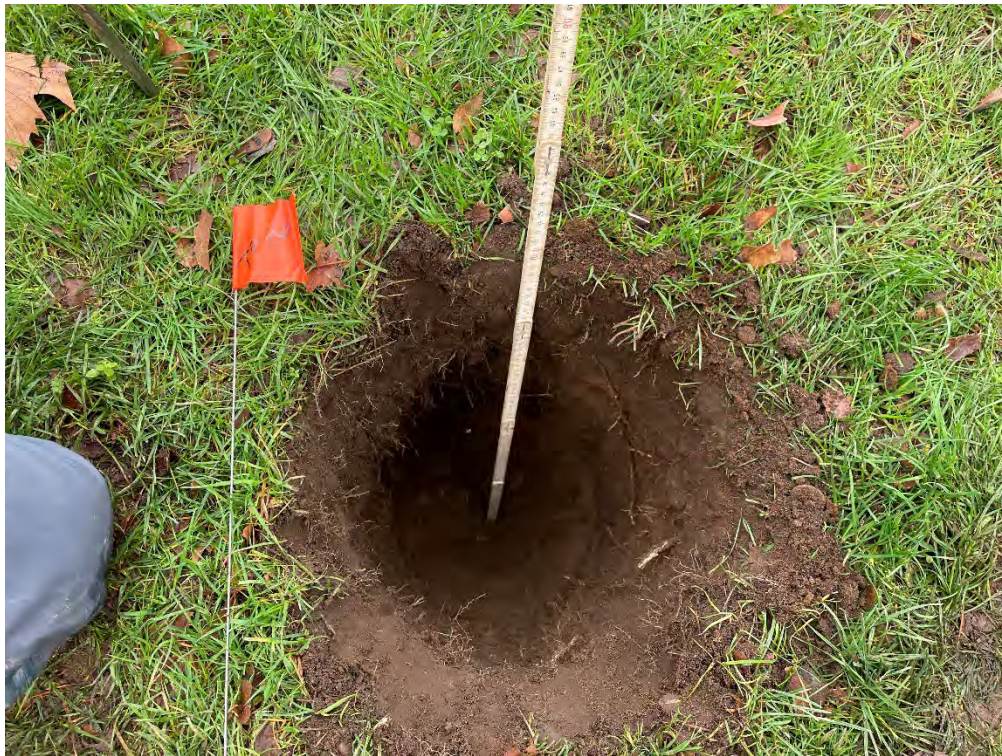
Photo 22—Soil profile at TP-6 in Alternative 4A study area.

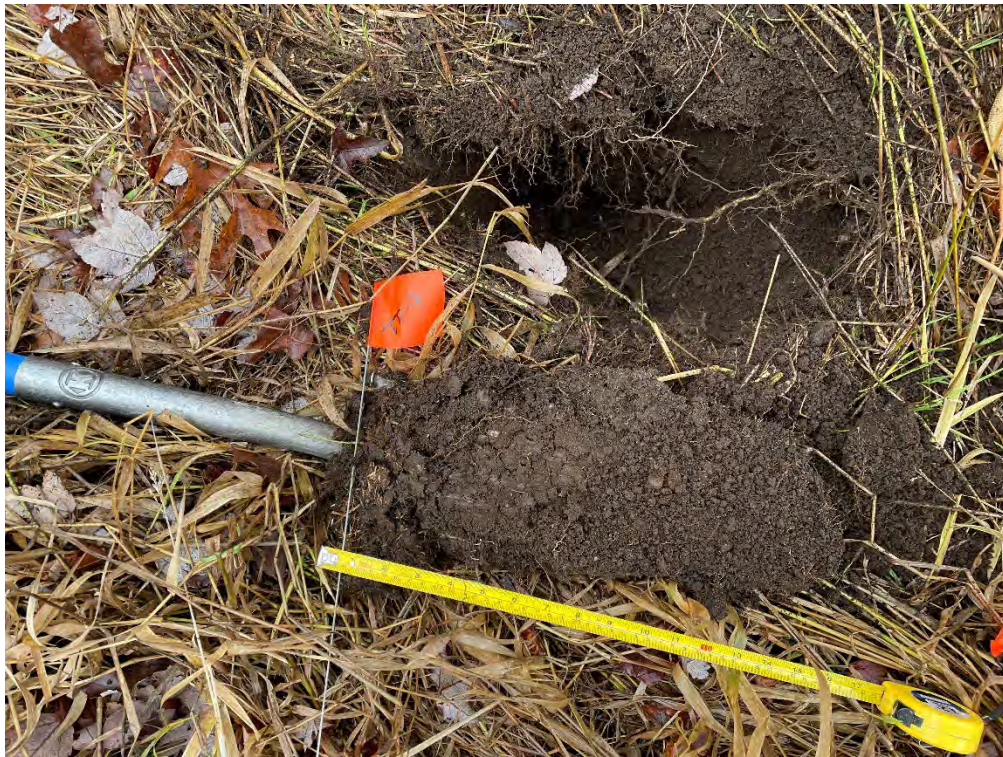
Photo 25—Soil profile at TP-7 in Alternative 4A study area.

TP-7 was located east of TP-6 in the rain garden project area. Dominant vegetation within TP-7 included mowed lawn and reed canarygrass. Vegetation within TP-7 passed the Dominance Test and therefore met the wetland vegetation criterion. Soil in the top layer (0-18 inches) was a very dark brown (10YR 2/2) silt loam. Soil in the second layer (18-20+ inches) was a dark brown (7.5YR 3/4) silt loam. The soils did not meet any hydric soil indicator; therefore, the hydric soil criterion was not met. No primary or secondary hydrology indicators were observed. Since TP-7 did not meet all 3 criteria, the area represented by TP-7 is not a wetland.

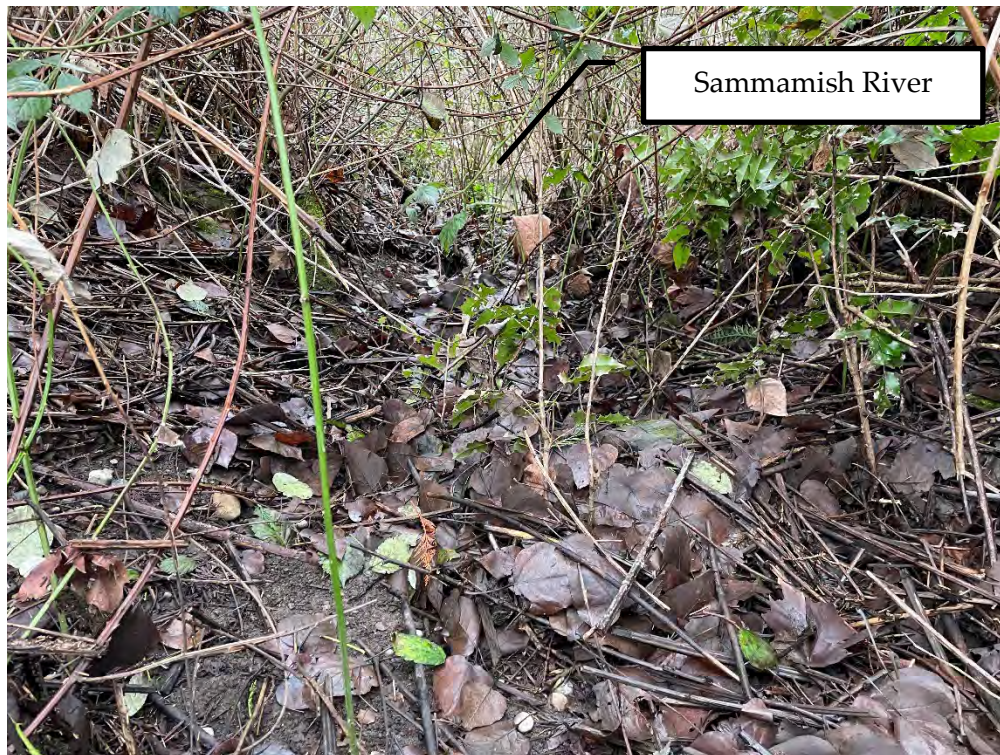
Photo 33—Unnamed ditch outlet to Sammamish River. Note no water present on January 24, 2022

Habitat conditions in the ditch for fish are very low quality. Salmonid spawning habitat and access to upstream spawning habitat do not exist. The upstream extent of the ditch lacks a defined channel or scour line, is choked with vegetation, and terminates within 170 meters of the eastern culvert; therefore, it does not constitute a significant reach of potential salmonid habitat. The lack of habitat complexity or cover, in addition to primary hydrologic contributions from pollutant-generating impervious surfaces, qualifies this habitat as very low quality, if not adverse, for potential rearing.

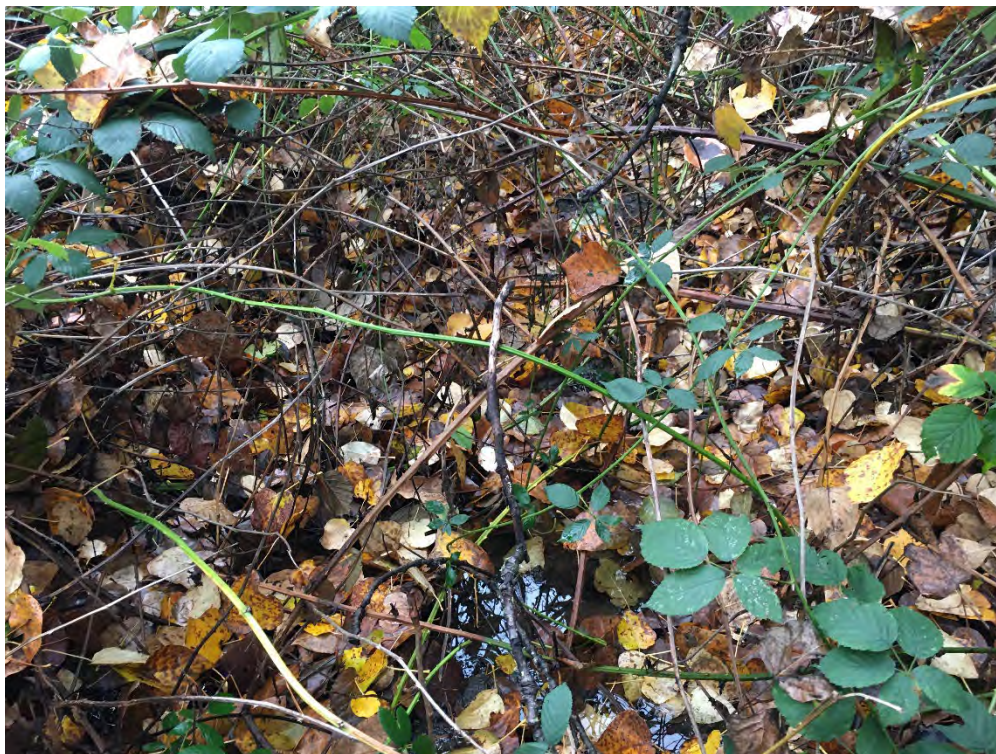
Photo 34—Unnamed ditch near outlet (same location as Photo 33). Note water present on November 29, 2021

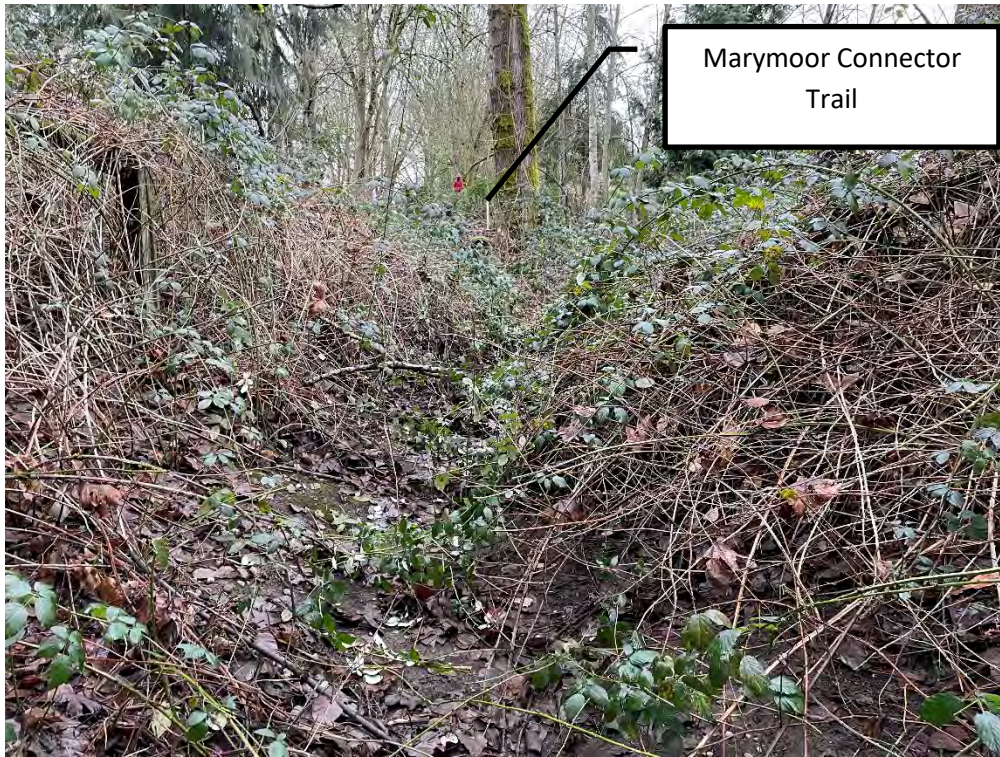
Photo 35—View to east of unnamed ditch from Photo 33.

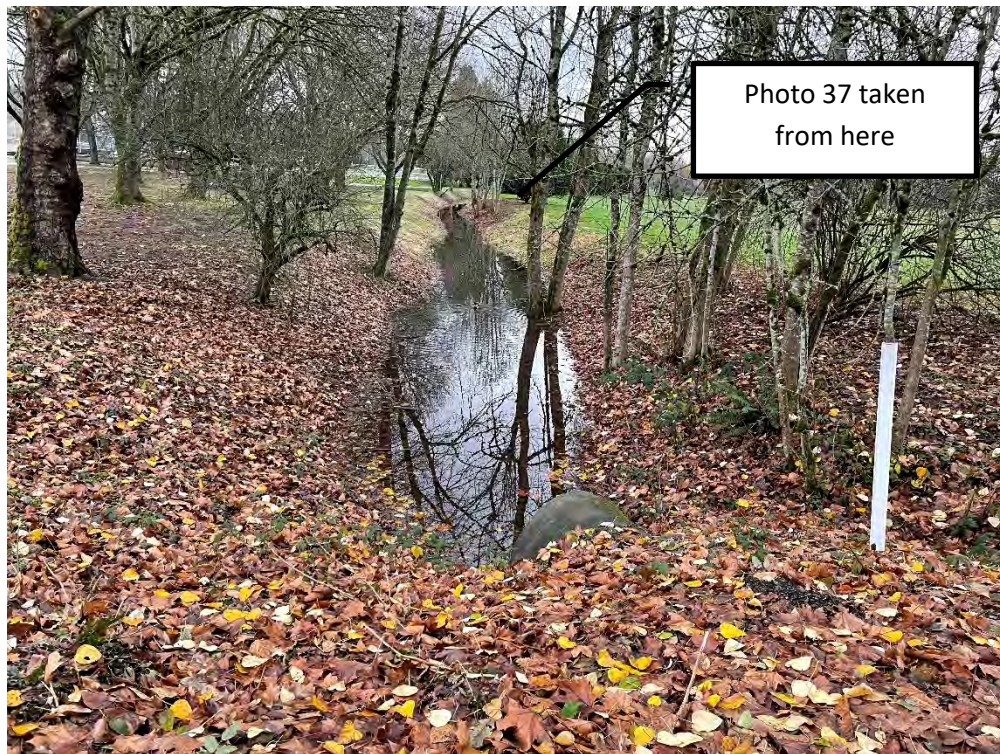
Photo 36—View to east of unnamed ditch from Marymoor Connector Trail.

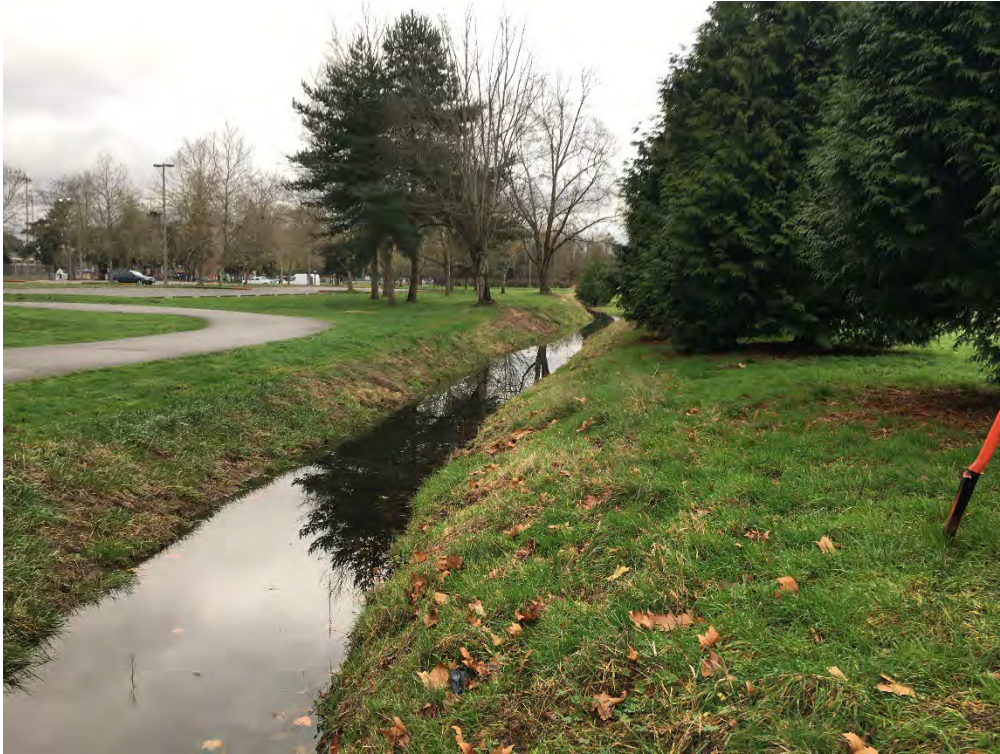
Photo 37—View to east of unnamed ditch.
