Damaged Pipe Investigation

Discovery Park Environmental Learning Center February 16, 2017 6:30-8:30 p.m.

Pipe Background

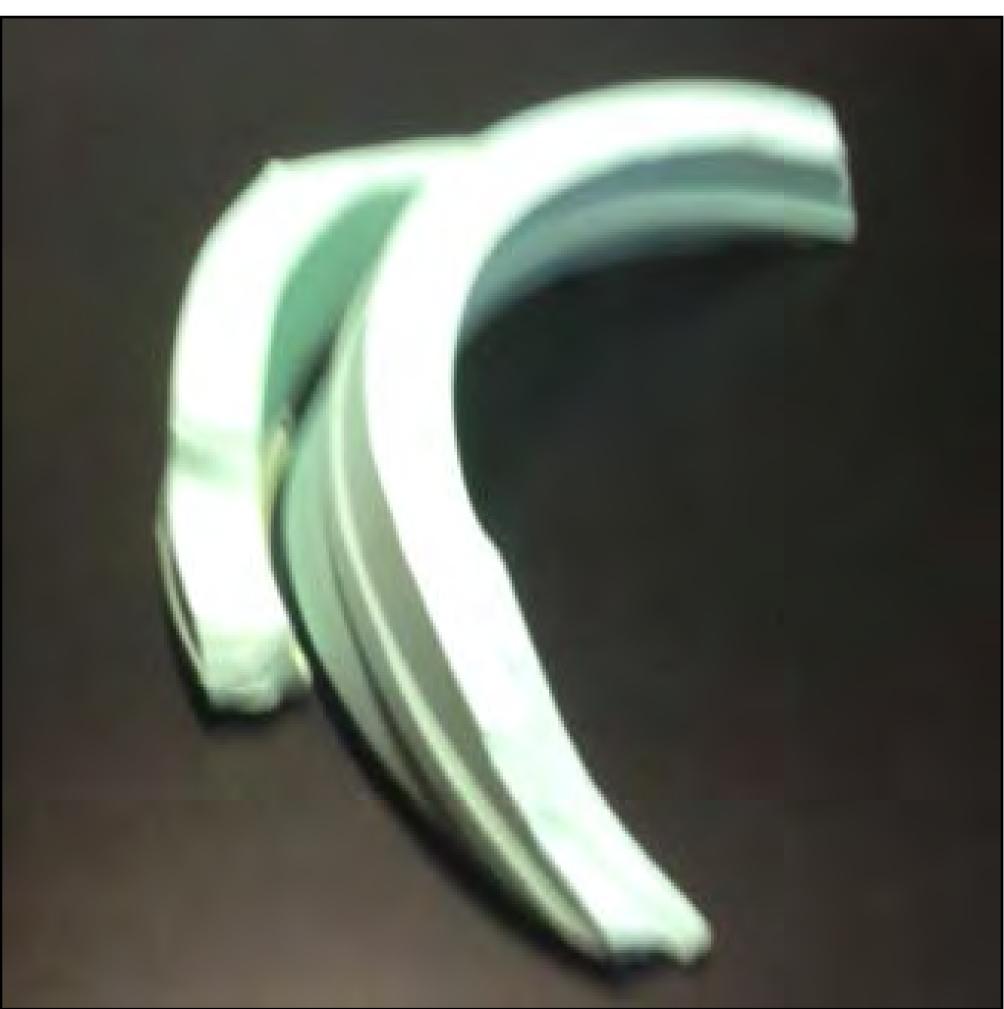
Investigation starts September 2016 Tank did not fill during storm

- Inspections eliminate
 City sewers as source
- No indications of a problem from surface
- Pipe debris found in November
