King County

Restoring the West Point Treatment Plant

Mark Isaacson, Director
Wastewater Treatment Division
March 22, 2017

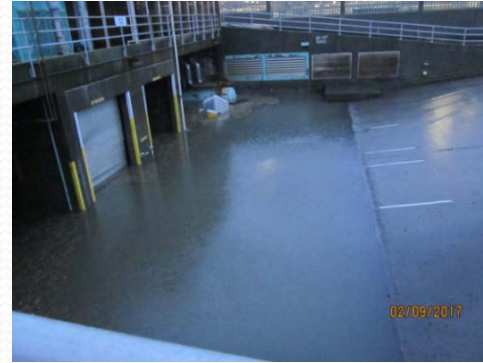
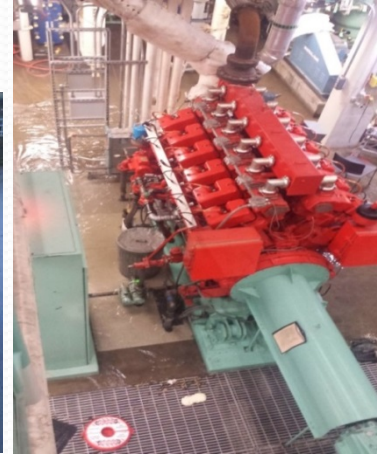
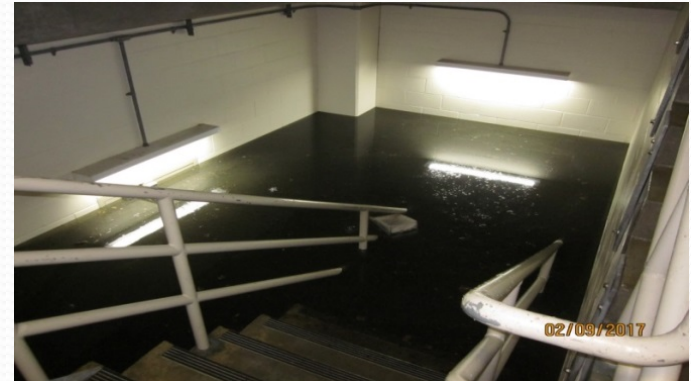
February 9, 2017

- Severe flooding caused by power and equipment failure led to flooding inside the plant on Feb. 9
- 180 million gallons of stormwater-sewage discharged to Puget Sound
- Damage temporarily reduced plant capacity, treatment level
- Two smaller bypasses occurred on Feb. 15-16

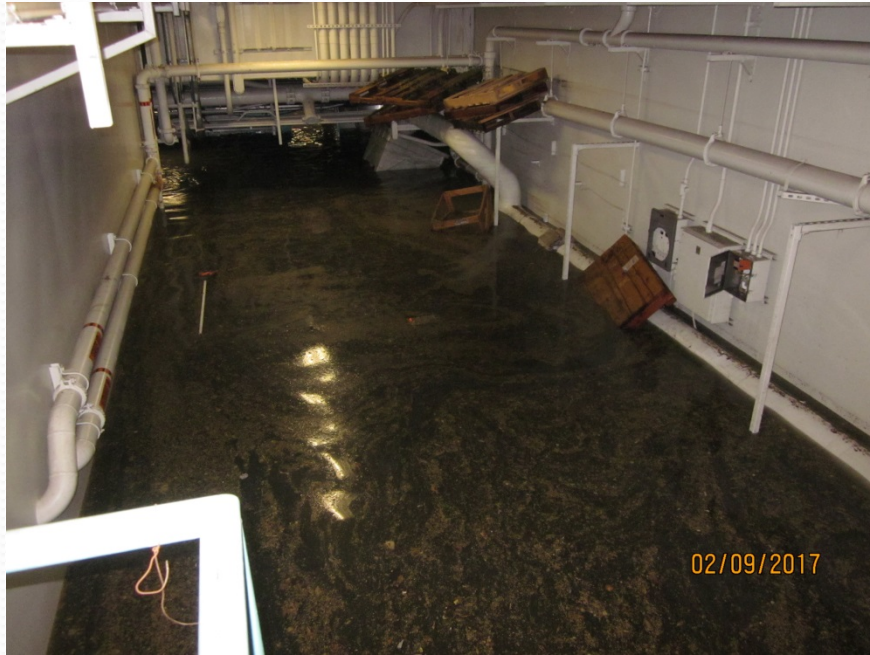
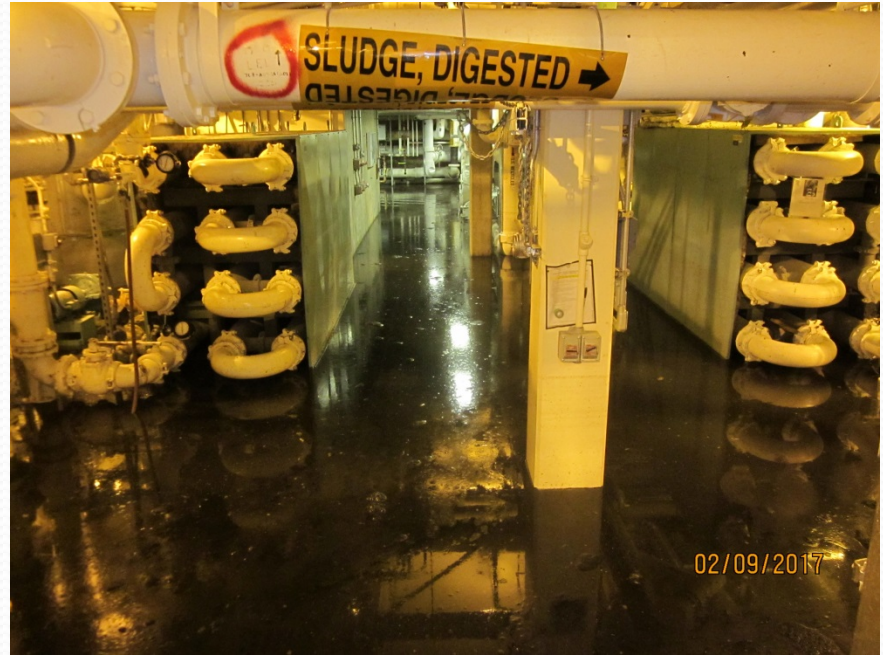
February 9, 2017

Flooded galleries

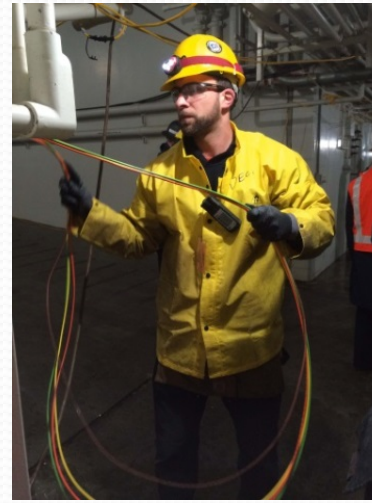
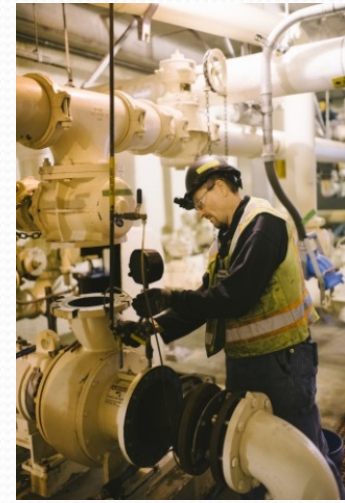
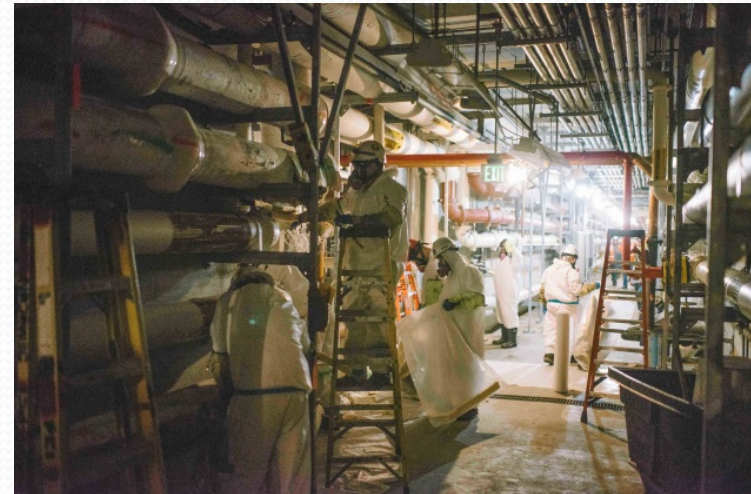
Type of Equipment Damaged	Equipment Count
12 x 12-foot tunnels	1 Mile
Electric Motors	149
Pumps	127
Electrical Motor Control Centers Buckets	200
Electrical Panels	125
Electrical Transformers	25
Local Electrical Control Stations	125
Light Fixtures	>2000
Outlets and Switches	>1200
Instruments	>125
Solenoids	>200
Equipment Control Systems	3

Recovery efforts

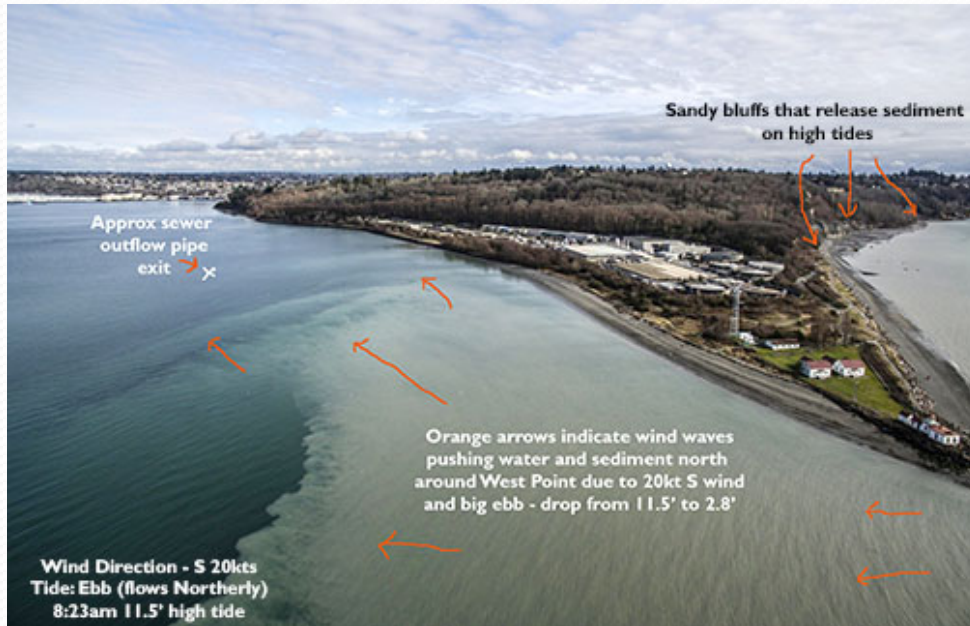
Coastal sediment off West Point

- Seattle Times photo from 3/12 story – Not bypass-related
 - No seagulls
 - Low bacteria count from lab samples
 - Several hours after bypass stopped
 - Sediment plumes off West Point are normal
