February 9, 2016

Re: Boise Creek Arch Bridge  
King County Parks - Foothills Trail  
Task 300.4 Structural - Boise Creek Arch Bridge  
DRAFT Structural Recommendations Report  
Exeltech Project No. 1527

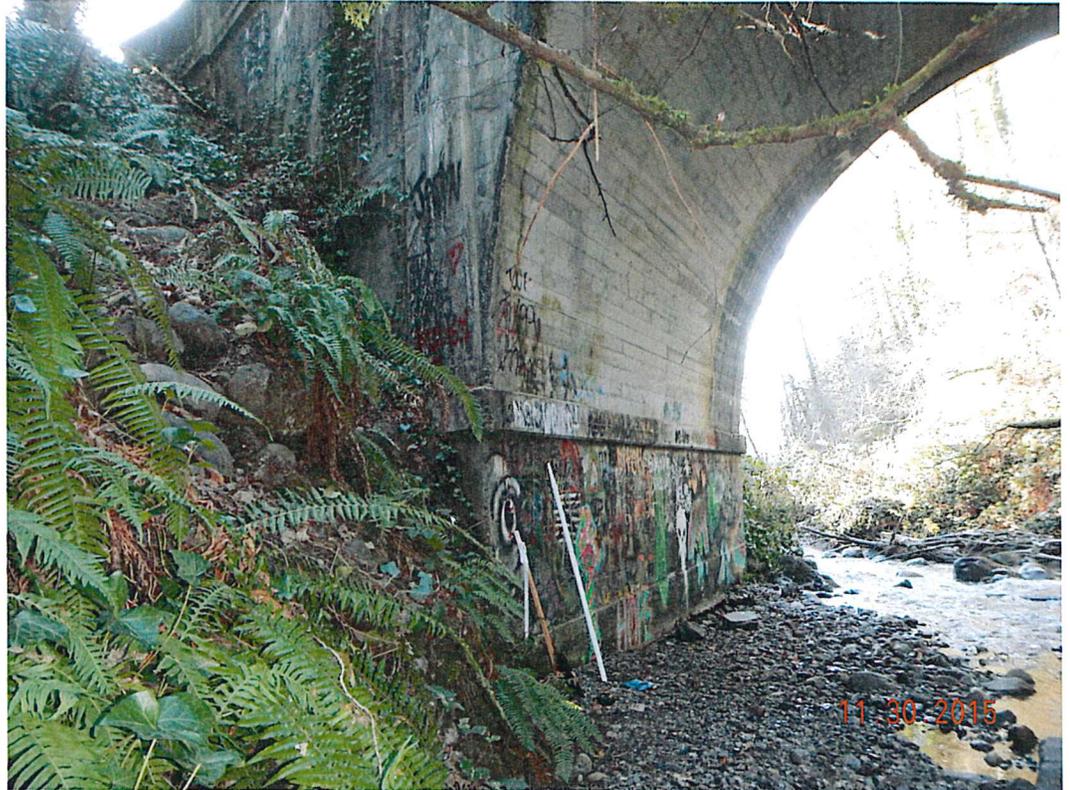
Photographs  
Photo Type: S - Scour  
Orientation: N  
Dates: 11/30/2015  
Repairs: 10000  
Scour - North footing west end

Repair No	Pr	R	Repair Description	Noted	Maint	Verified
10000	1	S	<i>Repair the scour at the north footing. The footing is undermined 7' horiz. x 4' vertical.</i>	11/30/15		
10001	3	J	<i>Replace the roadway slab at the NW corner. The NW Panel has settled and is undermined.</i>	11/30/15		
10002	3	S	<i>Repair the scour at the south footing. The footing is undermined 2' horiz. x 1' vertical.</i>	11/30/15
