**GEOTECHNICAL ENGINEERING SYUDY
BOW LAKE TRANSFER STATION IMPROVEMENTS
FACILITIES MASTER PLAN
KING COUNTY, WASHINGTON**

November 16, 1993

**DRAFT GEOTECHNICAL EVALUATION REPORT
WSDOT PROPERTY
BOW LAKE TRANSFER STATION/RECYCLING FACILITY
KING COUNTY, WASHINGTON**

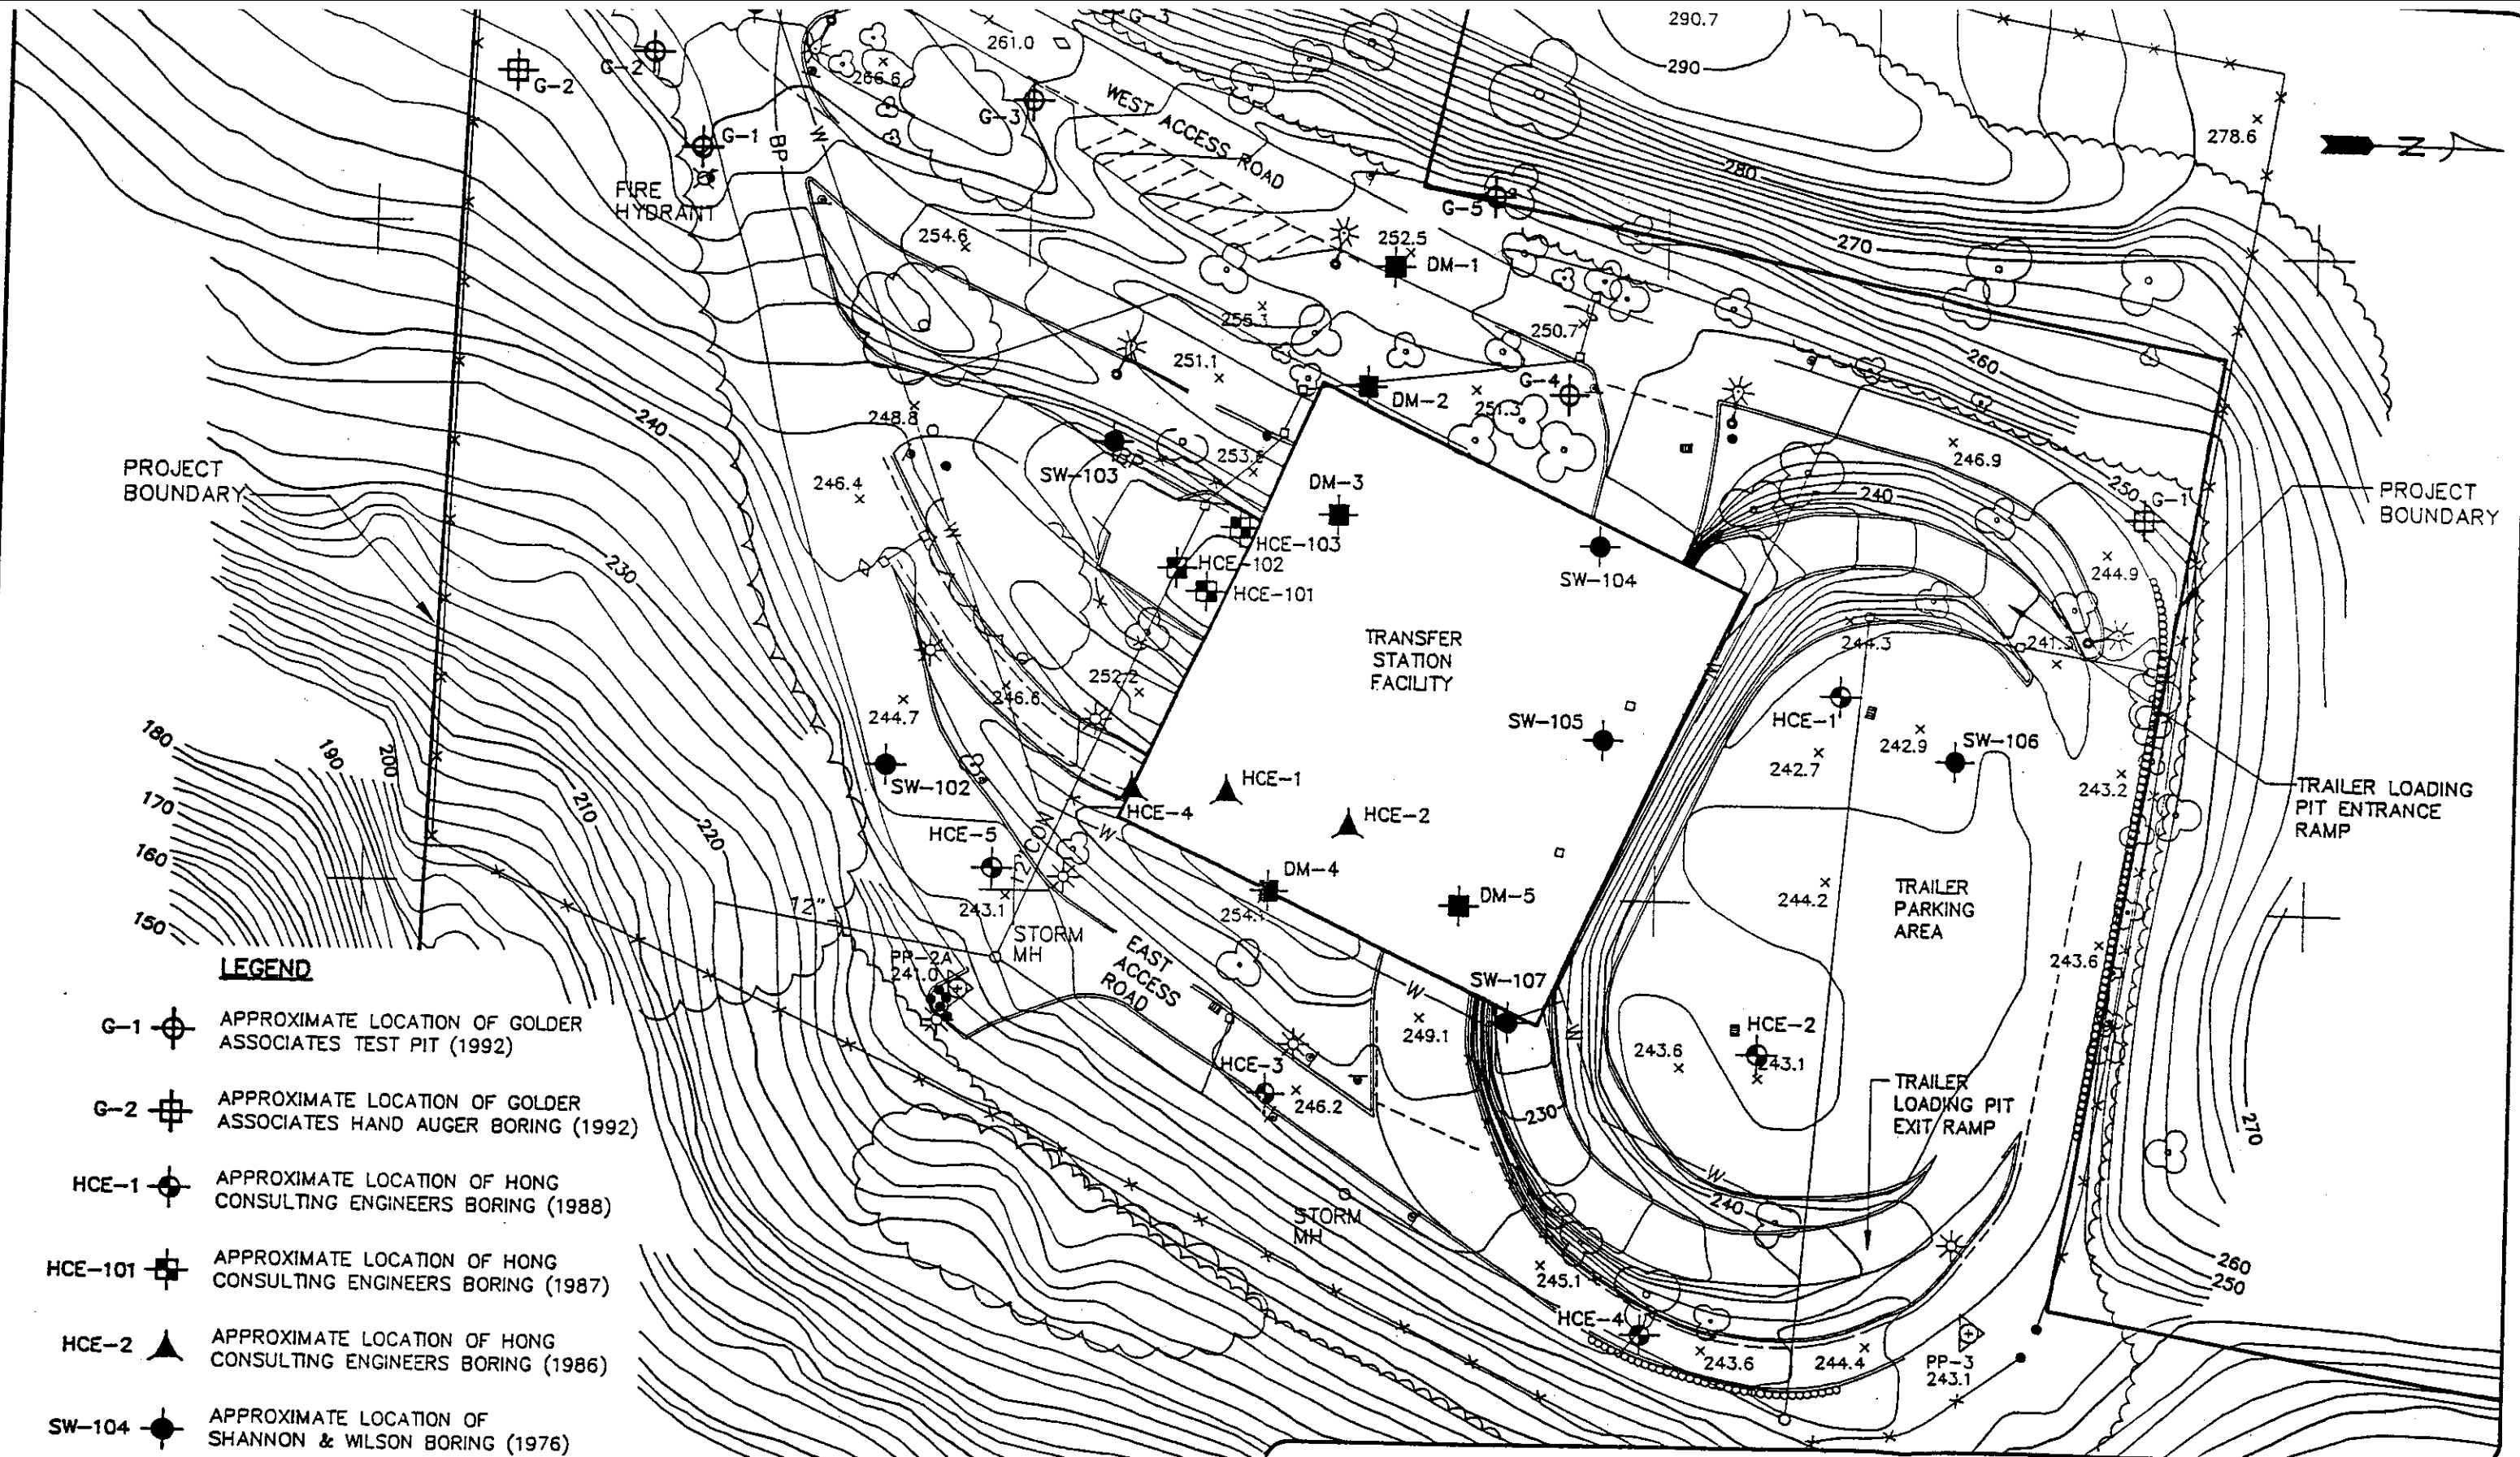
SITE AND EXPLORATION PLAN

- G-1 APPROXIMATE LOCATION OF GOLDER ASSOCIATES TEST PIT (1992)
- G-2 APPROXIMATE LOCATION OF GOLDER ASSOCIATES HAND AUGER BORING (1992)
- HCE-1 APPROXIMATE LOCATION OF HONG CONSULTING ENGINEERS BORING (1988)
- HCE-101 APPROXIMATE LOCATION OF HONG CONSULTING ENGINEERS BORING (1987)
- HCE-2 APPROXIMATE LOCATION OF HONG CONSULTING ENGINEERS BORING (1986)
- SW-104 APPROXIMATE LOCATION OF SHANNON & WILSON BORING (1976)
- DM-3 APPROXIMATE LOCATION OF DAMES & MOORE BORING (1965)

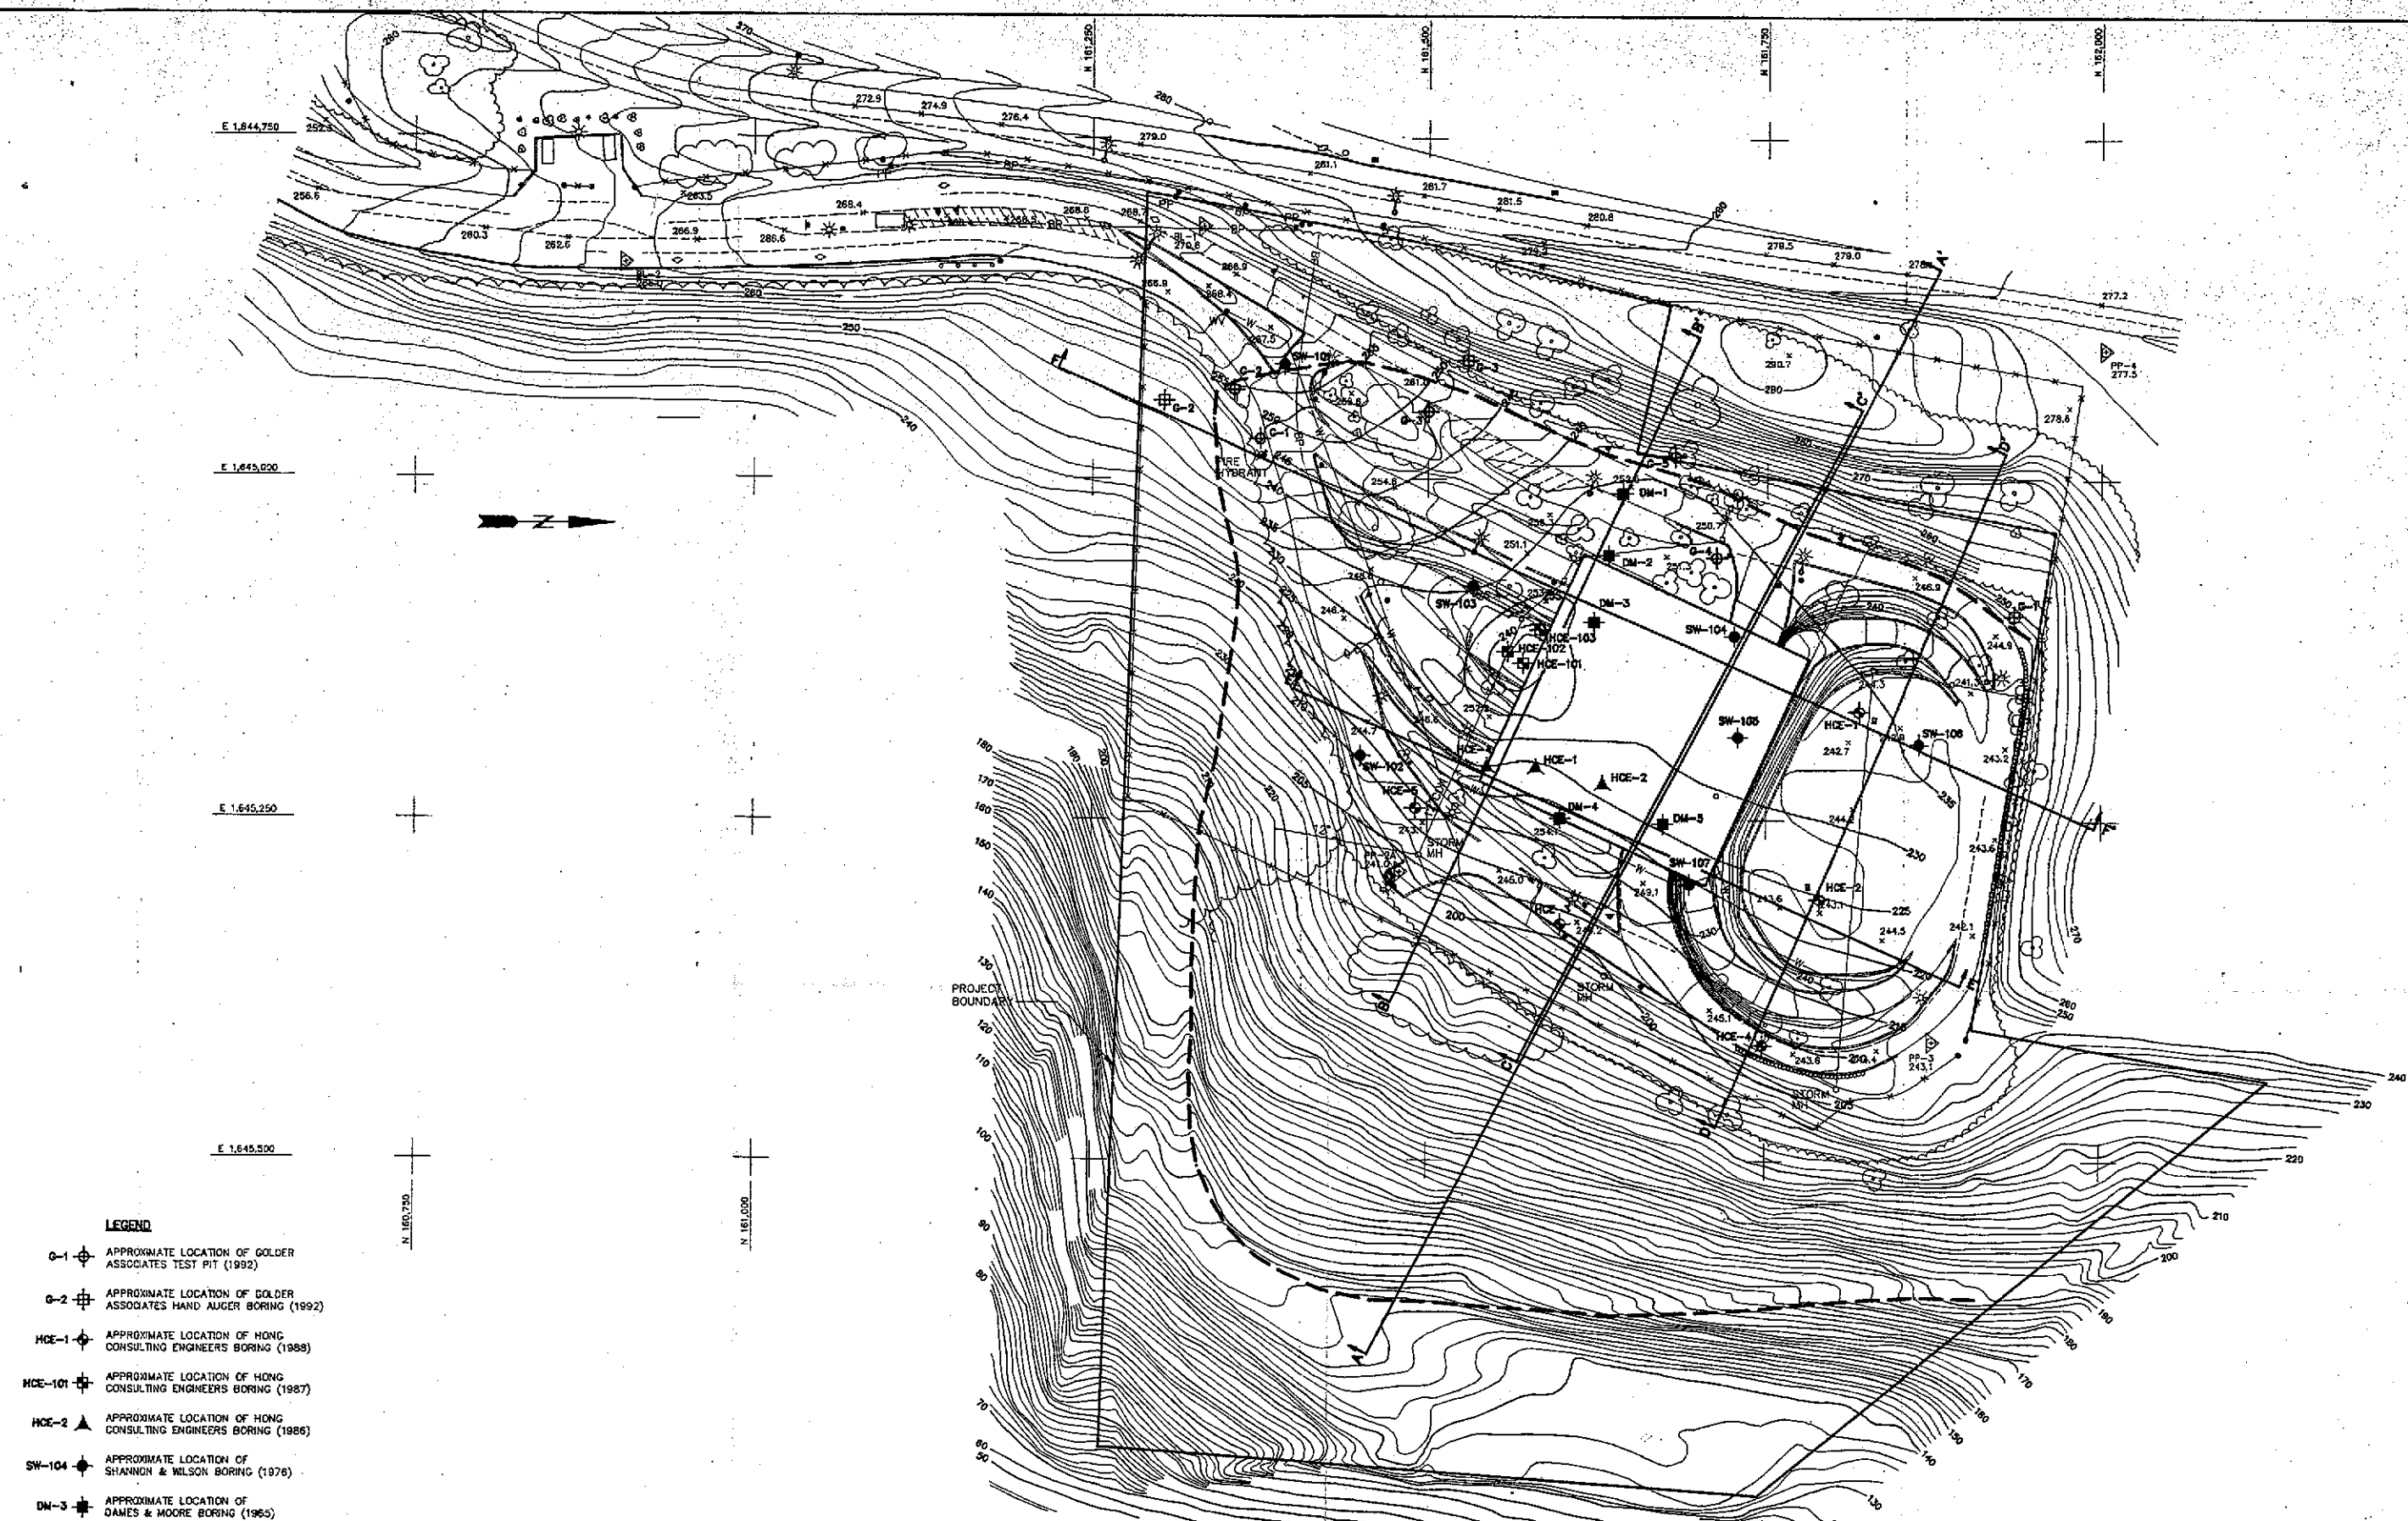
REFUSE LIMITS AND
CROSS SECTION LOCATION PLAN

- LEGEND**
- G-1 APPROXIMATE LOCATION OF GOLDER ASSOCIATES TEST PIT (1992)
 - G-2 APPROXIMATE LOCATION OF GOLDER ASSOCIATES HAND AUGER BORING (1992)
 - HCE-1 APPROXIMATE LOCATION OF HONG CONSULTING ENGINEERS BORING (1988)
 - HCE-101 APPROXIMATE LOCATION OF HONG CONSULTING ENGINEERS BORING (1987)
 - HCE-2 APPROXIMATE LOCATION OF HONG CONSULTING ENGINEERS BORING (1986)
 - SW-104 APPROXIMATE LOCATION OF SHANNON & WILSON BORING (1976)
 - DN-3 APPROXIMATE LOCATION OF DAMES & MOORE BORING (1965)
 - CROSS-SECTION LOCATION
 - 255 GENERALIZED SOLID WASTE FILL BOTTOM CONTOURS
 - ESTIMATED LIMITS OF REFUSE

As part of our study, we estimated the bottom contours of the landfill, as well as the lateral extent of the refuse materials. The estimated lateral and vertical extent of the refuse materials is shown on Figure 3. These estimates were based on aerial photographs and the previous subsurface investigations. Bottom contours of the refuse material were only estimated in the areas where subsurface information was available. The vertical extent of the refuse and fill materials are also shown on the Generalized Geologic Cross Sections, Figures 4 through 9.

From the reported subsurface information for each boring we were able to estimate the contour lines for the bottom surface of refuse materials. The contours of the lower limits of refuse are shown in red on the Refuse Limits and Cross-section Location Plan, Figure 3. Six subsurface profiles, Figures 4 through 9, were constructed across the site based on information from the previous reports. The locations of the cross-sections are also shown on Figure 3.

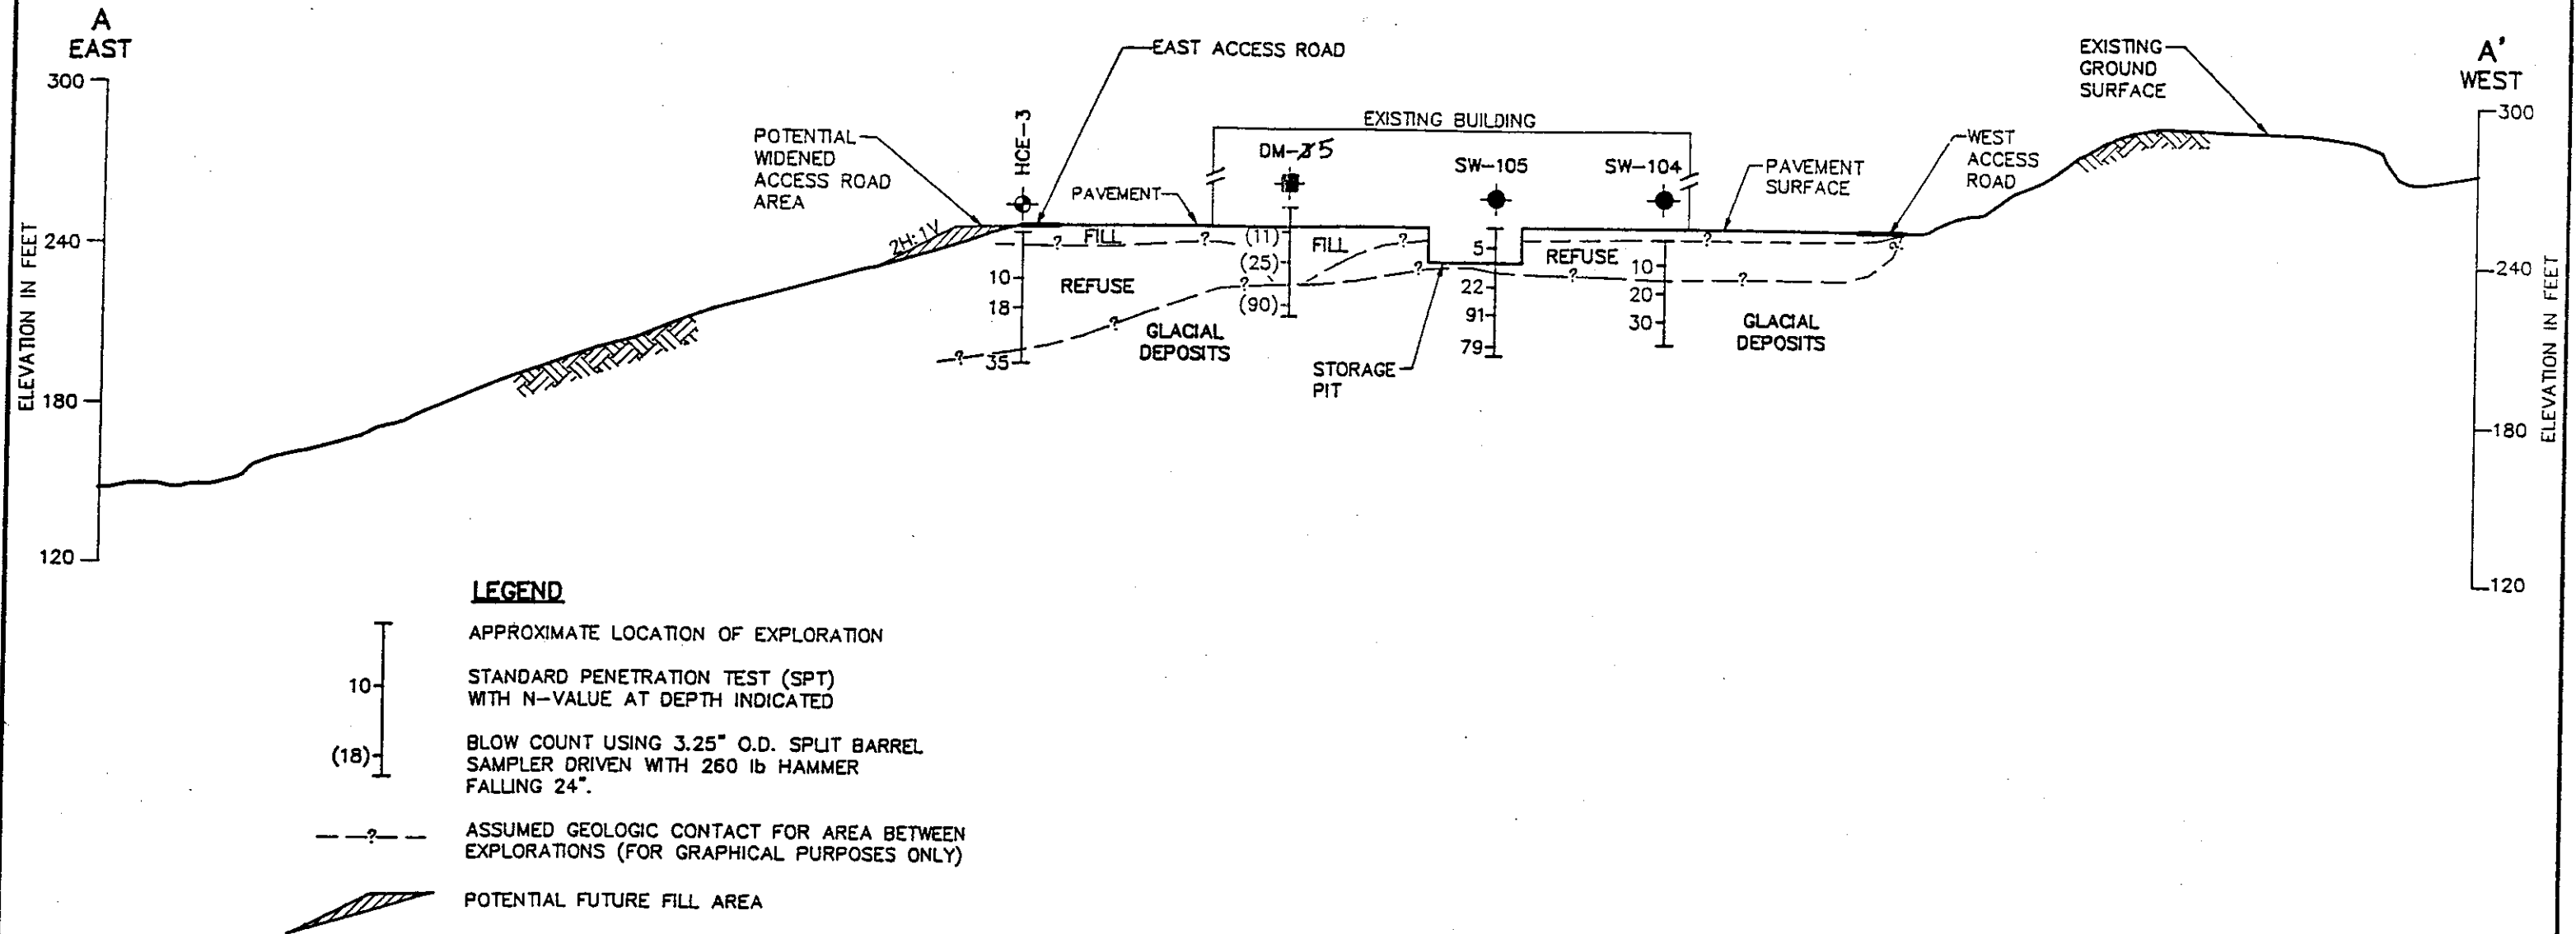
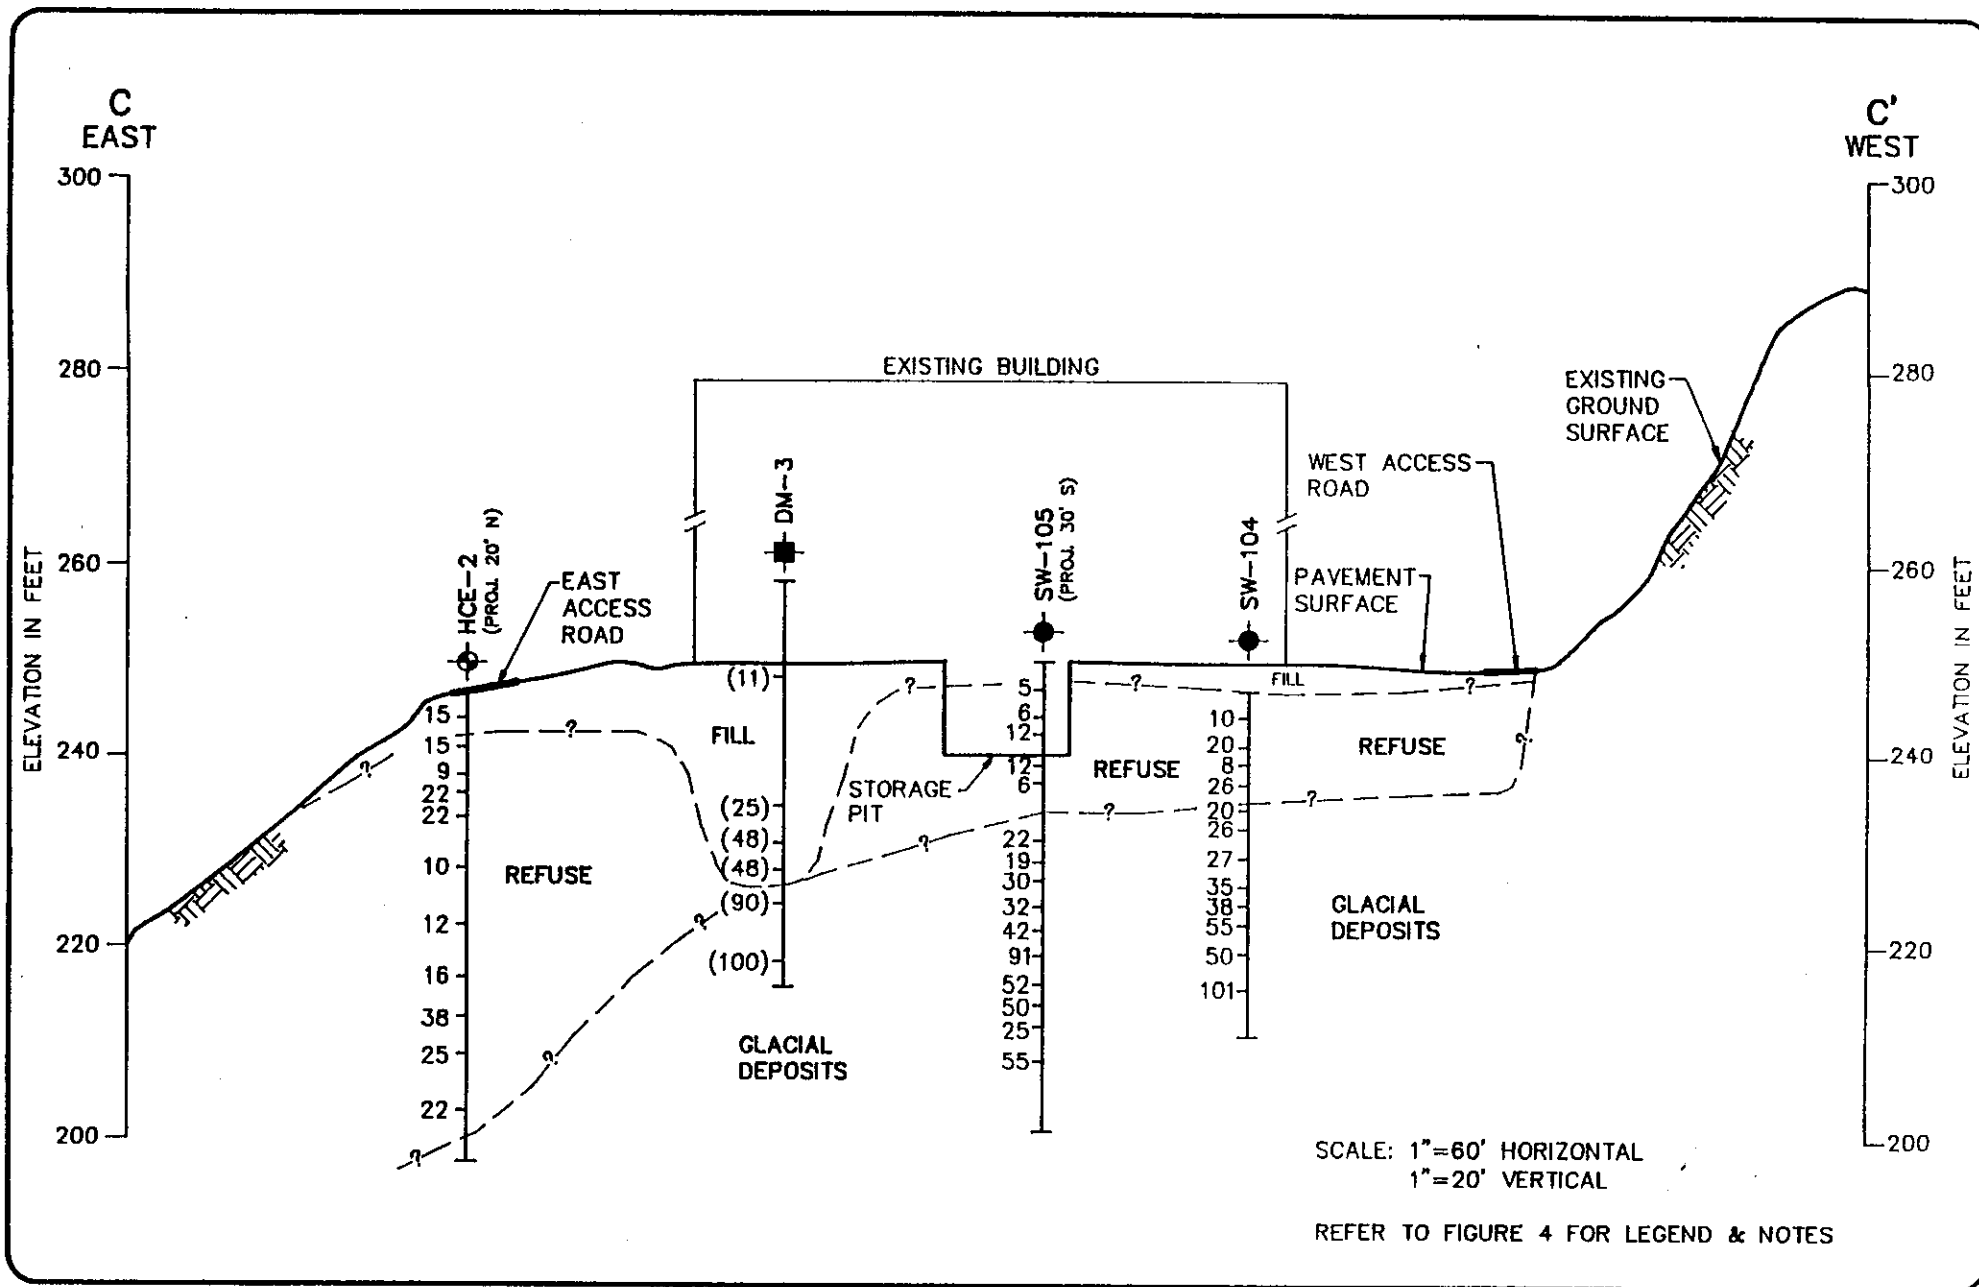
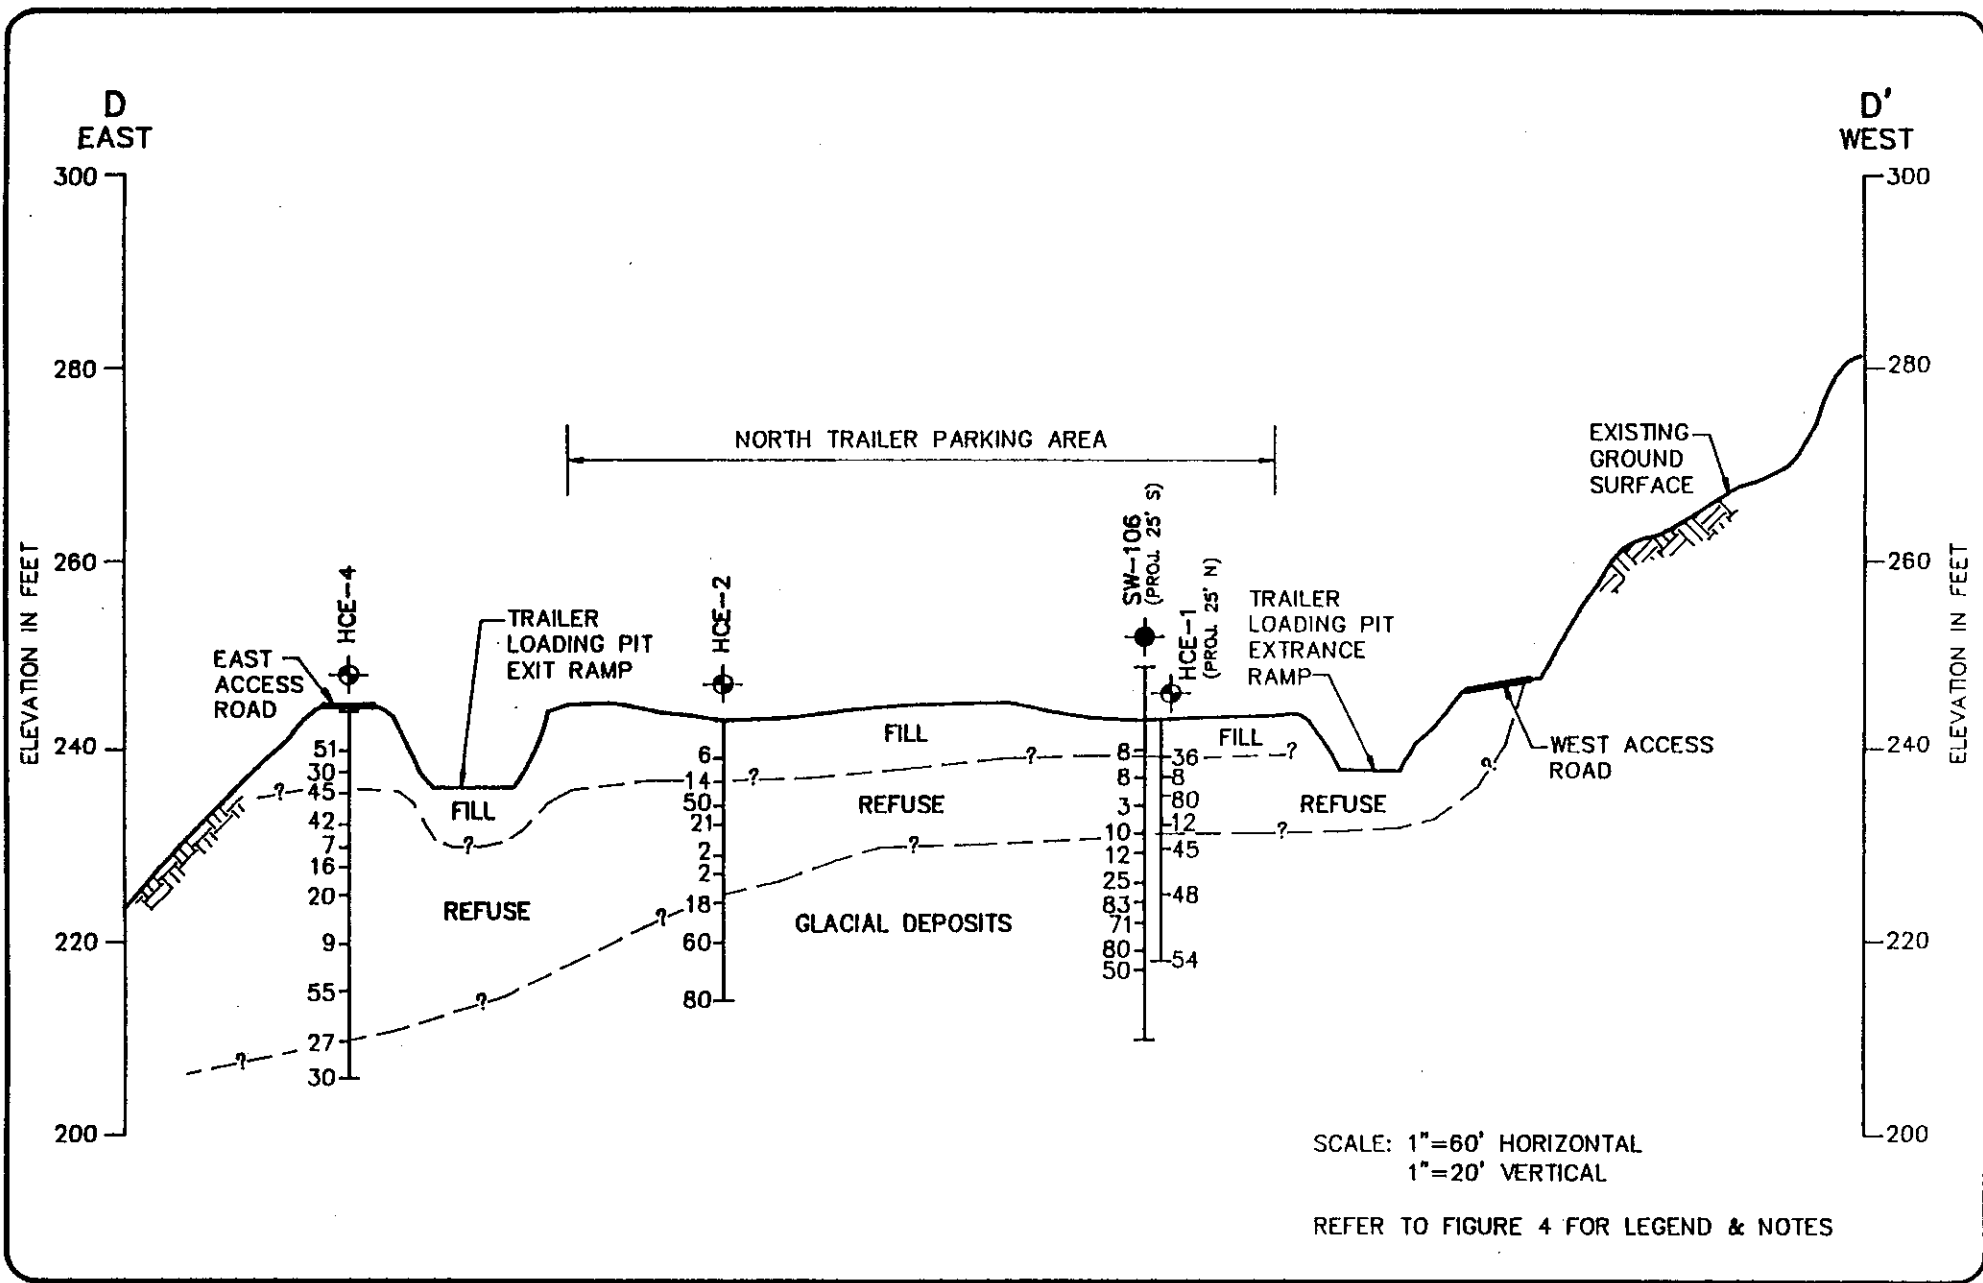
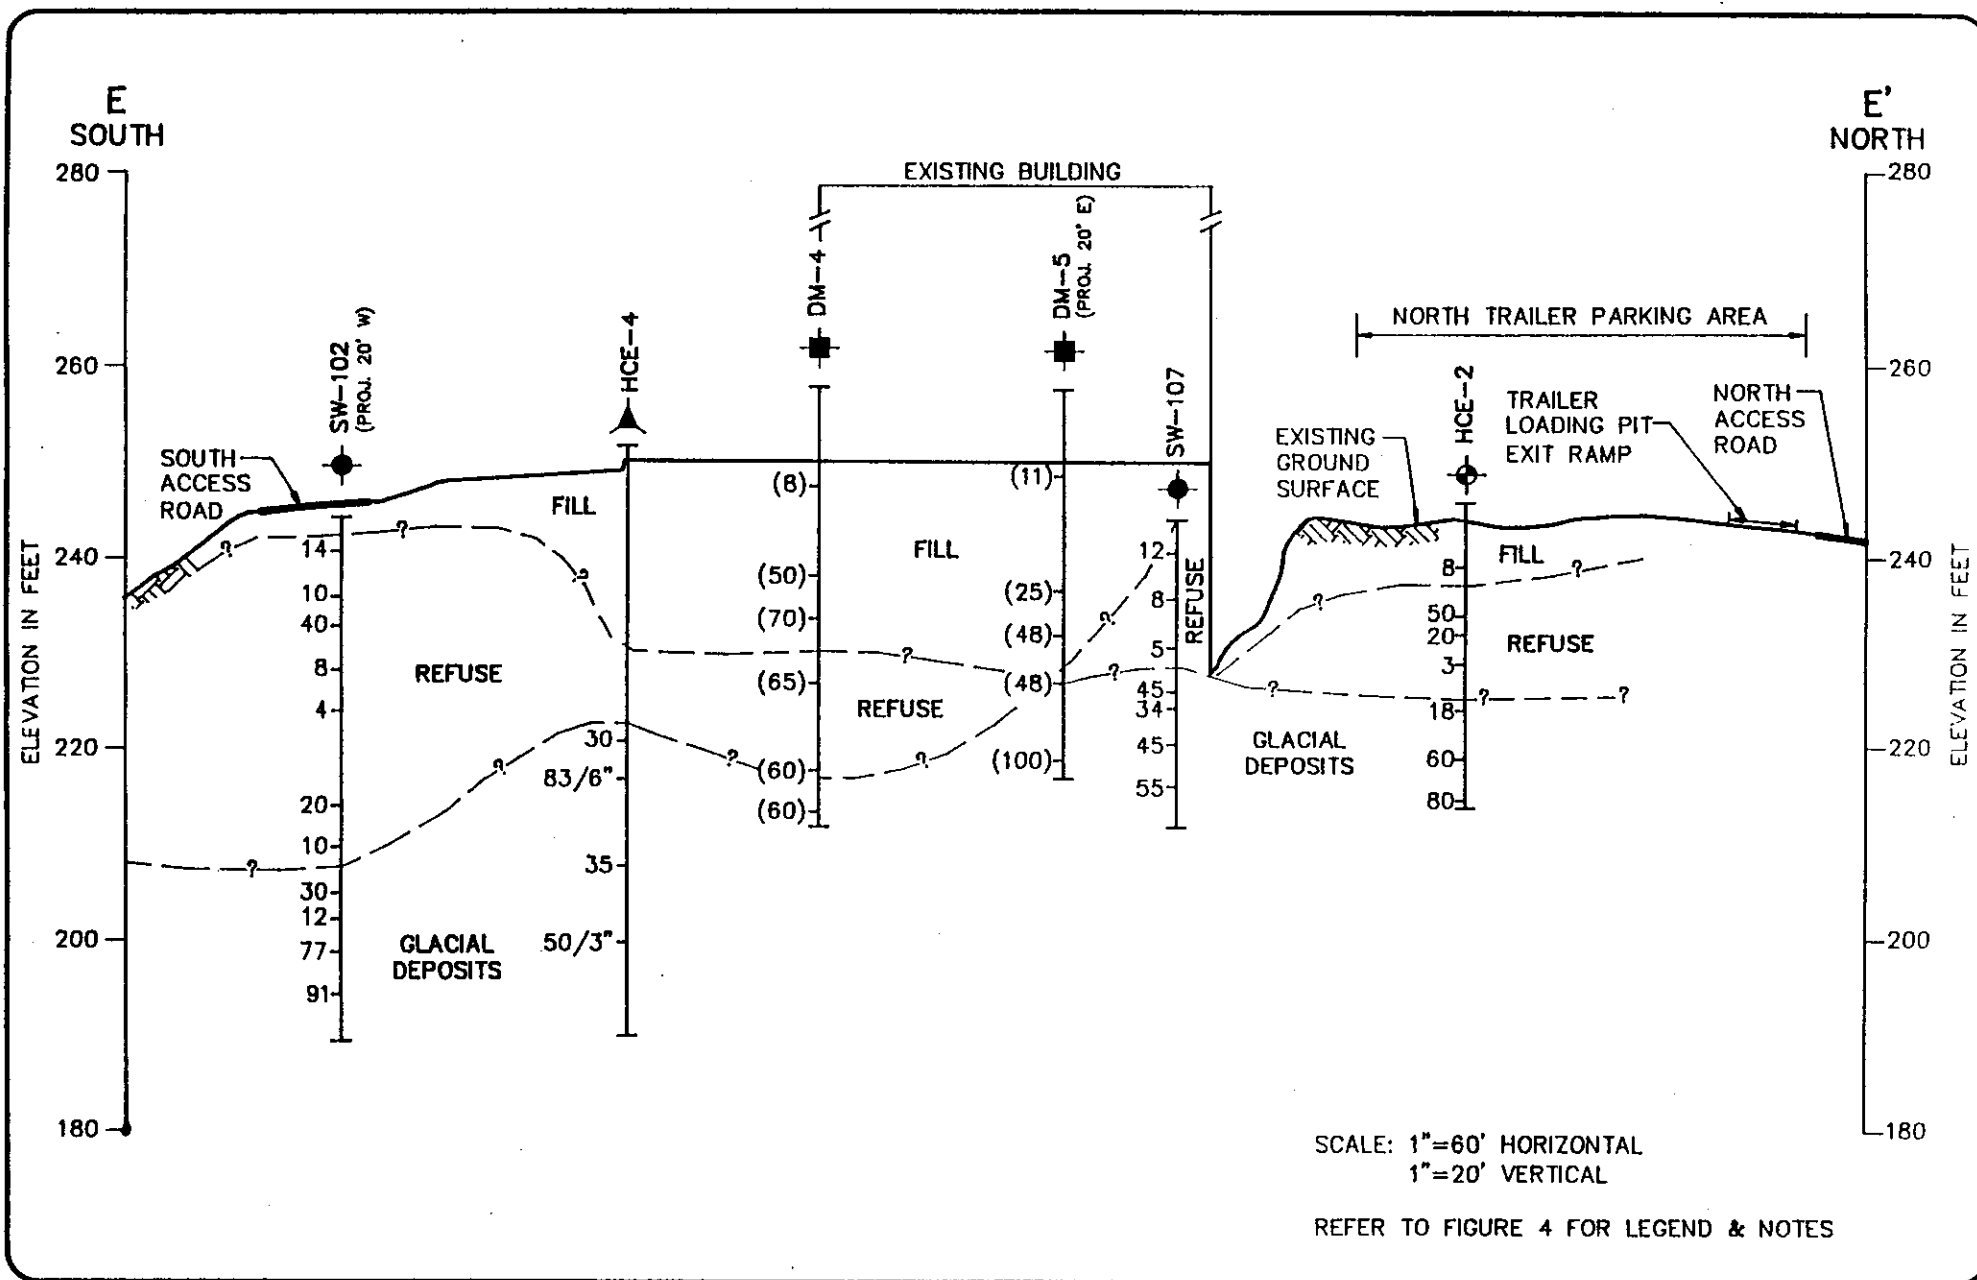
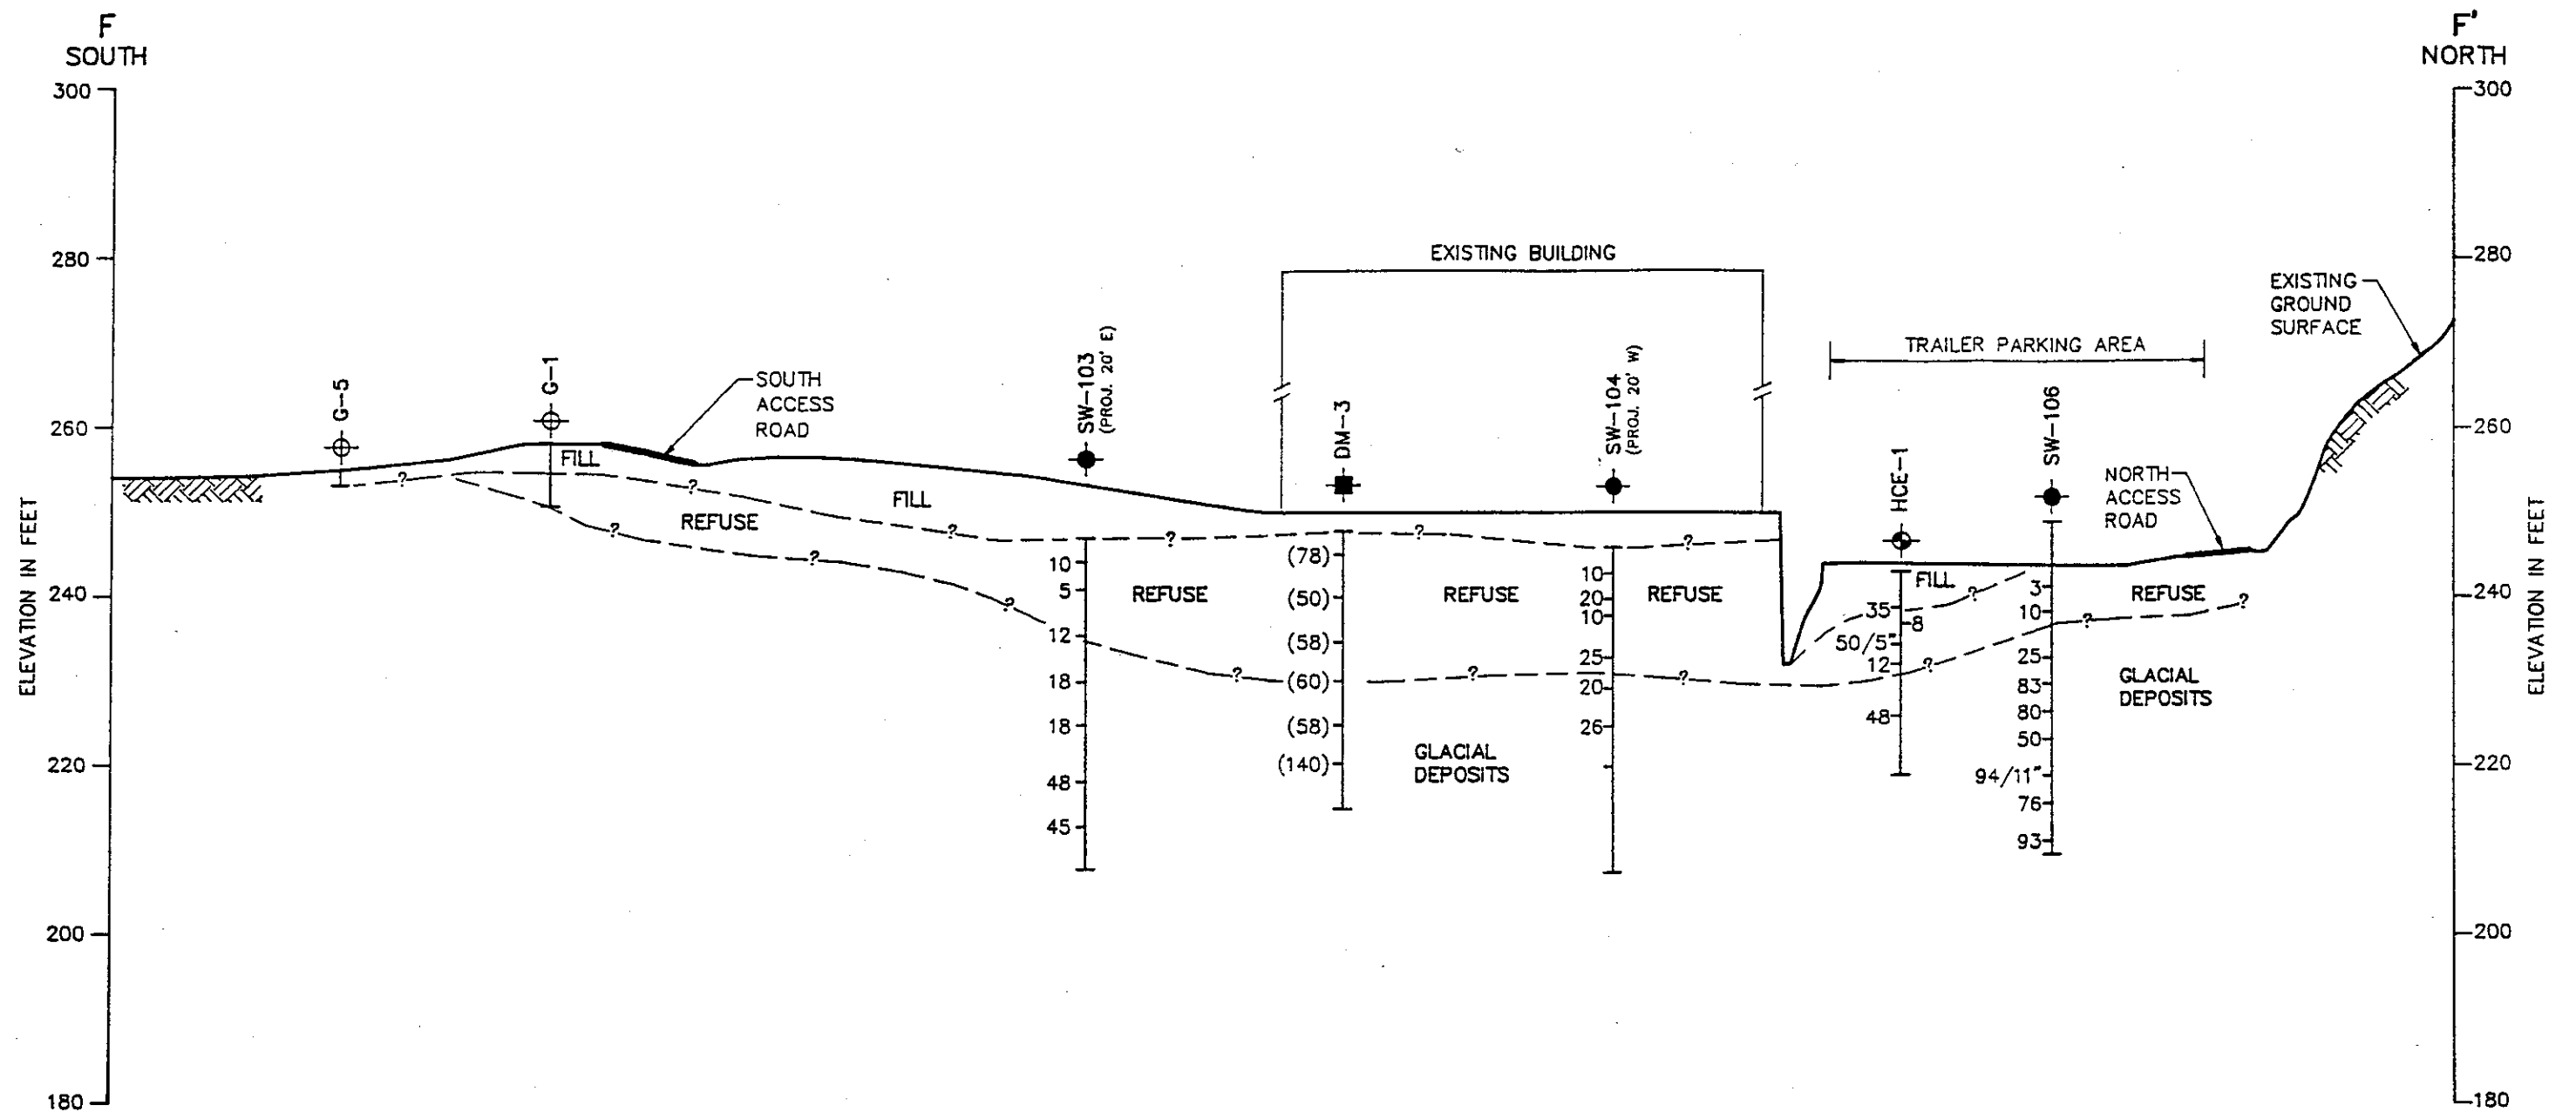
SCALE: 1"=60' HORIZONTAL
1"=20' VERTICAL

Fill slopes constructed over refuse and loose fill materials will increase the overburden pressure on the underlying compressible materials and increased settlement will likely occur. Potential widening of the east access road may require several feet of additional fill on the east side of the road (Figure 4). This additional fill placement will likely increase settlement in the immediate vicinity of the fill and differential settlement between the new section of the road and the original section may occur. Settlement can be reduced by minimizing fill heights.
