**GEOTECHNICAL ENGINEERING SYUDY
BOW LAKE TRANSFER STATION IMPROVEMENTS
FACILITIES MASTER PLAN
KING COUNTY, WASHINGTON**

November 16, 1993

**DRAFT GEOTECHNICAL EVALUATION REPORT
WSDOT PROPERTY
BOW LAKE TRANSFER STATION/RECYCLING FACILITY
KING COUNTY, WASHINGTON**

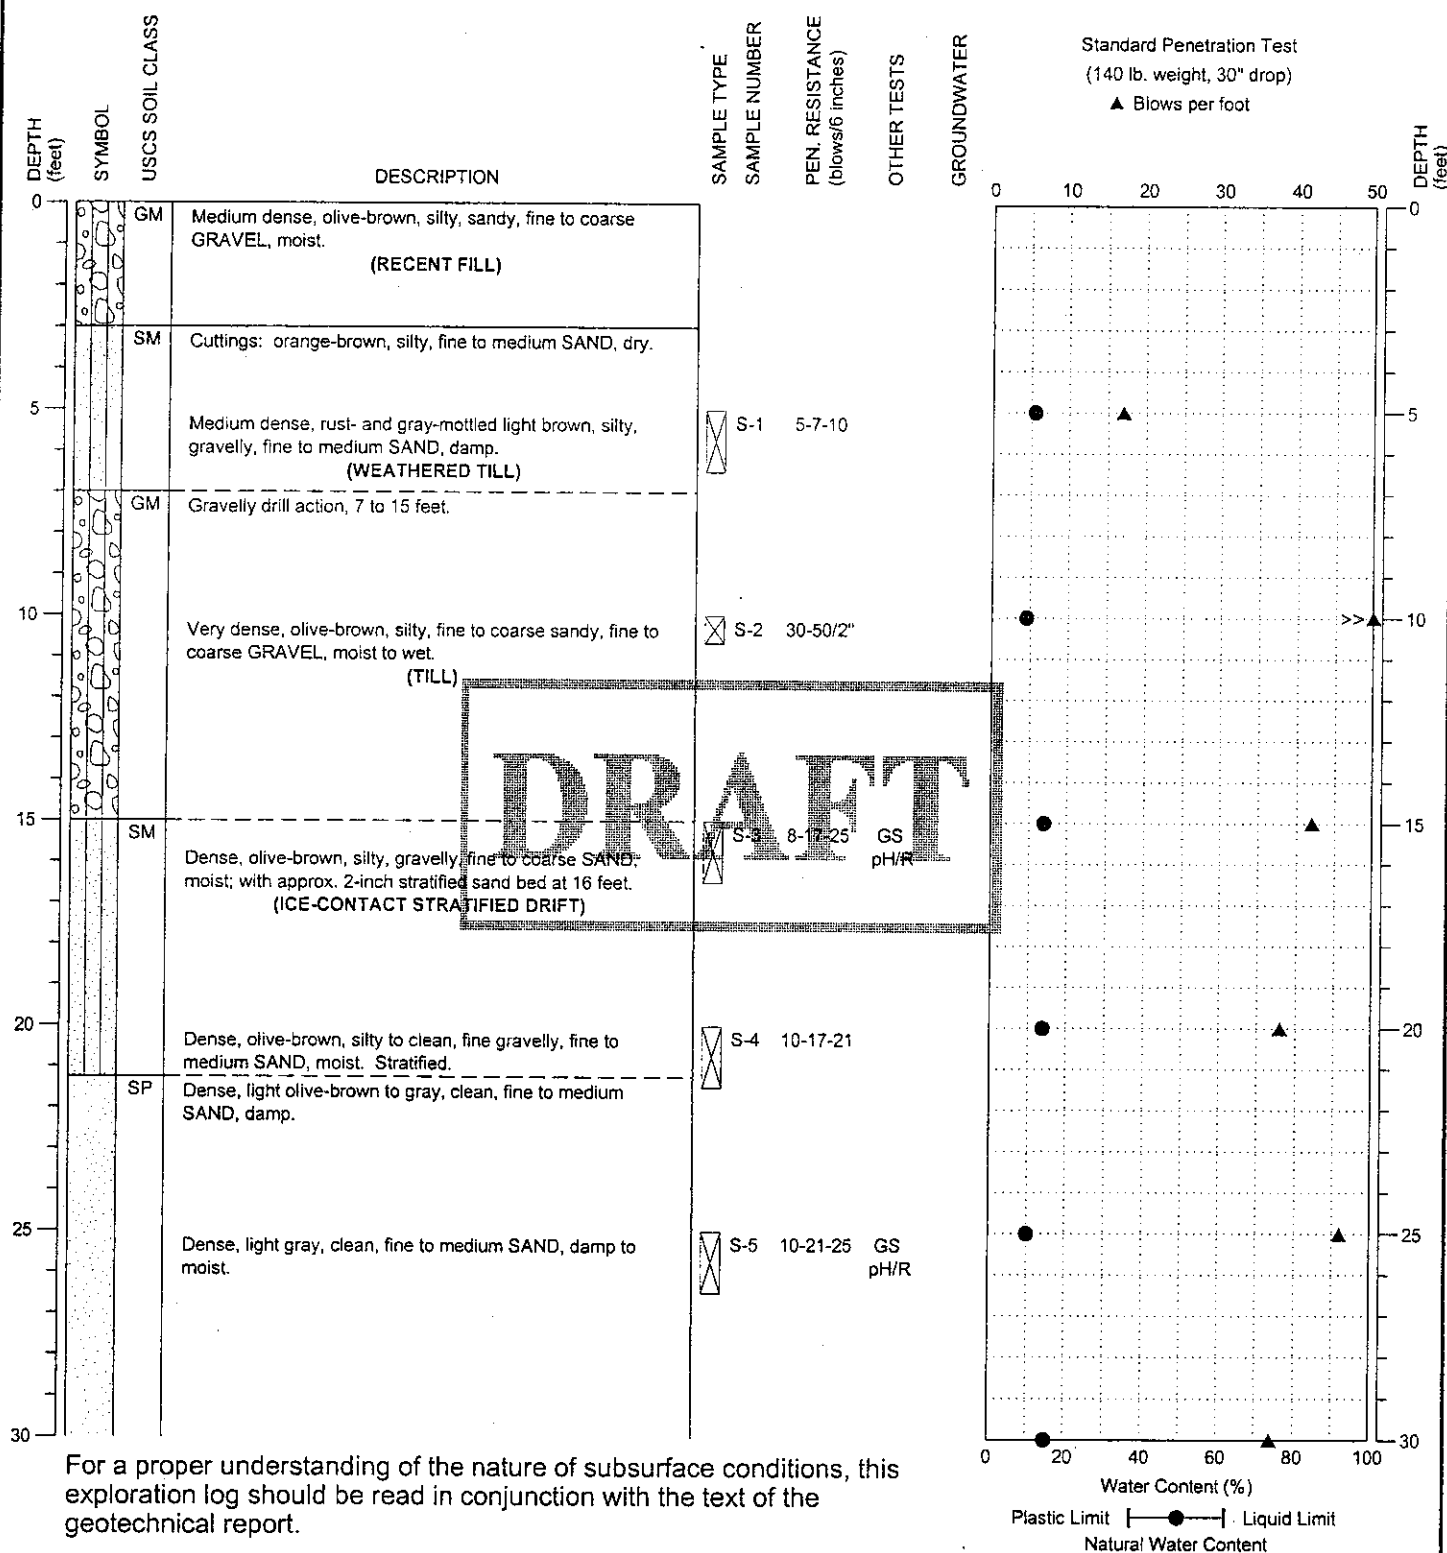
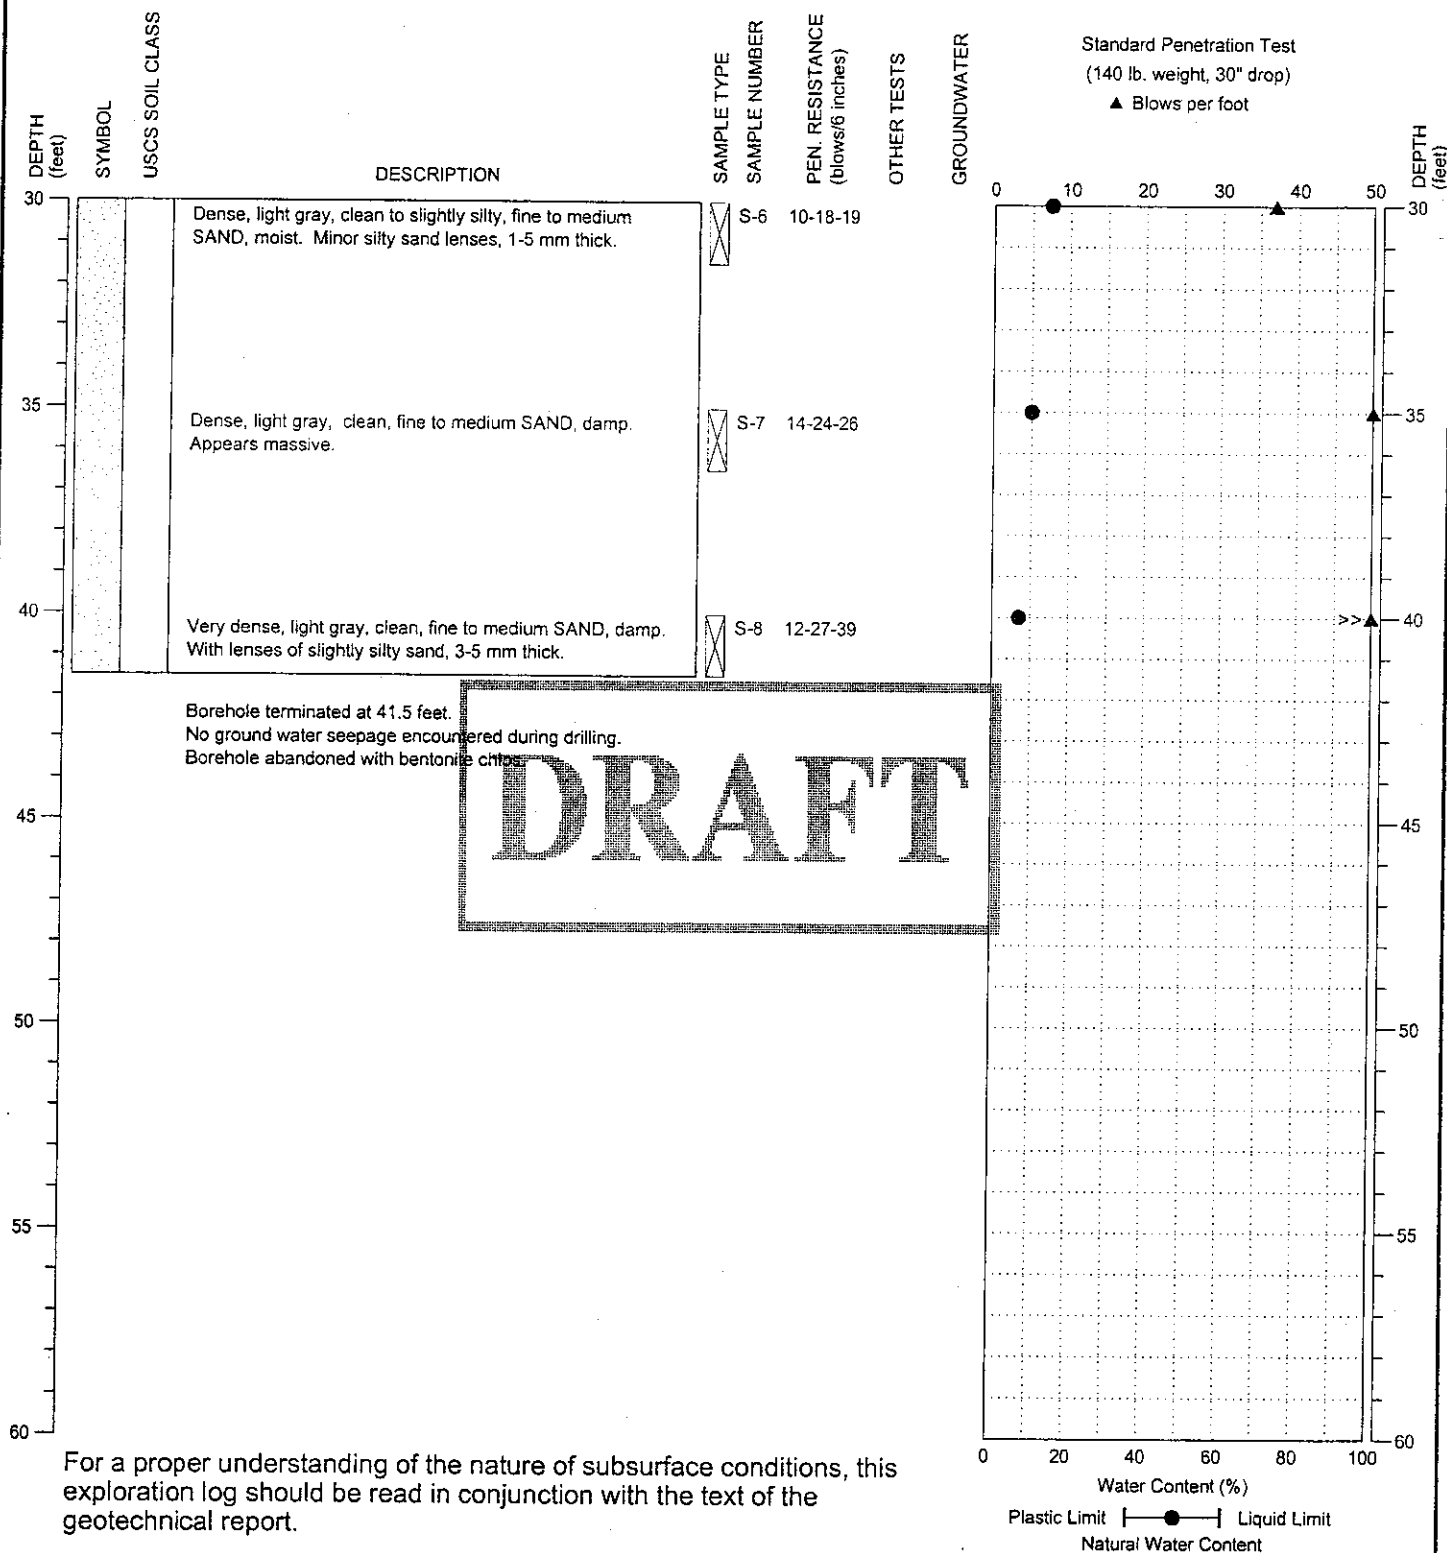
DRILLING COMPANY: Holocene Drilling
 SURFACE ELEVATION: 279.00 ± feet
 DRILLING METHOD: Hollow-Stem Auger, Mobile B-61 truck rig
 SAMPLING METHOD: SPT w/ Autohammer
 LOCATION: See Site & Exploration Plan, Figure 2

DATE STARTED: 10/9/2003
 DATE COMPLETED: 10/9/2003
 LOGGED BY: B. Thurber

A legend of the terms and symbols used on HWA exploration logs is given in Appendix A, (see Figure A-1). The summary boring logs for BH-2 through BH-5 are also included in Appendix A (see Figures A-2 through A-5). The soil boundaries indicated on the logs as distinct lines are interpreted between sample intervals and, accordingly, may not be precisely where indicated. Moreover, soil contact boundaries are often transitional in nature and not distinct as implied from the log representation. The soil and ground water conditions depicted on the exploration logs are also only for the specific dates and

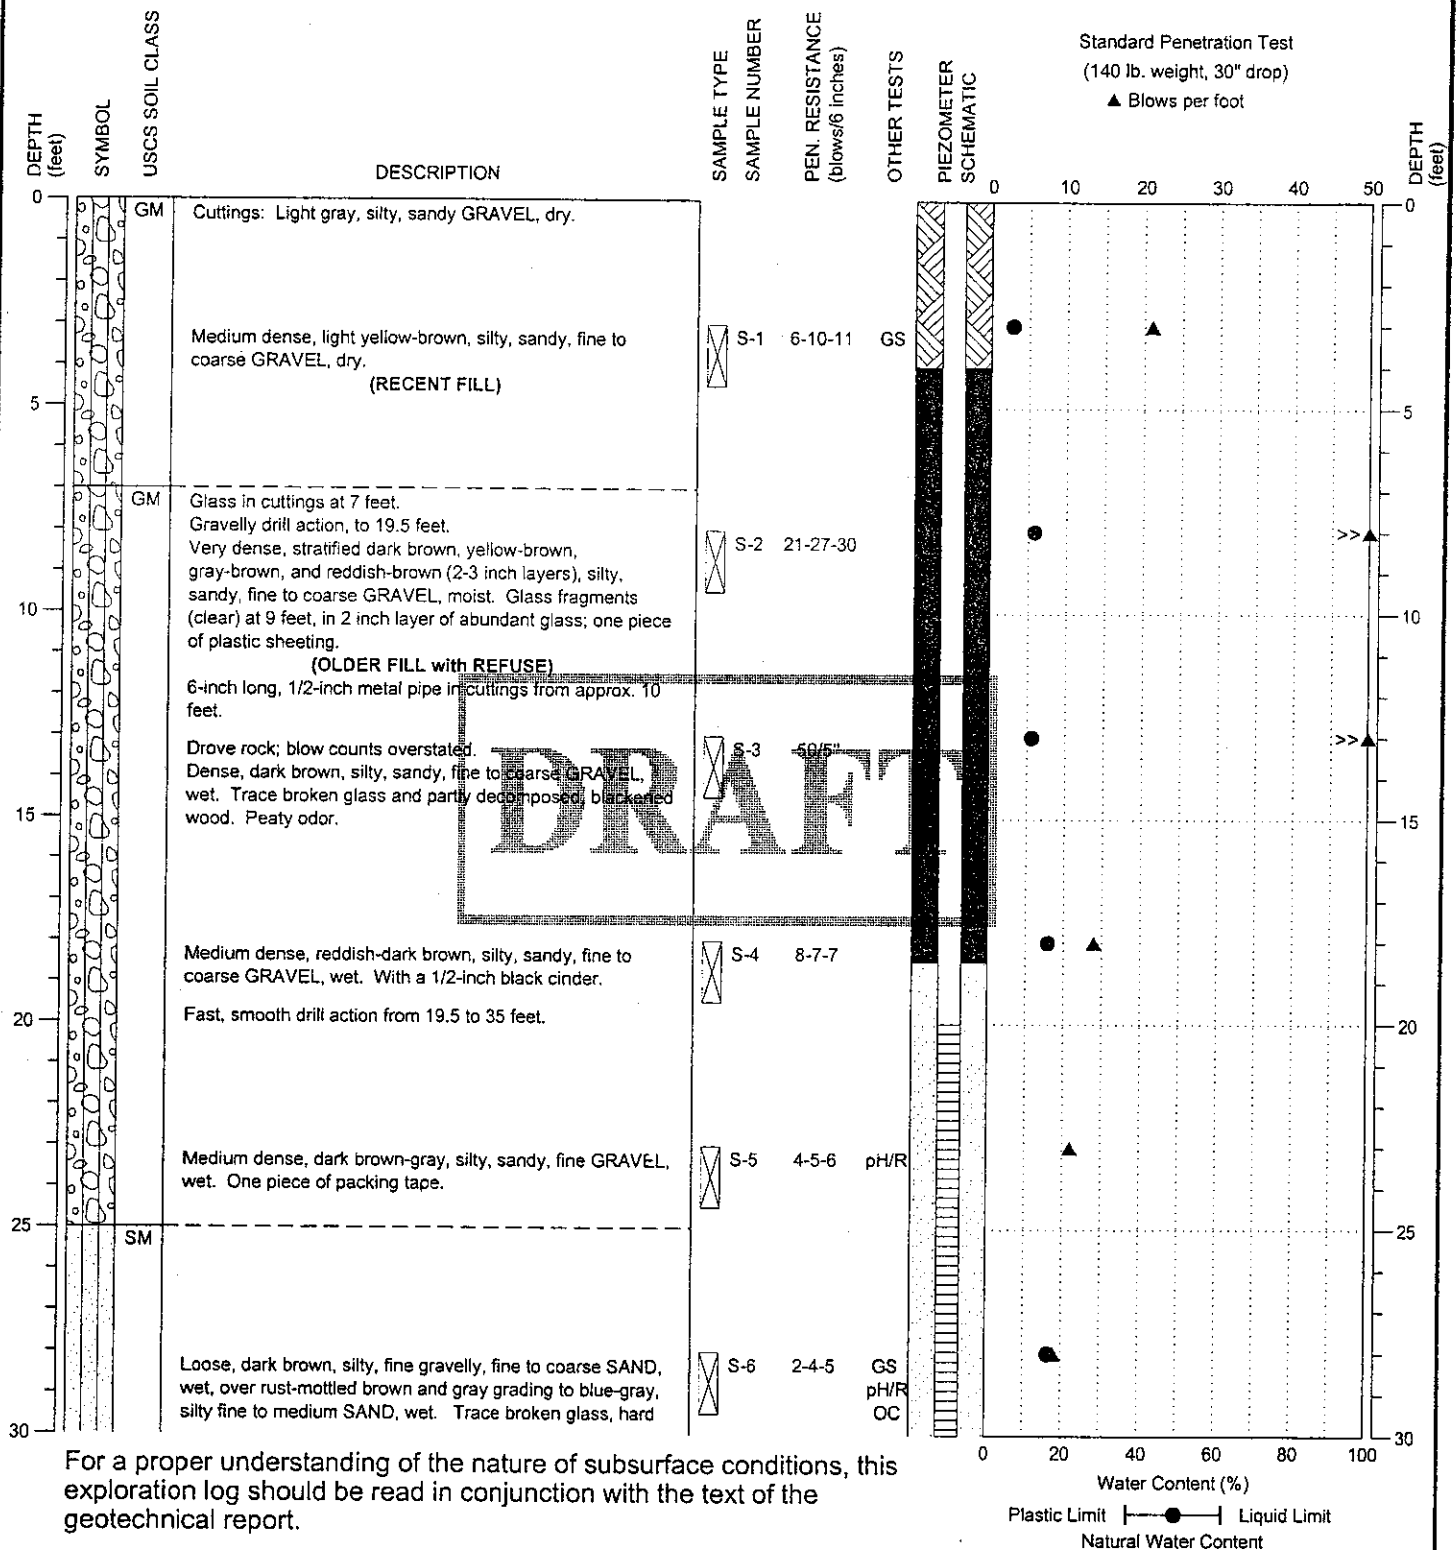
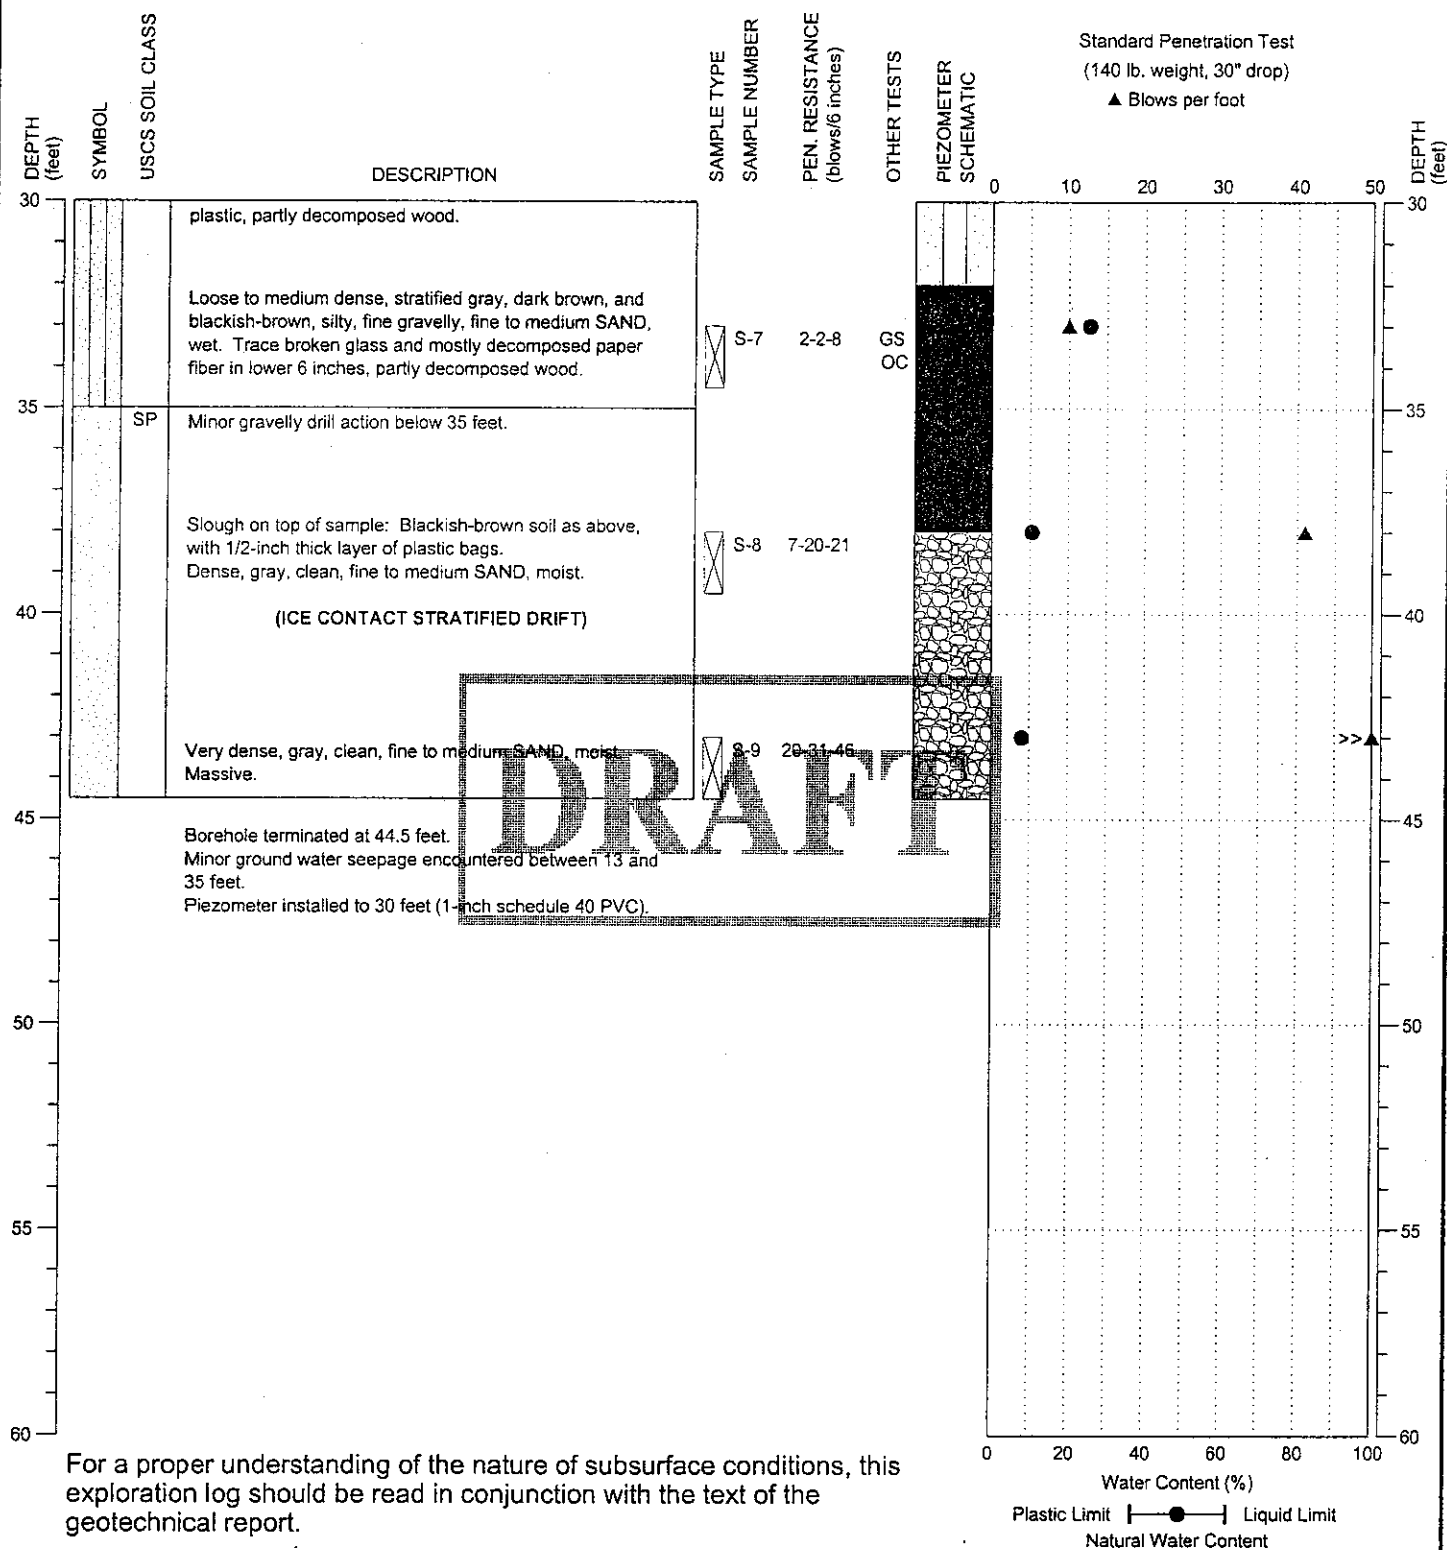
DRILLING COMPANY: Holocene Drilling
 SURFACE ELEVATION: 275.00 ± feet
 DRILLING METHOD: Hollow-Stem Auger, Simcoe 4000 tracked rig
 SAMPLING METHOD: SPT w/ Cathead
 LOCATION: See Site & Exploration Plan, Figure 2

DATE STARTED: 10/10/2003
 DATE COMPLETED: 10/10/2003
 LOGGED BY: B. Thurber

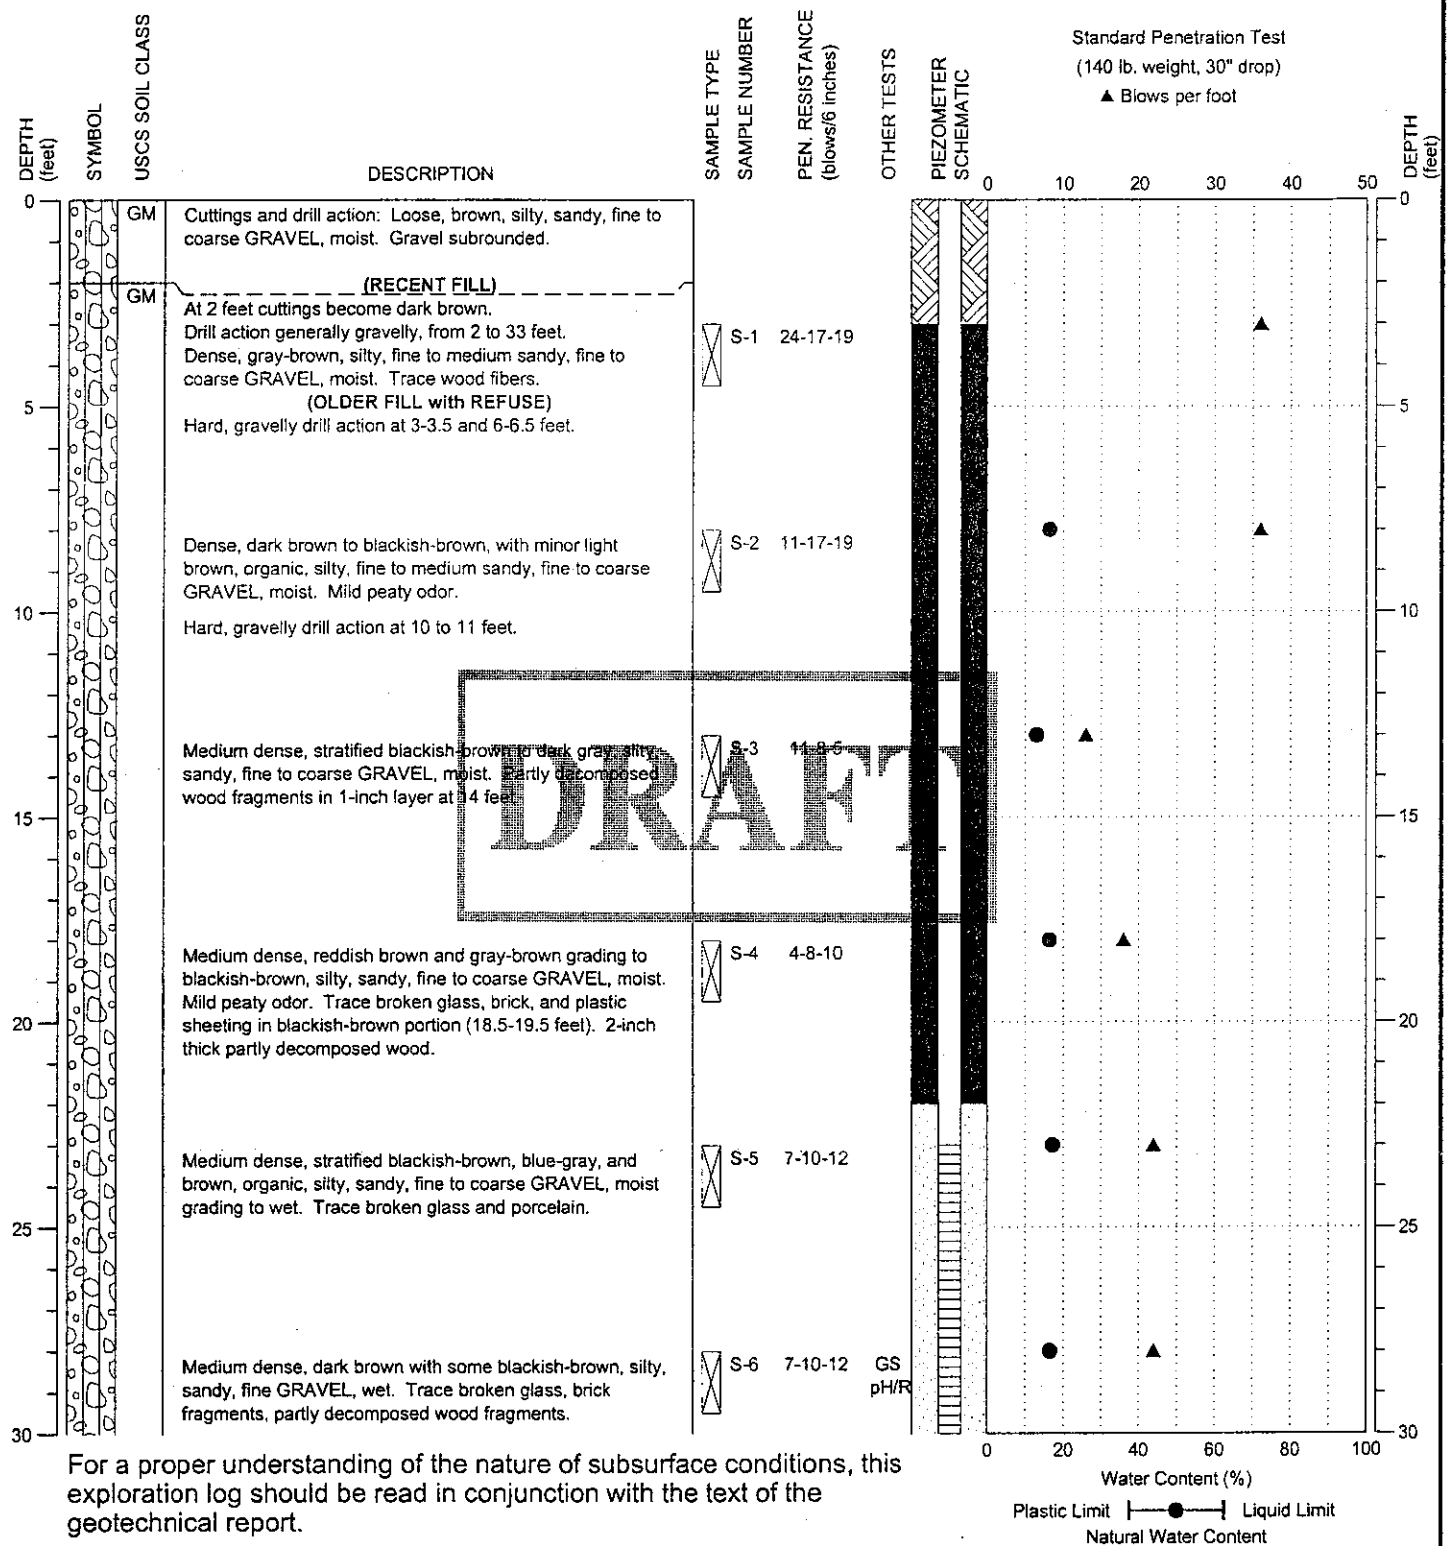
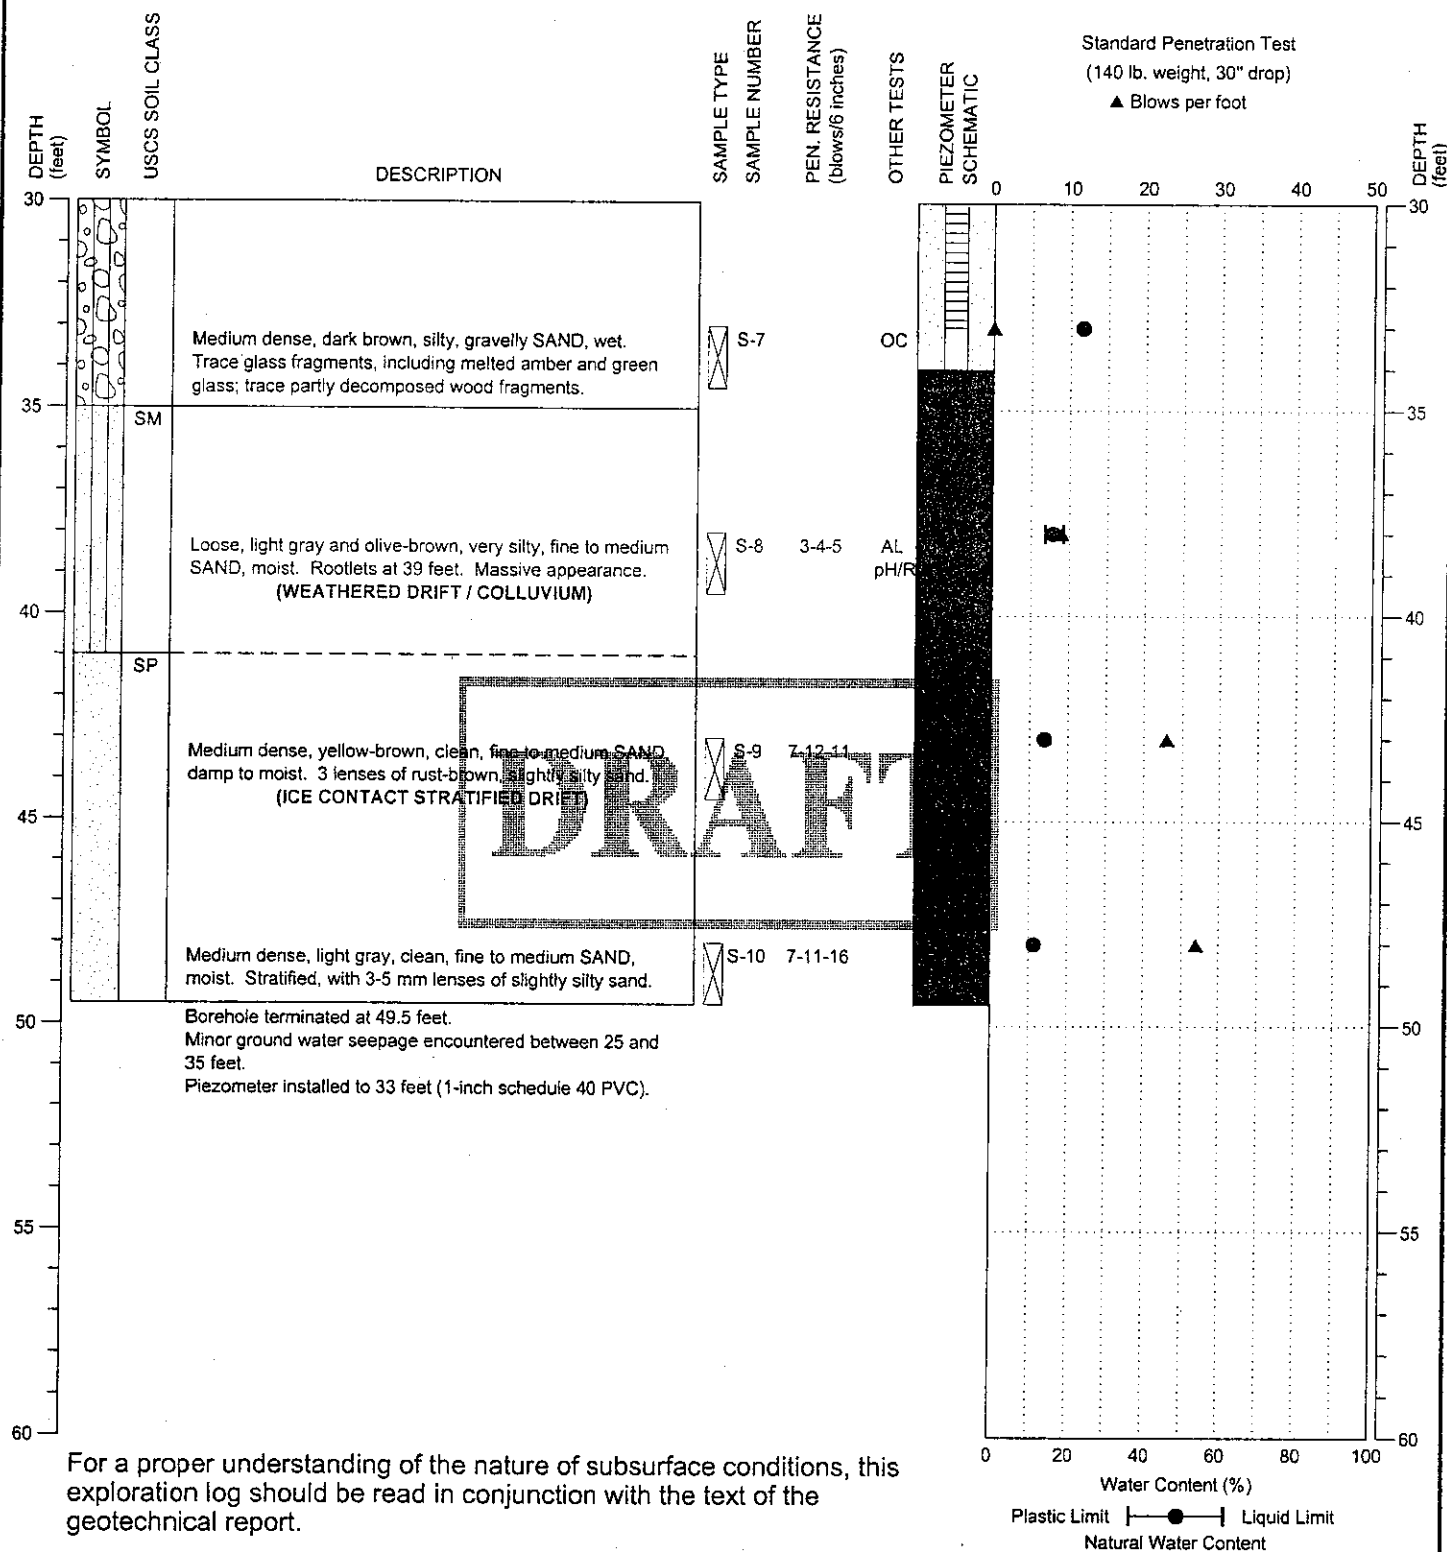
DRILLING COMPANY: Holocene Drilling SURFACE ELEVATION: 286.00 ± feet
 DRILLING METHOD: Hollow-Stem Auger, Simcoe 4000 tracked rig
 SAMPLING METHOD: SPT w/ Cathead
 LOCATION: See Site & Exploration Plan, Figure 2

DATE STARTED: 10/9/2003
 DATE COMPLETED: 10/10/2003
 LOGGED BY: B. Thurber

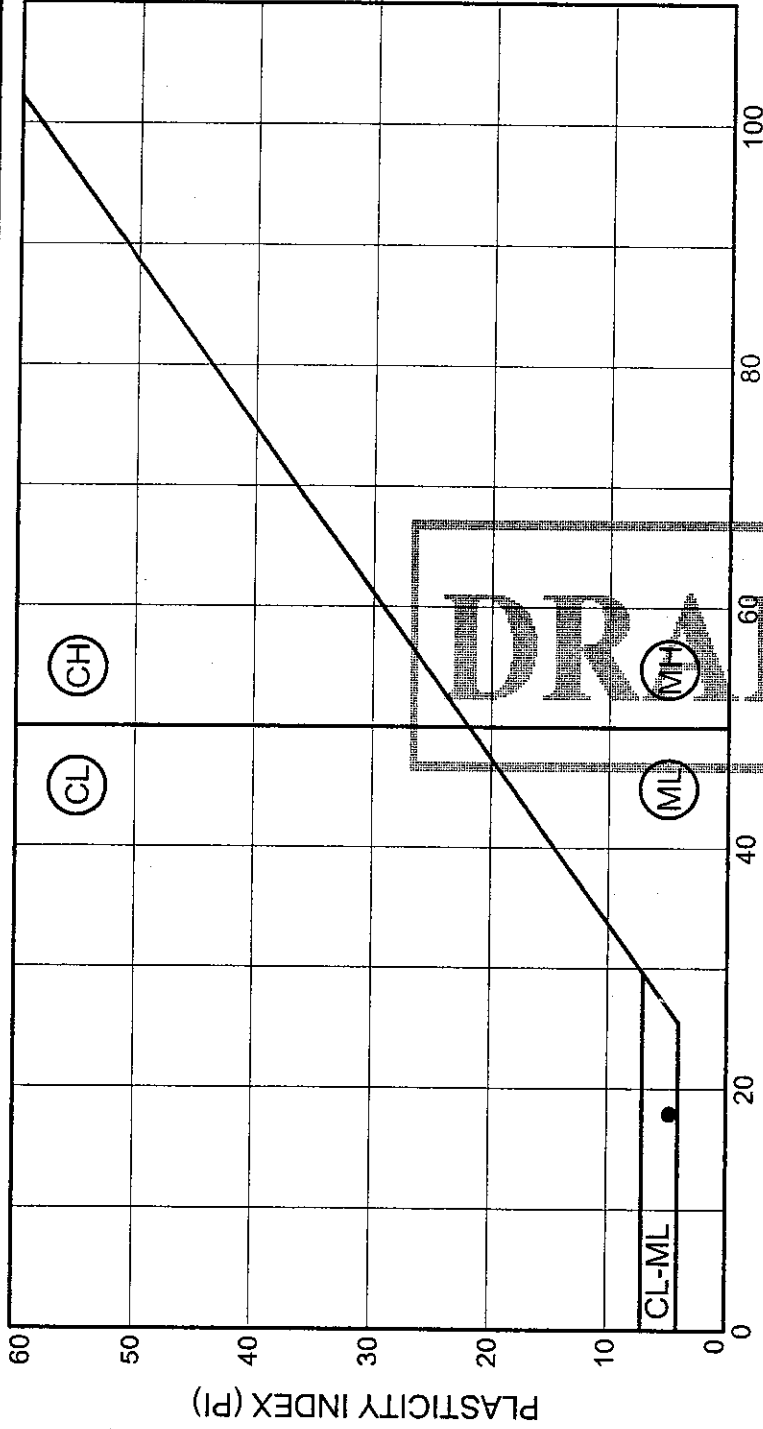
SYMBOL	SAMPLE	DEPTH (ft)	CLASSIFICATION	% MC	LL	PL	PI	% Fines
●	BH-4	38.0 - 39.5	(CL-ML) Olive brown, Silty CLAY	16	18	13	5

Laboratory testing of samples retrieved from the borings included moisture content, particle size analysis, Atterberg limits, moisture/density, ash and organic content, and resistivity. In addition, TCLP testing was undertaken on a composite sample of "refuse-like" material to determine disposal requirements. Details of the laboratory test methods used and a summary of the test results are presented in Appendix B.

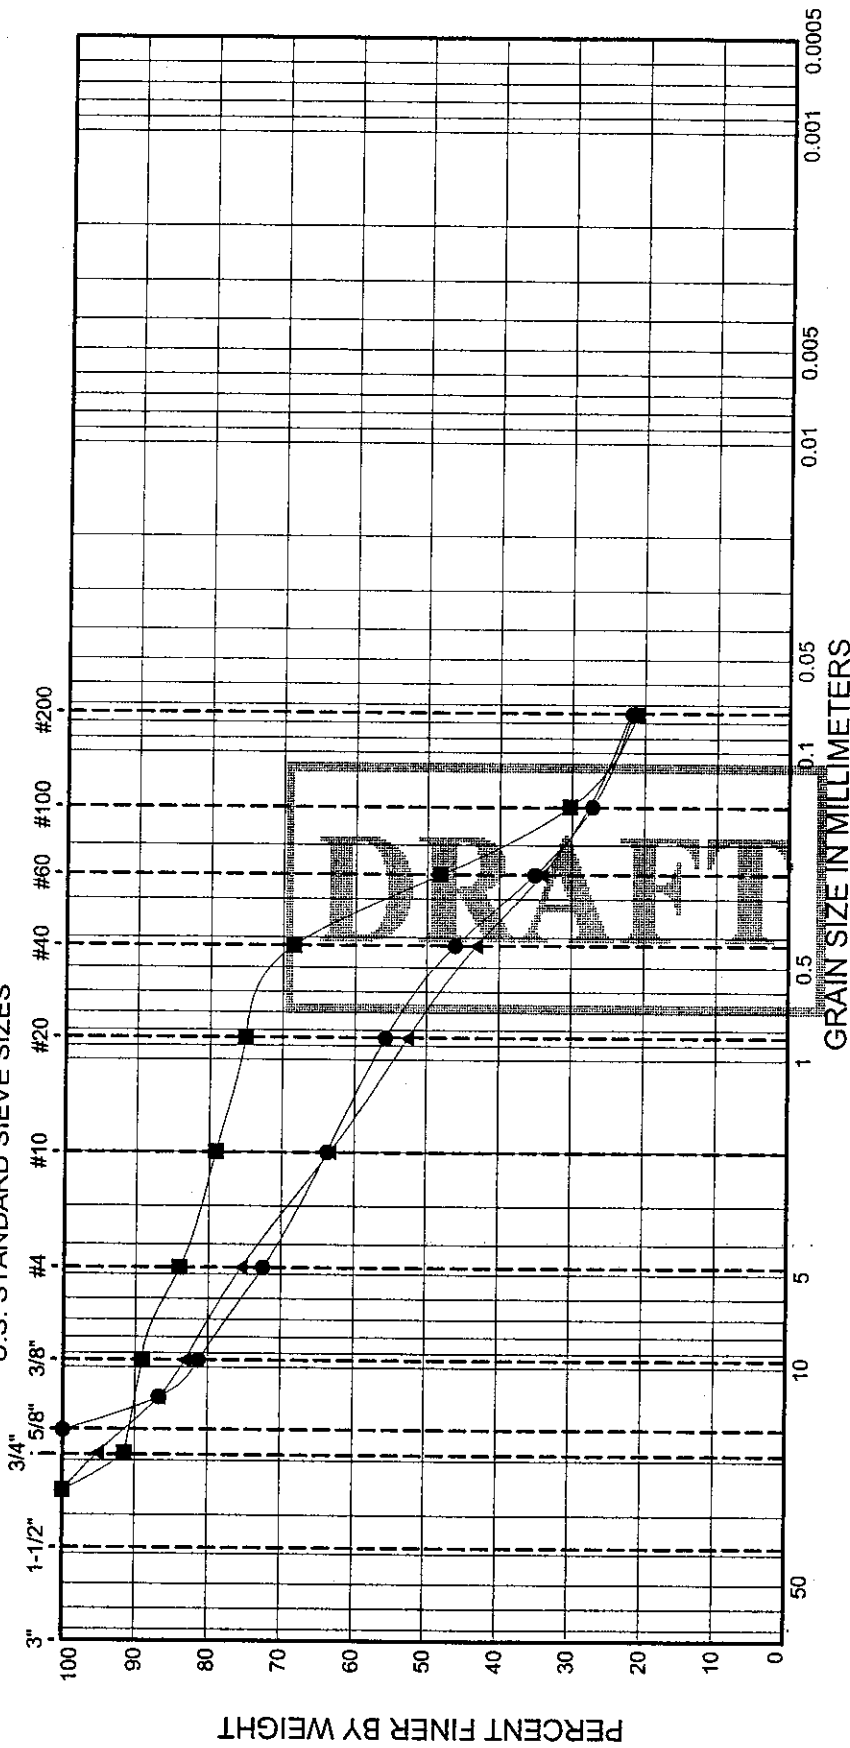
SYMBOL	SAMPLE	DEPTH (ft)	CLASSIFICATION OF SOIL- ASTM D2487 Group Symbol and Name	% MC	LL	PL	PI	Gravel %	Sand %	Fines %
●	BH-3	28.0 - 29.5	(SM) Dark brown, silty SAND with gravel(1.9 % organics)	16				27.5	50.7	21.8
■	BH-3	33.0 - 34.5	(SM) Black, silty SAND with gravel(3.5% organics)	25				15.9	63.0	21.1
▲	BH-4	28.0 - 29.5	(SM) Dark brown, silty SAND with gravel	16				24.5	53.4	22.1

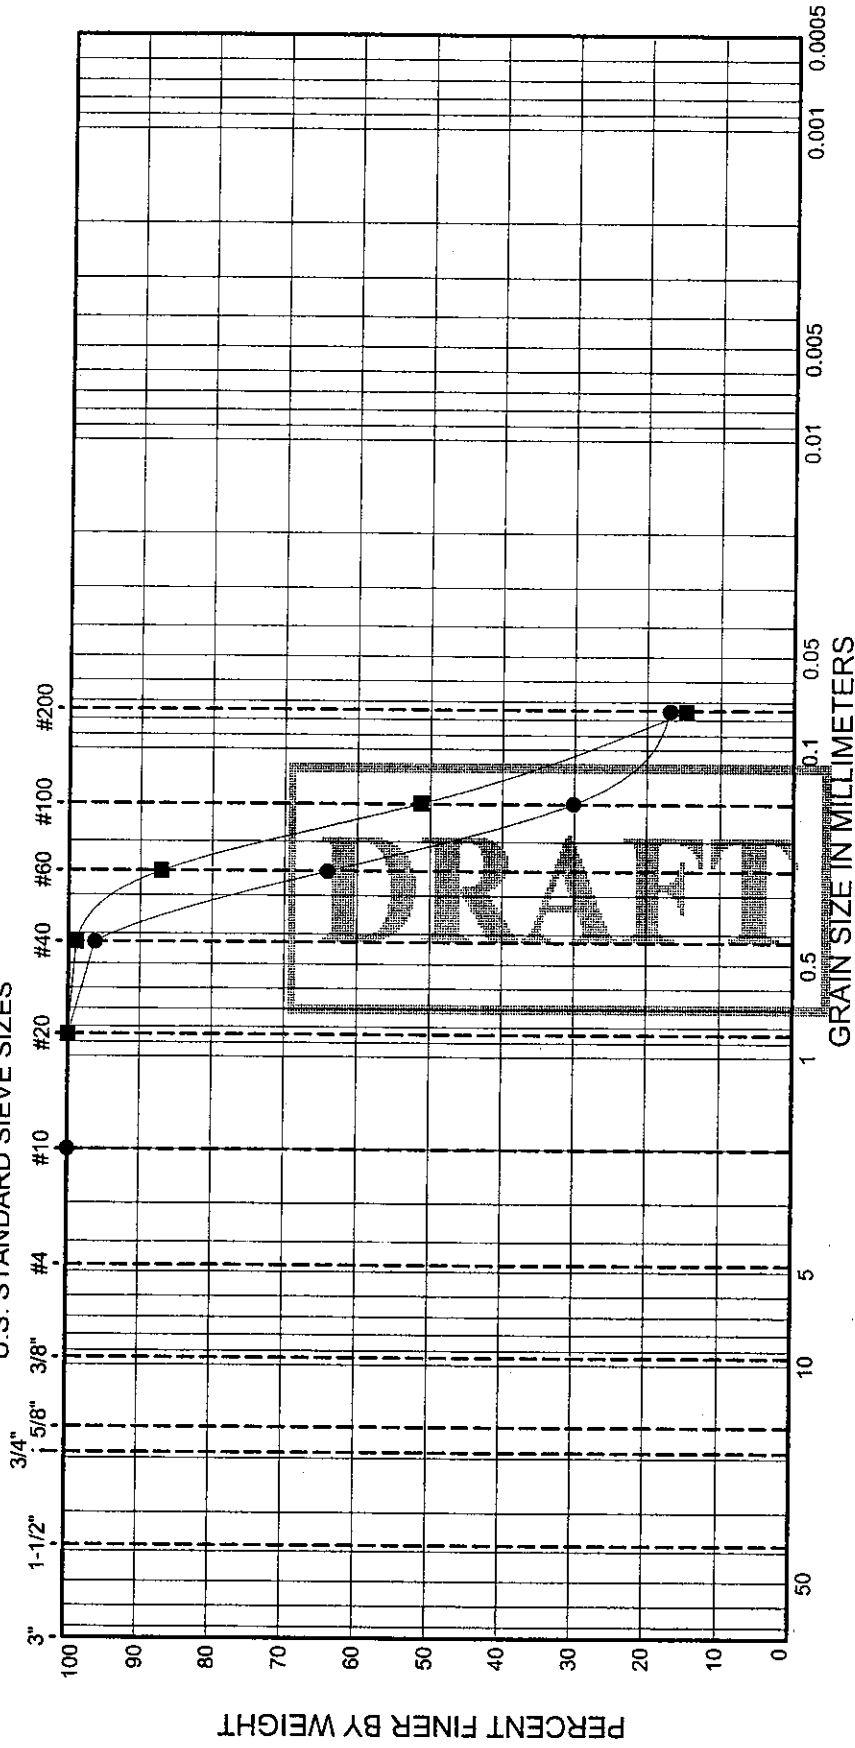
SYMBOL	SAMPLE	DEPTH (ft)	CLASSIFICATION OF SOIL- ASTM D2487 Group Symbol and Name	% MC	LL	PL	PI	Gravel %	Sand %	Fines %
●	BH-5	15.0 - 16.5	(SM) Olive brown, silty SAND	14				83.1	16.9	
■	BH-5	25.0 - 26.5	(SM) Grayish brown, silty SAND	6				85.3	14.7

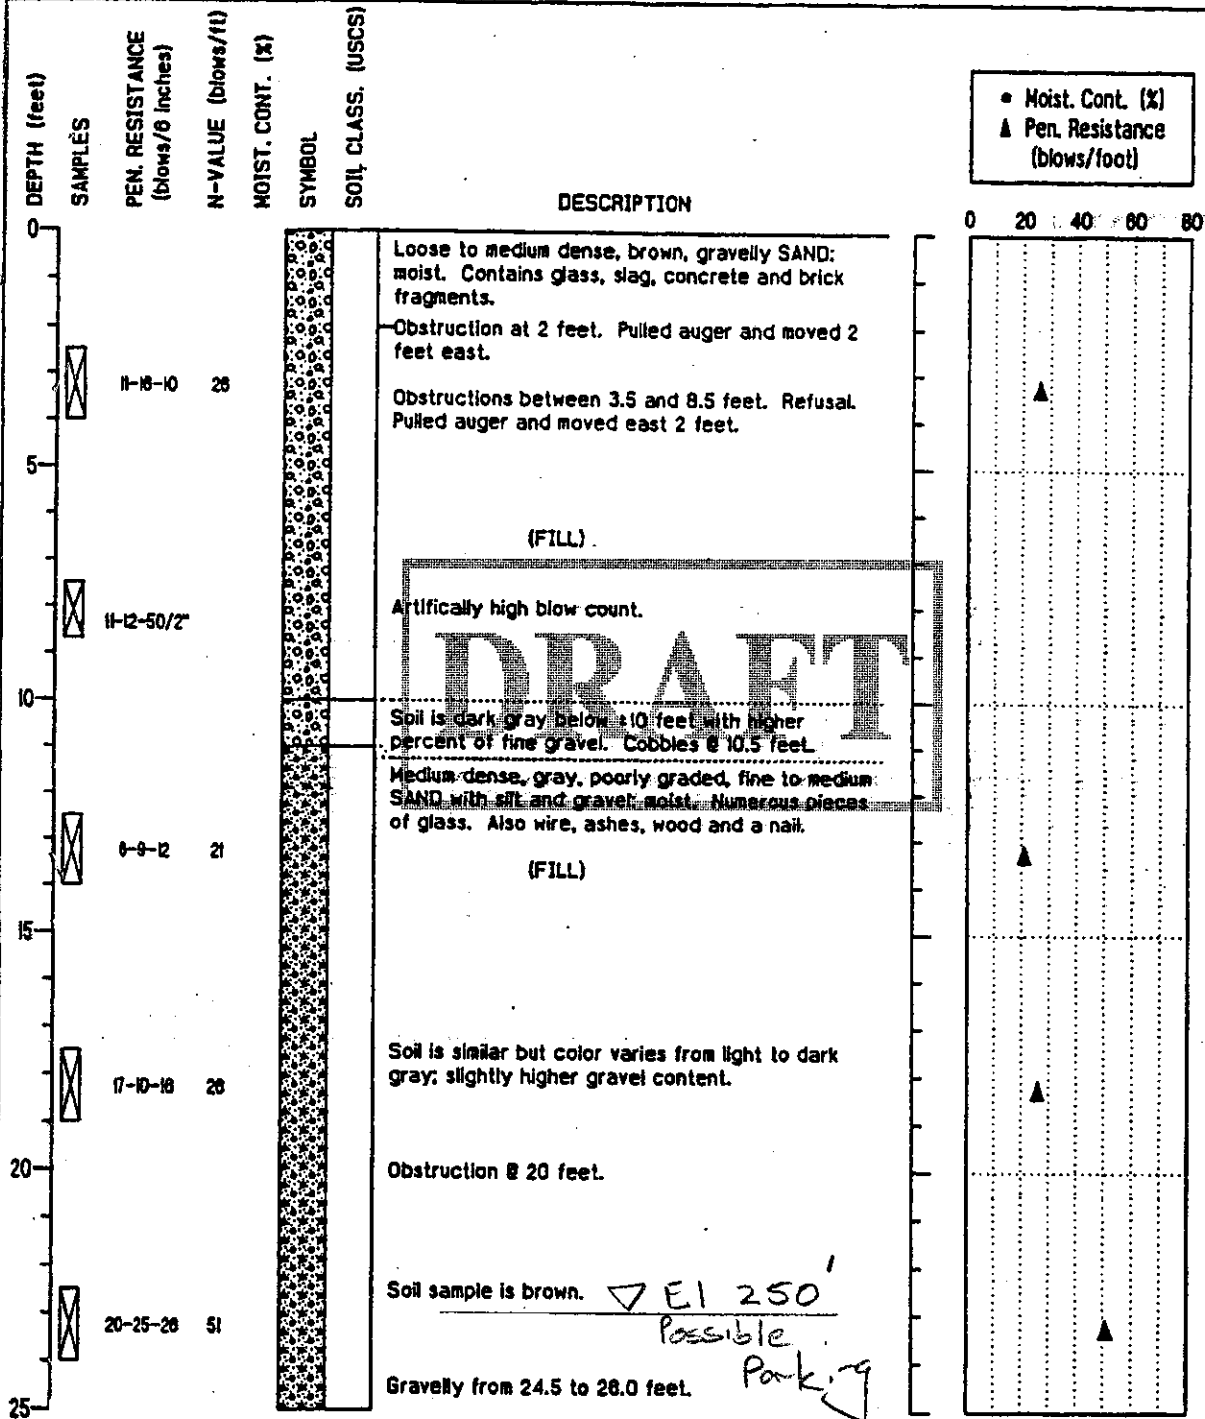
PROJECT: BOW LAKE TRANSFER STA. BORING: BH-1

DRILLING COMPANY: Pacific Testing Laboratories
 DRILLING METHOD: 4-inch I.D. CFHS Auger
 SAMPLING METHOD: SPT

TOTAL DEPTH: 44.0 Feet
 SURFACE ELEVATION: +273 Feet
 MEASURING POINT EL.: Feet

Boring #	Ground Elevation (feet)	Depth to Base of Fill (Bottom Elevation) (feet)	Thickness of Fill Remaining below Final Grade (feet)*	Total Boring Depth (feet)	Description of Material below Final Grade
BH-1	273	29.5 (243.5)	6.5	44	Medium dense, fine to medium sand with silt and gravel
BH-2	279	3 (276)	No fill remaining	41.5	Weathered till grading to till over ice-contact drift
BH-3	275	35 (240)	10	44.5	Loose to medium dense, silty gravelly sand with refuse inclusions over dense, fine to clean sand, ice-contact drift
BH-4	286	35 (251)	1	49.5	Thin layer of medium dense fill over medium dense, clean fine to medium sand, ice-contact drift
BH-5	279	2 (277)	No fill remaining	41.5	Medium dense to very dense, fine to medium sand, ice-contact drift
