October 2, 2018  
Project No. 170017H001

Subject: Subsurface Exploration, Infiltration Testing, Design Infiltration Rate,  
and Groundwater Mounding Analysis  
Maple Valley Asphalt Plant  
18825 SE Renton-Maple Valley Road  
King County, Washington

MAPLE VALLEY ASPHALT PLANT  
KING COUNTY, WASHINGTON

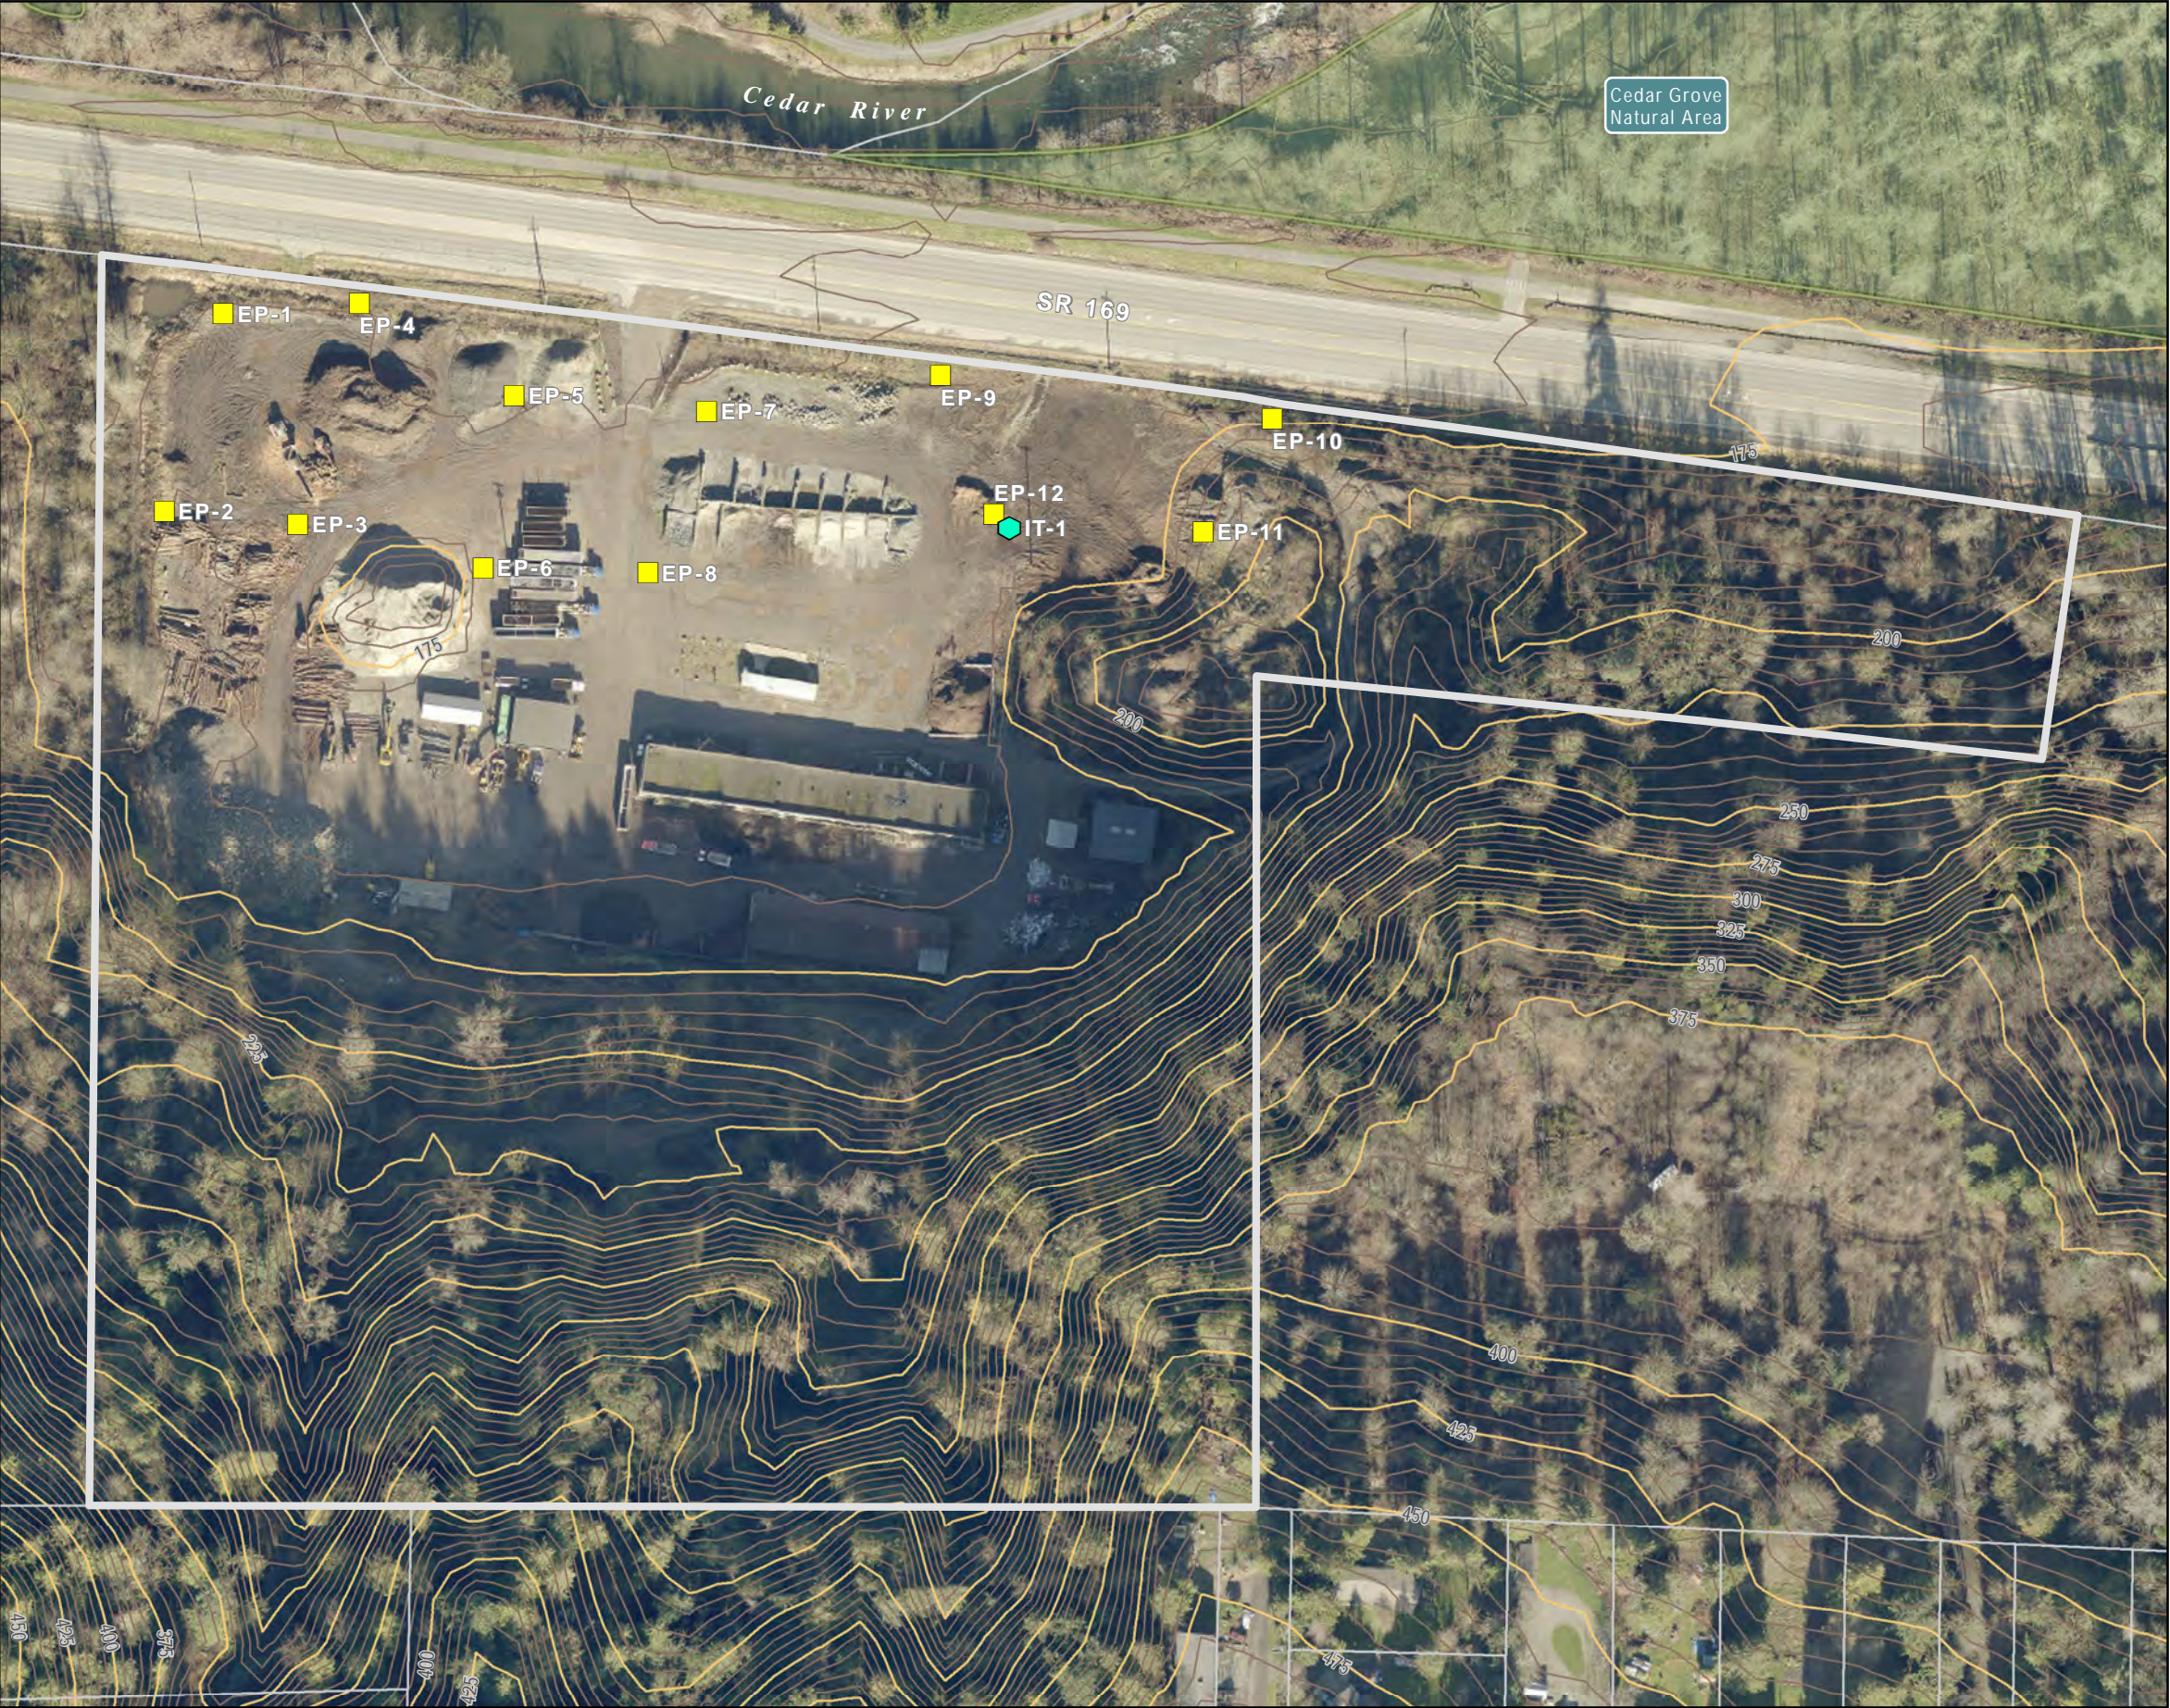
PROJ NO.	170017H001	DATE:	9/18	FIGURE:	2
----------	------------	-------	------	---------	---

The site location is shown on the "Vicinity Map," Figure 1. The approximate locations of explorations completed by AESI for this study are shown on the "Exploration Map," Figure 2. Monitoring well locations installed onsite by Farallon are presented on Figure 3, "Site Plan." Appendix A contains interpretive logs of AESI's explorations, laboratory test results, and

Subsurface exploration and infiltration testing were completed on January 18, 2018 and April 24, 2018 and consisted of twelve exploration test pits (EP-1 to EP-12) and one infiltration test (IT-1). Explorations EP-12 and IT-1, completed on April 24, 2018, were focused in the proposed infiltration facility area. Soil samples were obtained from the excavator for grain-size analysis. The various types of materials and sediments encountered in the explorations, as well as the depths where characteristics of these materials changed, are indicated on the exploration logs included in Appendix A. The depths indicated on the logs where conditions changed may represent gradational variations between sediment types in the field. AESI's explorations were approximately located in the field relative to known subject site features (Figure 2).

An infiltration test was completed at the location shown on Figure 2 to obtain a preliminary design infiltration rate for the proposed infiltration facility. The field-calculated infiltration rate was over 750 inches per hour (in/hr) (Appendix A). Applying suitable correction factors to the field-derived rates, as required in the 2016 KCSWDM, results in a rate of 134 in/hr. However, the maximum design infiltration rate allowable by the 2016 KCSWDM is 20 in/hr.

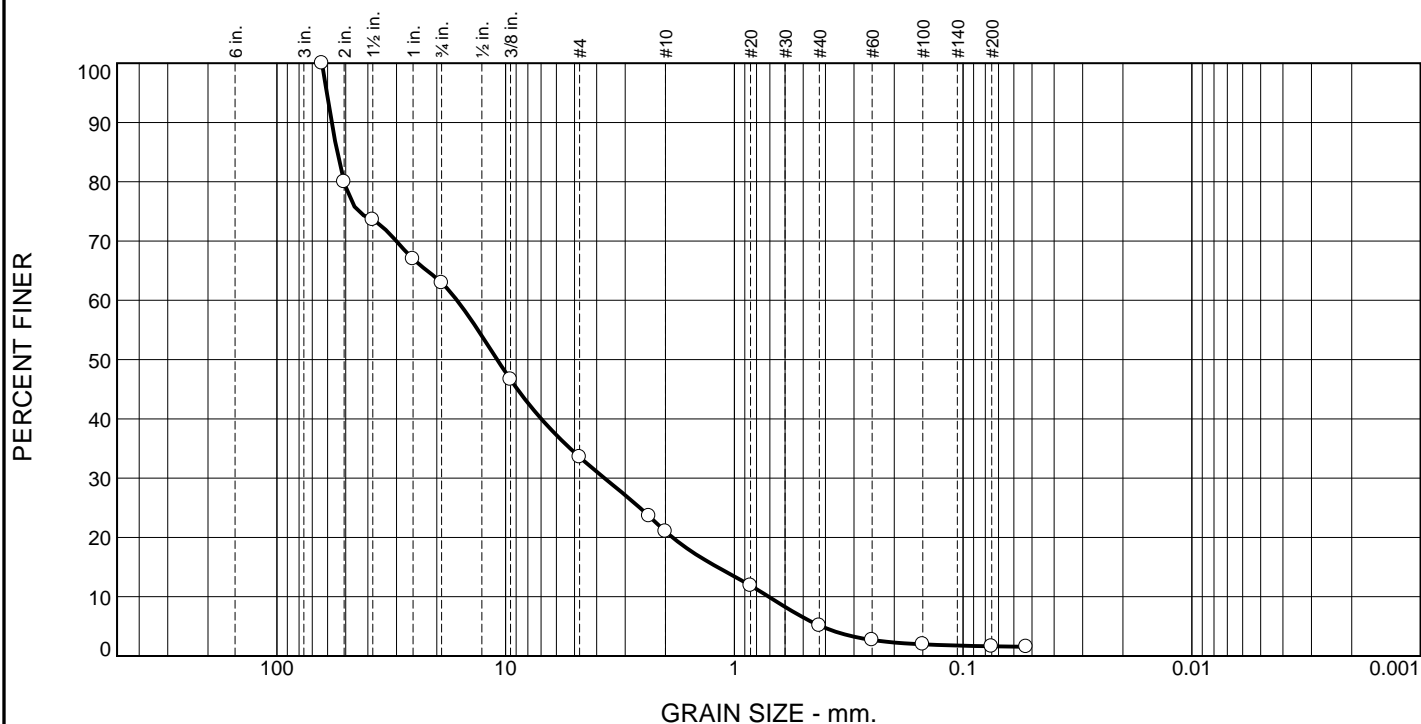
# Particle Size Distribution Report

% +3"	% Gravel		% Sand			% Fines	
	Coarse	Fine	Coarse	Medium	Fine	Silt	Clay
0.0	37.0	29.4	12.6	15.9	3.5	1.6

TEST RESULTS (ASTM D 422)			
Opening Size	Percent Finer	Spec.* (Percent)	Pass? (X=Fail)
2.5	100.0		
2	80.0		
1.5	73.6		
1	67.0		
.75	63.0		
.375	46.6		
#4	33.6		
#8	23.6		
#10	21.0		
#20	11.9		
#40	5.1		
#60	2.7		
#100	2.0		
#200	1.6		
#270	1.5

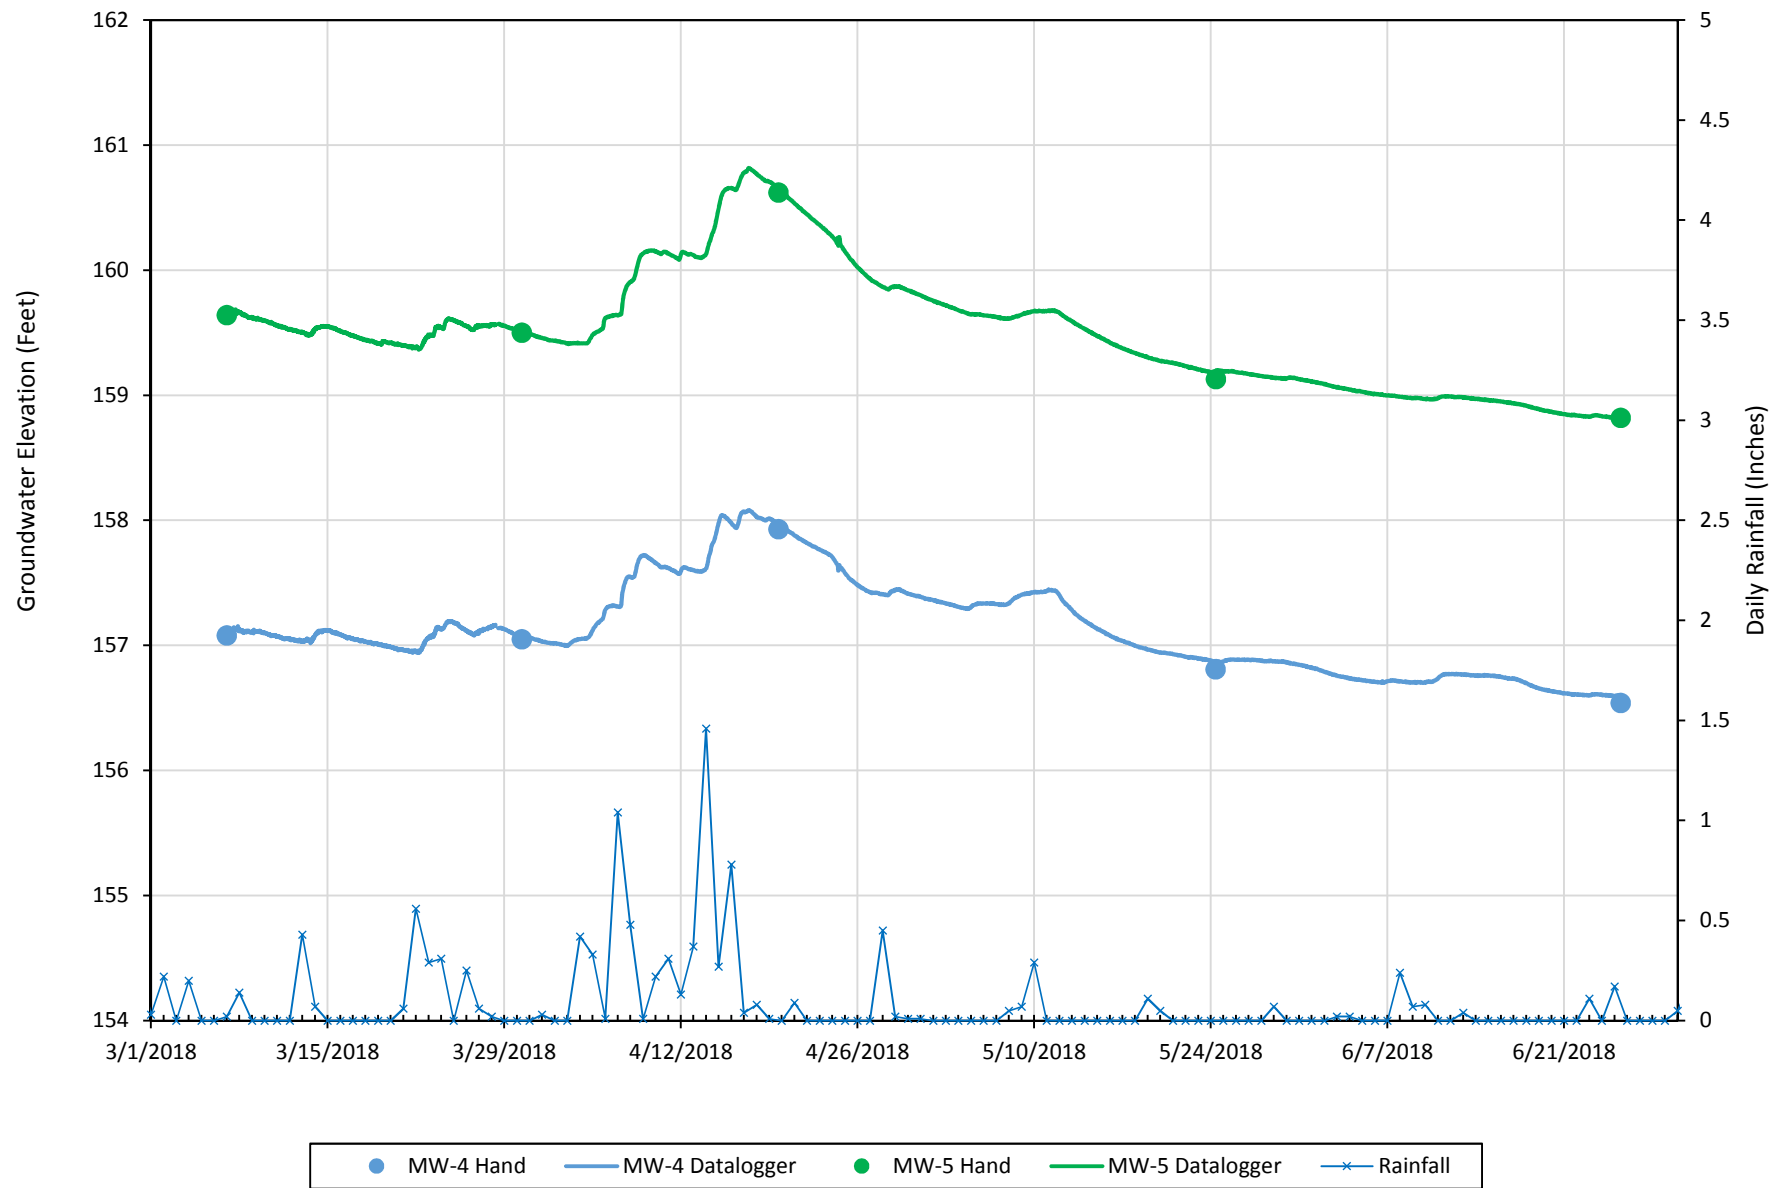
Appendix B: Groundwater Hydrograph MW-4 and MW-5  
Maple Valley Asphalt Plant

Groundwater was observed in AESI's explorations completed for this study between depths of 6.5 feet to 13.5 feet bgs. On-site monitoring wells, MW-1 to MW-7, were completed within the alluvial aquifer and were terminated above the base of the aquifer at 20 feet bgs. MW-4 was drilled to a bottom hole elevation of approximately 143.5 feet. A groundwater contour map prepared by Farallon (Appendix B) depicts a generally northeast-trending groundwater flow direction, with a gradient of approximately 0.06 to 0.08 feet vertical per foot horizontal (ft/ft). The maximum groundwater elevation recorded by Farallon near the infiltration facility was 160.82 feet (MW-5) in April 2018.

Based on the KCSWDM, the maximum design infiltration rate for the infiltration facility is 20 in/hr. The maximum groundwater elevation collected in the vicinity of the infiltration facility was 160.82 feet (MW-5) in April 2018. AESI used a maximum groundwater elevation of 161.9 feet, equating to a 3-foot separation from the bottom of the facility. The bottom of the aquifer was not encountered in our explorations or Farallon's monitoring wells. The elevation of the deepest point explored in the vicinity of the infiltration facility was 143.5 feet in MW-4 and was used in the model as the base of the aquifer.

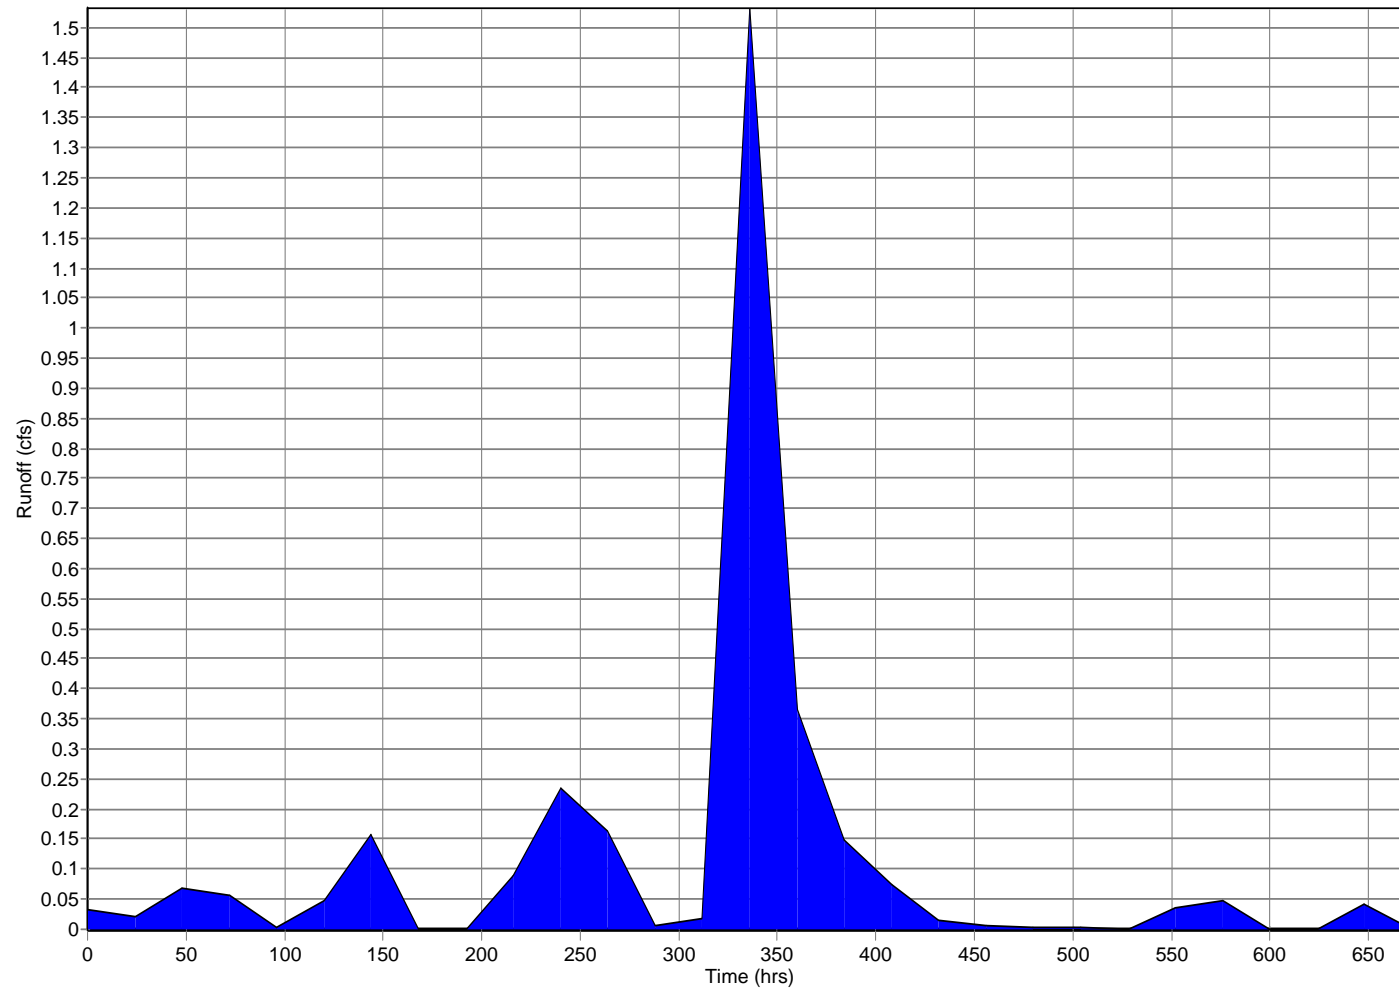
HYDROGRAPH : LIMV Peak Flow Hydrograph

Qpeak: 1.5320 cfs    Time of peak: 336.0 hrs    Vtotal: 273,154 ft<sup>3</sup>

DEA provided two stormwater hydrographs for the infiltration facility: one from a period that includes the highest flow rate (peak flow) and one from a period of maximum volume, derived from the Western Washington Hydrology Model (WWHM) surface water model. In DEA’s analyses, the period of the peak flow hydrograph is November 2, 2006 to December 1, 2006, with the peak flow occurring on November 6, 2006. The 30-day date range with the maximum volume is October 6, 2003 to November 4, 2003. Prints of the spreadsheet pages containing the hydrographs provided by DEA are included in Appendix C. DEA also provided facility

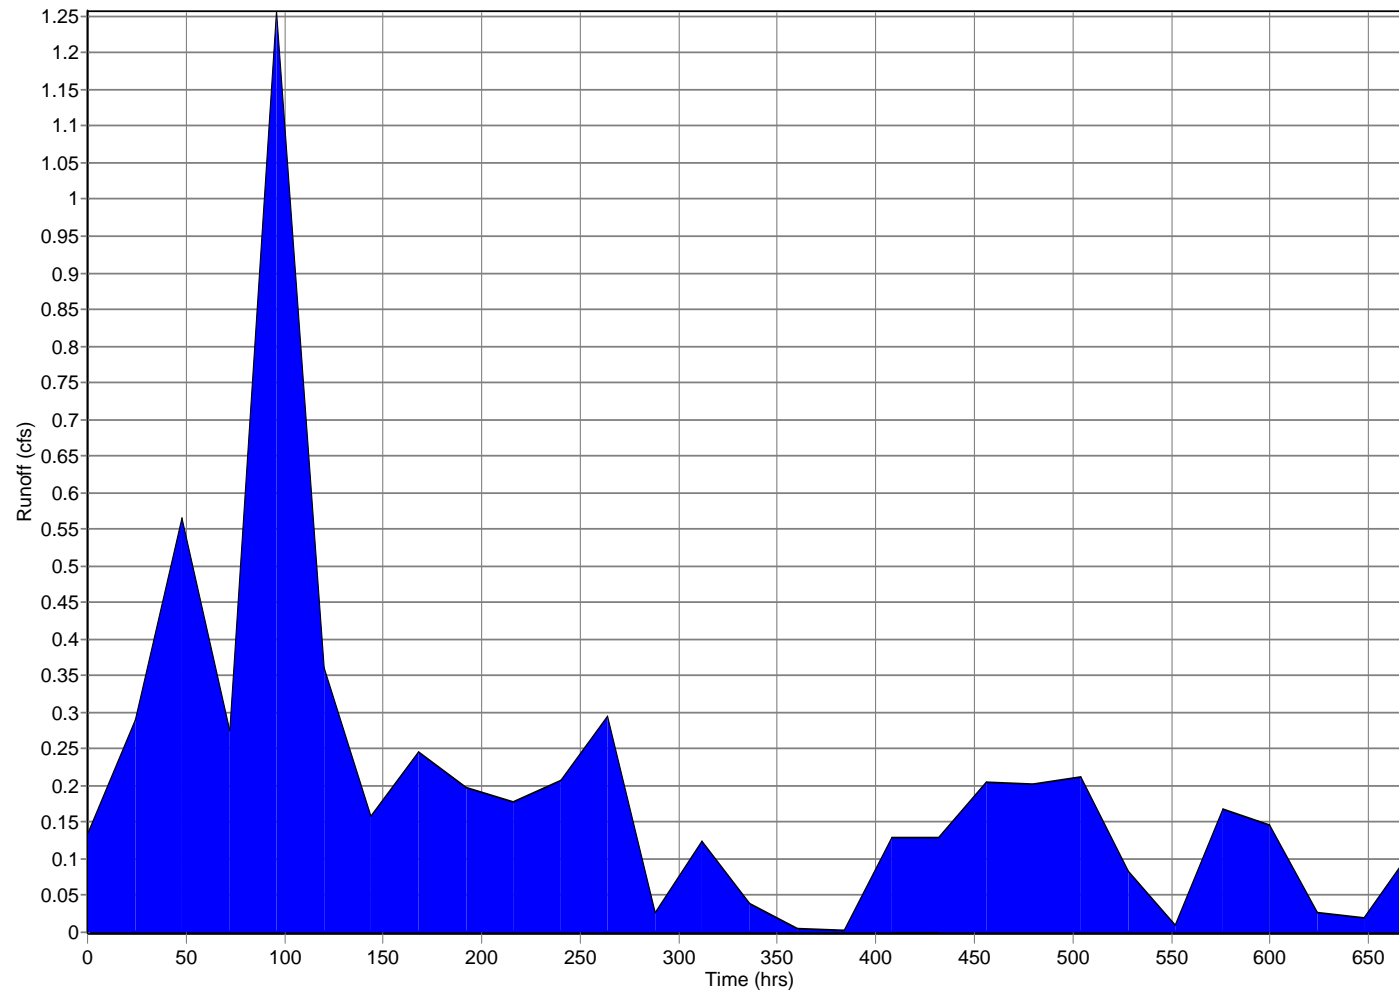
HYDROGRAPH : LIMV Max Volume Hydrograph

Qpeak: 1.2570 cfs    Time of peak: 96.0 hrs    Vtotal: 490,882 ft<sup>3</sup>
